# HOME INSPECTION REPORT

32 Radford Ave

Prepared by: Bob Papadopoulos P.Eng., RHI \*

Inspection Date: [March 31 2026](#)

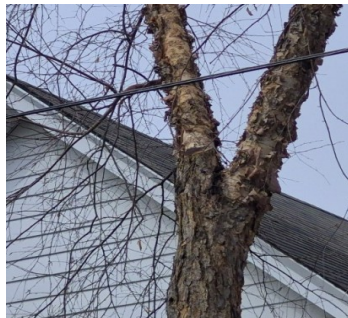
Sloped Surface: [overall surface in good repair](#)  
[some shingles lifting/damaged - repair as required](#)

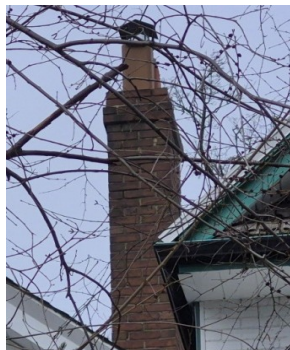
Chimney(s):  
 Southeast: [overall in good repair](#)

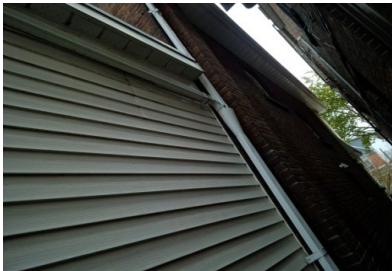
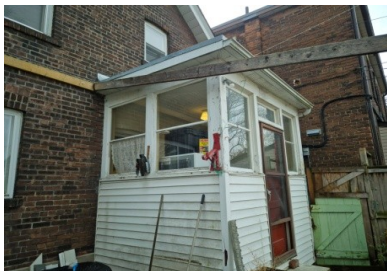
DOORS/WINDOWS: older units, continue to maintain, upgrades as required

DETACHED GARAGE: older, typically ongoing repairs  
likely more cost effective to replace

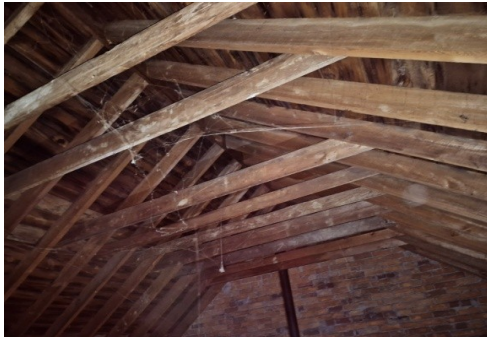
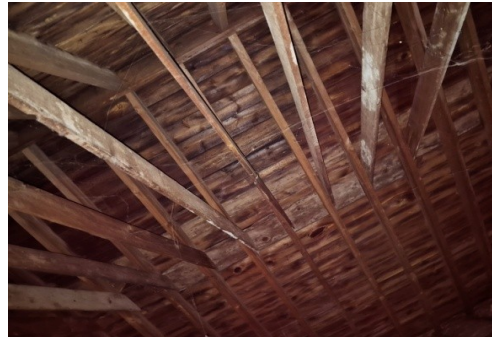
overall well built house

ROOF: overall in good repair

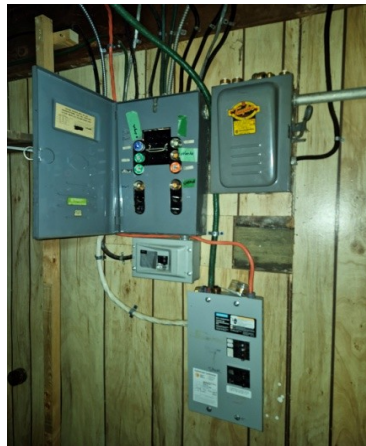
SERVICE PANEL: [over fused units \(i.e. wrong fuse size\)- repair](#)

[older fuse panel: upgrade as required/renovating and/or if required for insurance](#)

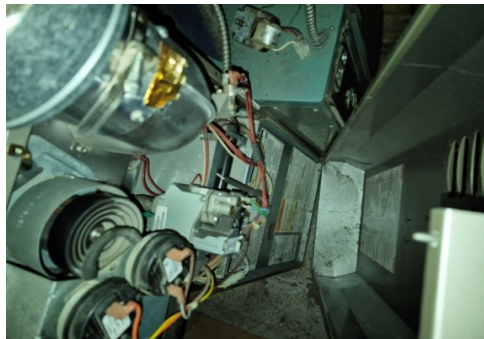
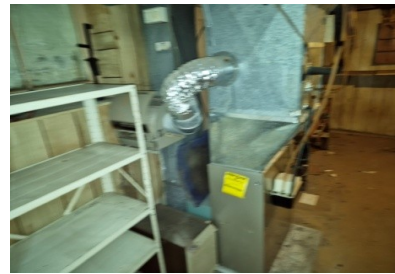
FORCED AIR FURNACE: continue servicing until replacement becomes necessary  
 Electronic Filter: old, appears not in use, repair/replace  
 Humidifier: old, replace

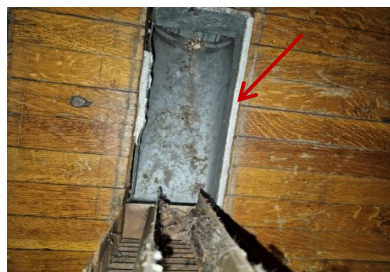
Registers: insulation around some registers may contain asbestos  
 encapsulating the insulation is often the best approach  
 Environmental Consultants can assist if this is a concern

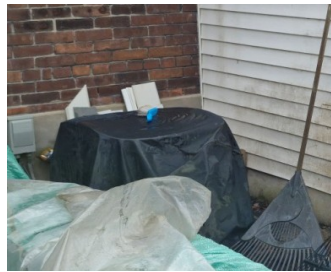
AIR CONDITIONER: not tested: should be serviced before using  
old unit, continue servicing until replacement becomes necessary

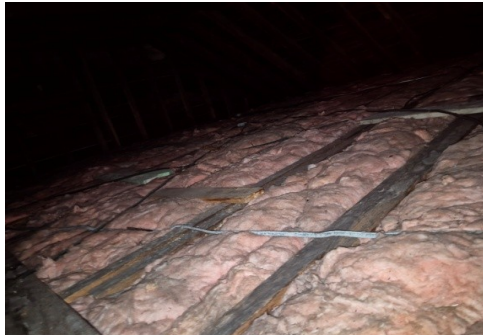
ROOF SPACE: recommend upgrading insulation to improve comfort and efficiency  
 recommend installing vapour barrier  
 recommend improving ventilation with soffit vents

exposed wires - should be installed properly before adding insulation

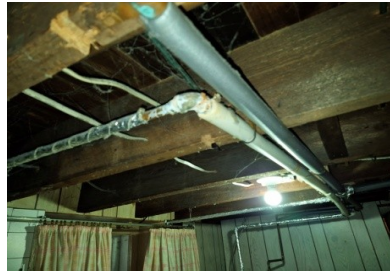
SUPPLY PIPING: majority appears to be copper, where examined in good repair  
Galvanized Steel: older, corroded, requires replacement
