# HOME INSPECTION REPORT

76 Parkway Ave  
Toronto

Inspection Date: [April 15 2026](#)

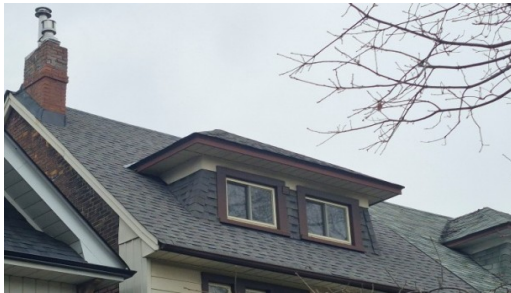
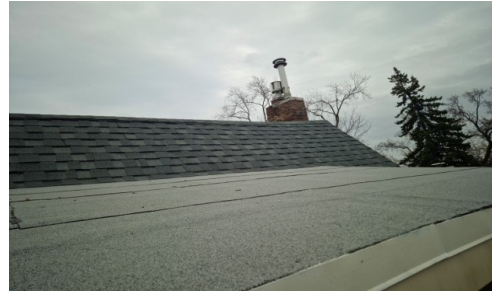
Sloped Surface: overall surface in good repair  
 Flat Surface: overall surface in good repair

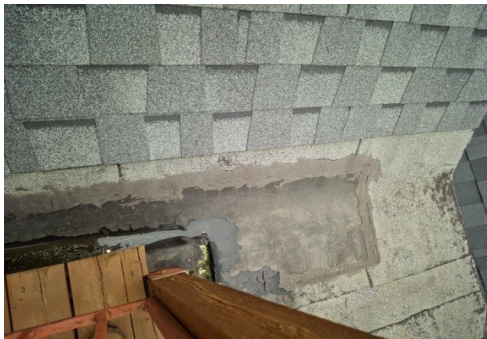
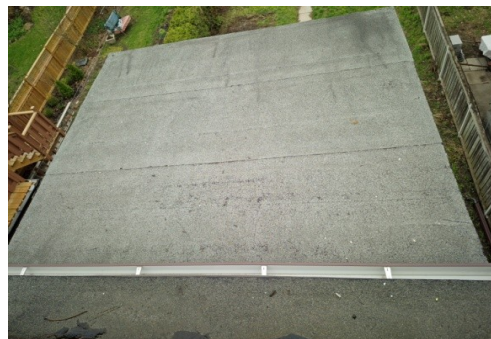
2nd Flat: deck/extension: overall surface in good repair  
 Roof/Wall: patched along edge - monitor/service as required

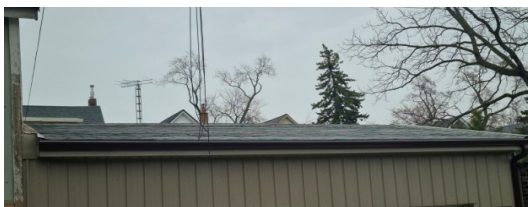
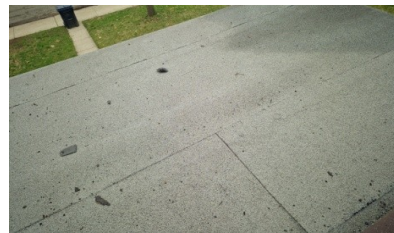
Garage: overall surface in good repair  
 Porch(s): overall surface in good repair

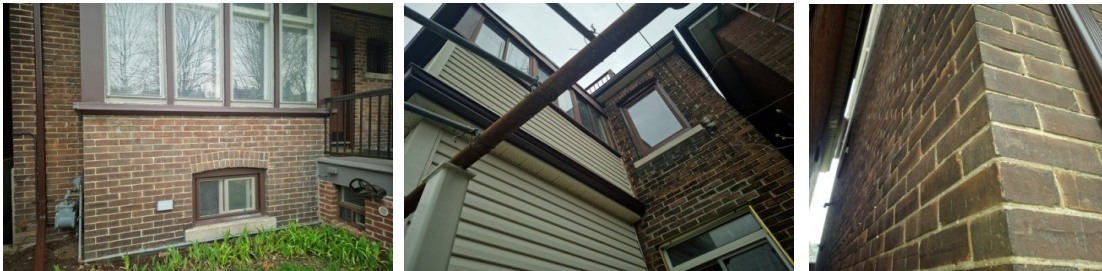
\*\*Walk(s): front of porch: budget to repair

WALL SURFACES: overall in good repair  
DOORS/WINDOWS: overall in good repair

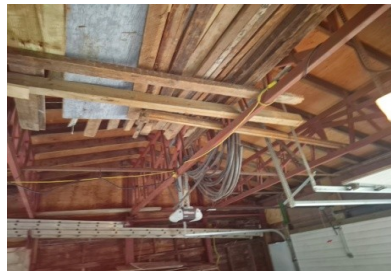
DETACHED GARAGE: overall in good repair, older structure that has been improved/restored

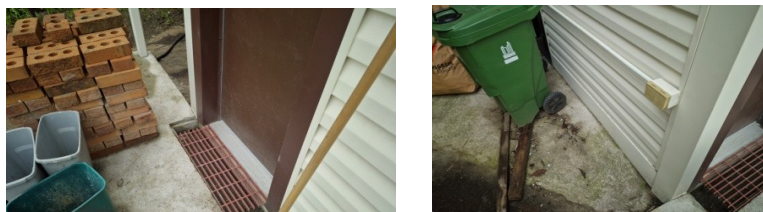
\*\*Walk(s): drainage/trough system unusual - service/ monitor performance  
rear drains near foundation- see Interior basement

Note: Maintain Gutters & Downspouts annually. Extend Downspouts at least 6-feet away from the house

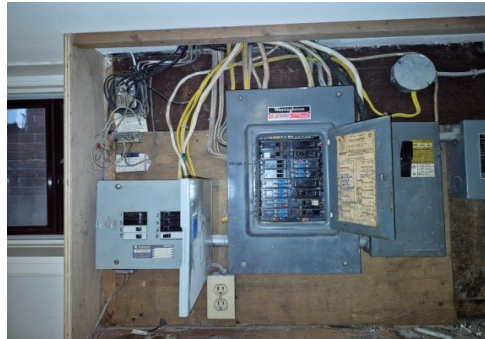
SERVICE ENTRANCE: **older mast: upgrade as required/renovating**  
 Main Disconnect: **overall in good repair**  
 SERVICE PANEL: **older, might require upgrading to larger panel if renovating**

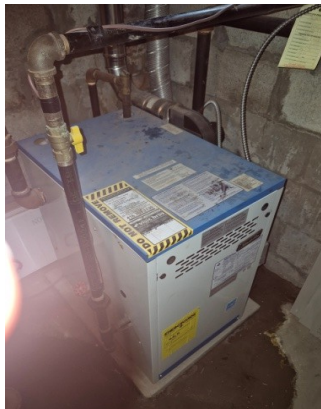
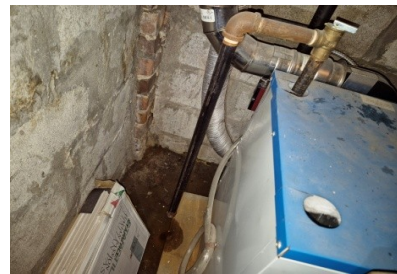
HOT WATER BOILER: service annually  
recommend obtaining replacement parts/servicing contract  
Pressure Relief Valve: dripping - repair

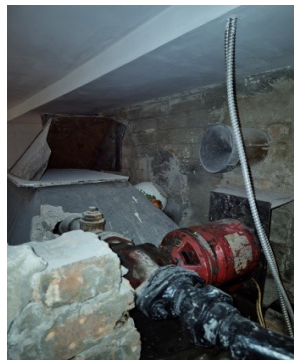
Radiator(s): monitor/repair valves as required

Piping: reported piping/pump integrated with wood stove for heat exchange,  
unusual- recommend further evaluation by specialist
