# HOME INSPECTION REPORT

9 Camborne Ave  
Toronto

Prepared for: Theodore Babiak Team

Inspection Date: April 8 2026

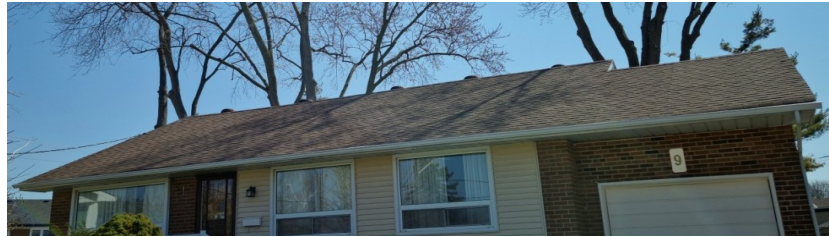
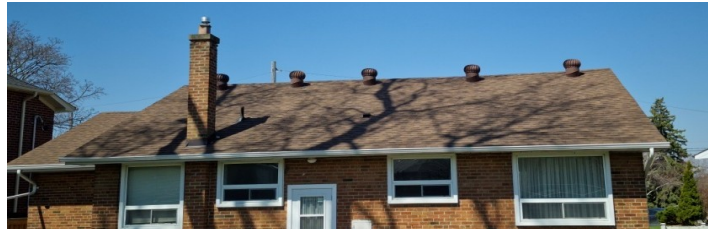
Sloped Surface: overall surface in good repair

Chimney(s): monitor/repair as required

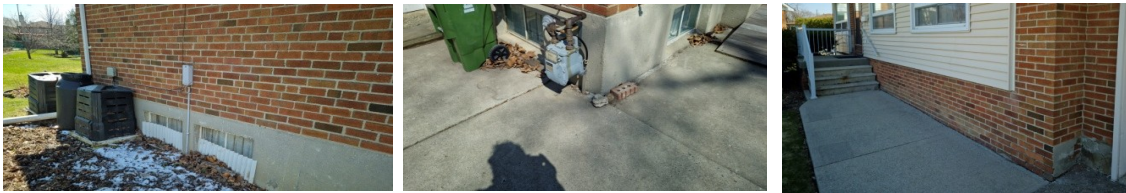
**\*\*Window wells: north side: might be required - see Interior Basement**  
**\*\*Walk(s)/Driveway(s): seal gaps along foundation wall**

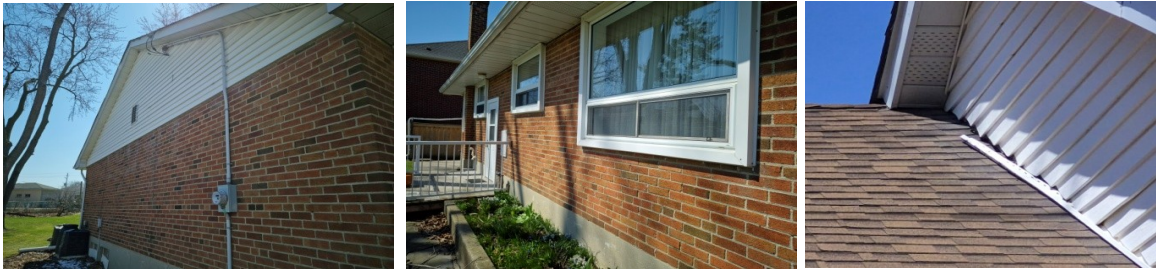
Brick: overall in good repair, repair at front corner

Vinyl Siding: trim repair at rear - minor

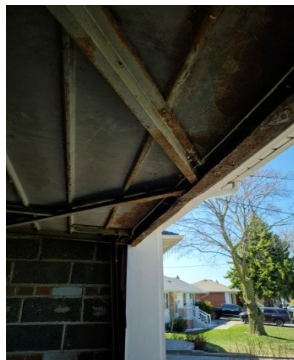
**ATTACHED GARAGE: older car door- budget to replace**

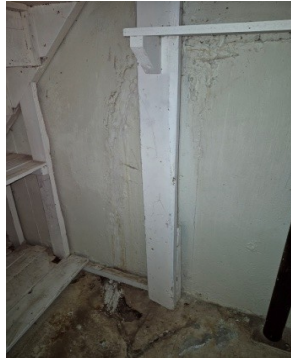
FOUNDATIONS: typical settlement crack under basement steps - prior repaired, see Interior Basement

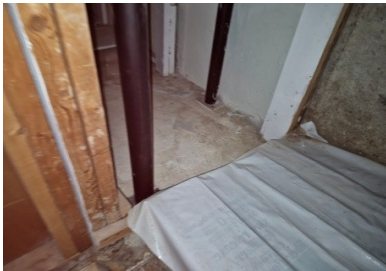
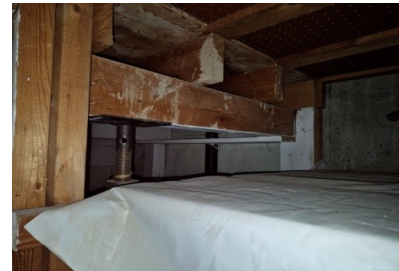
Stair Opening: basement wood supports damaged at floor: reinforced with metal posts

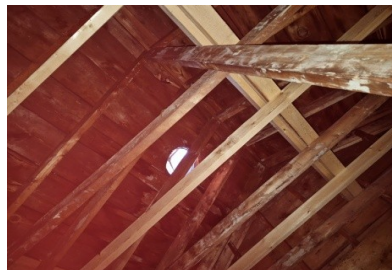
ROOF: overall in good repair

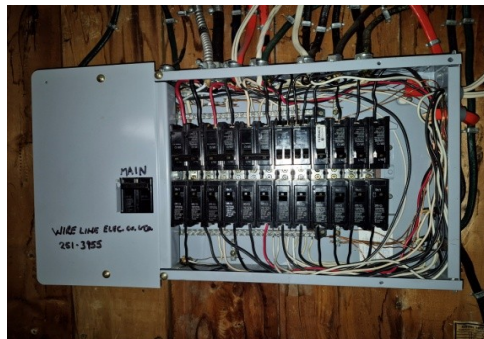
SERVICE ENTRANCE: **overall in good repair**  
 SERVICE PANEL: **overall in good repair**

Ungrounded Outlet(s): **provide GFCI's (ground fault circuit interrupters) and/or upgrade wiring if renovating**

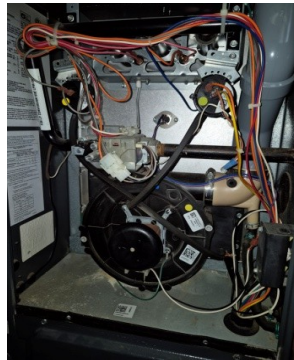
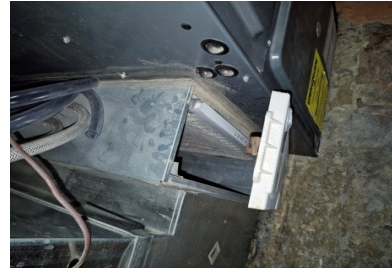
FORCED AIR FURNACE: [service annually](#)  
[recommend obtaining replacement parts/servicing contract](#)  
Filter: [recommend properly sized for cabinet - refer to model#](#)

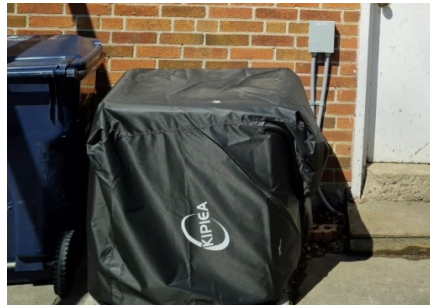
AIR CONDITIONER: not tested: should be serviced before using

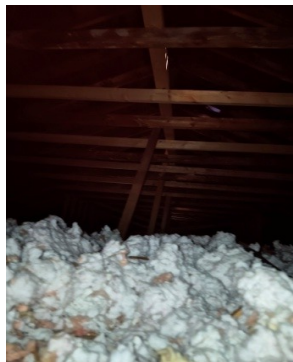
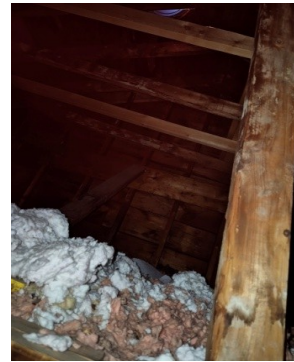
ROOF SPACE: recommend upgrading insulation to improve comfort and efficiency  
uneven distribution of insulation - improve/add insulation

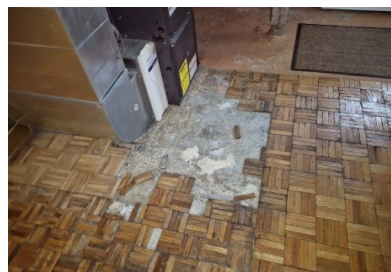
Floors/Walls/Ceilings: basement: anticipate renovations  
 Floors: basement: damaged, possibly water damage due to prior basement and/or plumbing leaks and/or furnace leak  
 Floors: basement: damaged, possibly due to moisture from concrete floor  
 \*\*Basement Leakage: presently no leaking detected with moisture meter random sampling typical efflorescence, staining and dampness for older foundation suspect prior leaking at rear of basement, prior foundation repair under steps, monitor, might require/recommend damp-proofing if renovating basement see steps below

1. gutters, downspouts, grading, driveways: ongoing maintenance and repair/see Exterior
2. cracks/form ties on foundation: monitor/repair as required
3. excavation/damp-proofing: monitor basement, consider step 3 as a last resort
