HOME INSPECTION REPORT

92 Indian Rd Cres
Toronto

Prepared by: [Bob Papadopoulos P.Eng., RHI](#) *

Inspection Date: [March 13 2026](#)

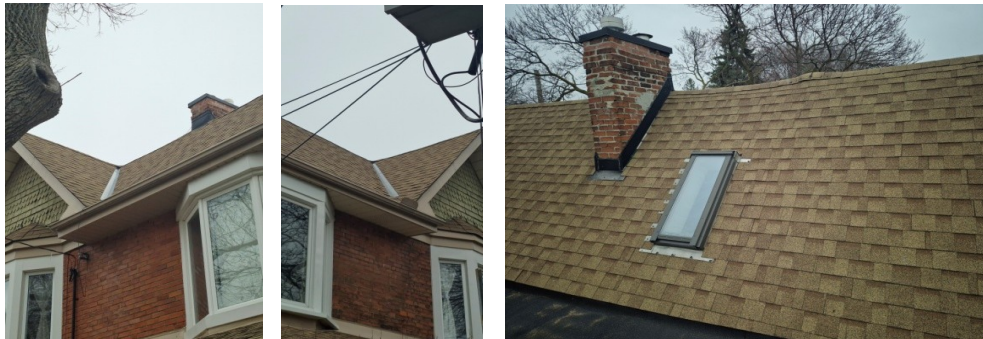
Sloped Surface: [overall surface in good repair](#)
 Skylight: [overall in good repair - service annually](#)
 Chimney(s): [overall in good repair](#)

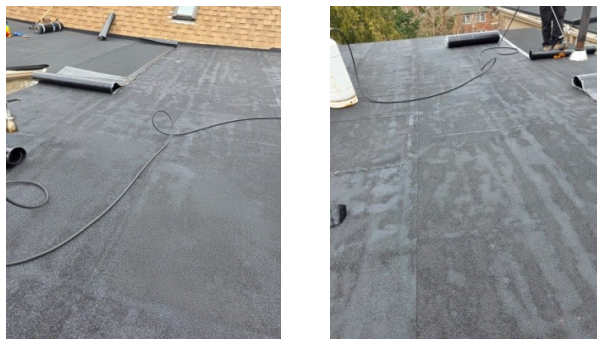
Flat Surface: [newly installed](#)

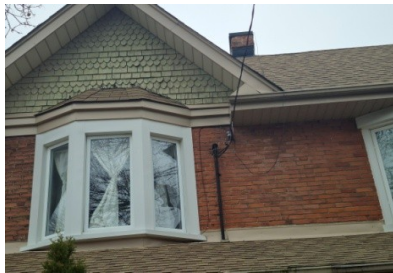
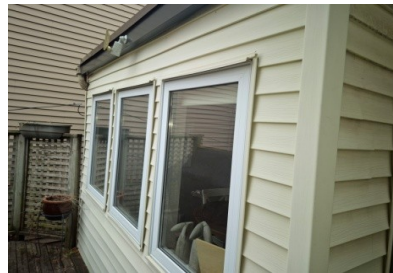
Wood Shingles: front: require general repairs and maintenance

PORCH rebuilt floor, columns require maintenance

DECK older, continue to maintain, budget to rebuild, central column added with no footing - monitor

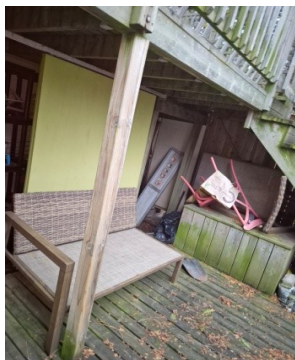
**BASEMENT WALKOUT: front and rear: limited access, ideally bottom landing of walkout should have drain, further evaluation/improve if required

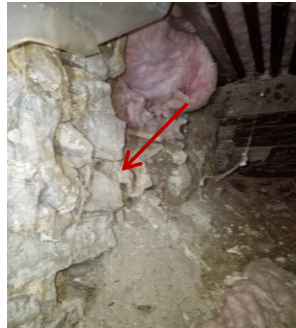
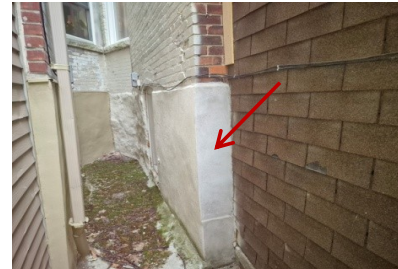
FOOTINGS/FOUNDATIONS west crawlspace: some damaged spot at 'inlet', this appears to be an older condition though should budget to repair- contact specialist, repair (poured concrete) noted at north west, overall continue to monitor and repair mortar as per usual for older stone foundation

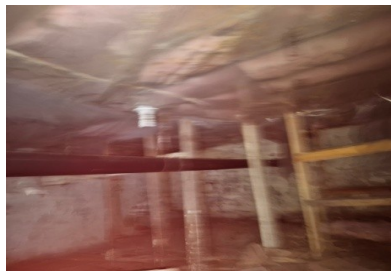
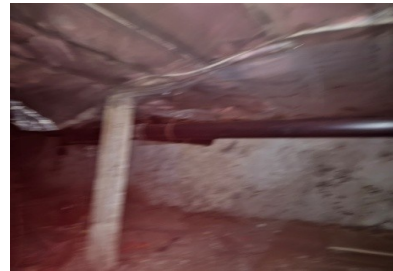
FLOORS: minor sagging floor at 2nd level and basement though typical for older house
Stair Opening: minor sagging around stair areas though typical for older house
FLOORS: basement floor joists are 'shored up' with 'make shift posts, overall performance is adequate and this is an older condition, continue to monitor and budget to improve i.e. proper post footings and beams, contact specialist

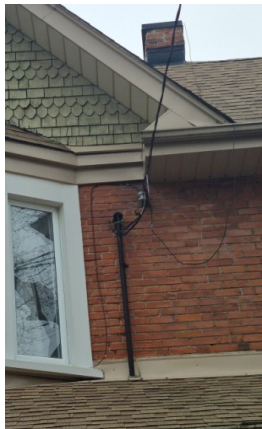
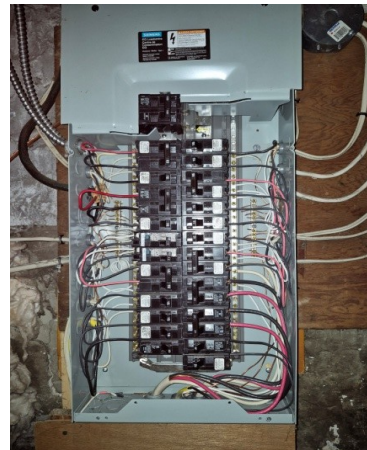
SERVICE ENTRANCE: overall in good repair
 SERVICE PANEL: overall in good repair

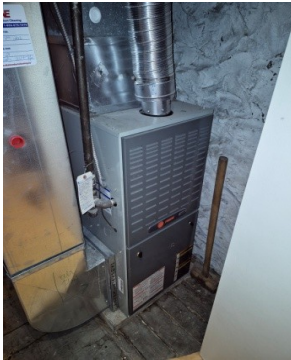
FORCED AIR FURNACE: [service annually](#)
[recommend obtaining replacement parts/servicing contract](#)
Filter: [replace 1-per-3 months](#)

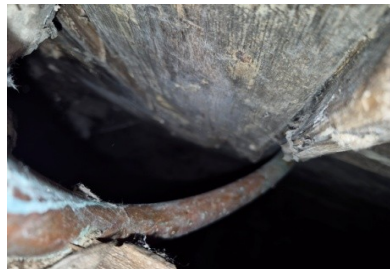
WATERMAIN: [crawlspace, recommend install heating cable/insulation to avoid freezing "seller reports never had any issues"](#)

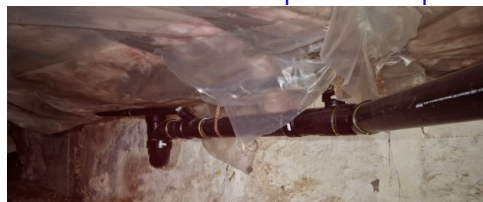
WASTE PIPING: [all piping examined was in good repair](#)
[newer installation in crawlspace](#)

Basement Floor Drain: [not visible in basement - provide if required](#)
