# HOME INSPECTION REPORT

348 Runnymede Rd  
Toronto

Prepared by: Bob Papadopoulos P.Eng., RHI \*

Inspection Date: [Feb 27 2026](#)

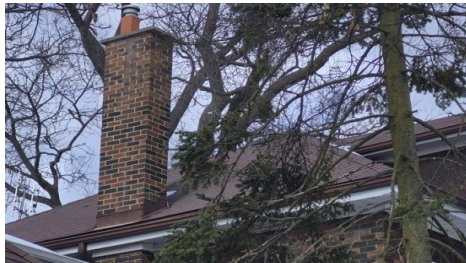
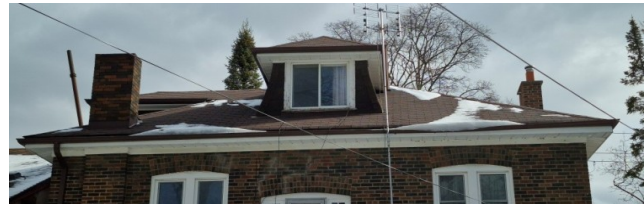
Roofing: [snow limited visibility, appears to be in good repair where visible](#)

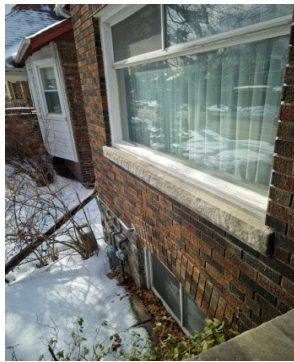
DOORS/WINDOWS: various requires general repairs and maintenance

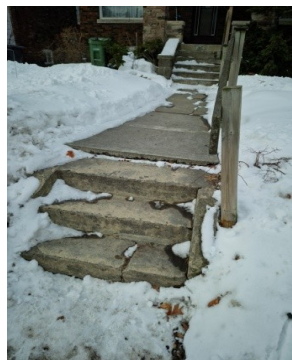
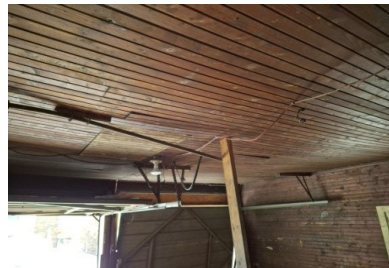
DETACHED GARAGE: older, typically ongoing repairs

bottom perimeter prone to rot - repair as required, budget to repair perimeter roof/ceiling requires structural repairs - contact specialist

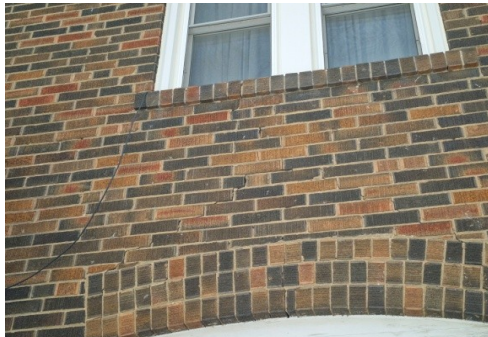
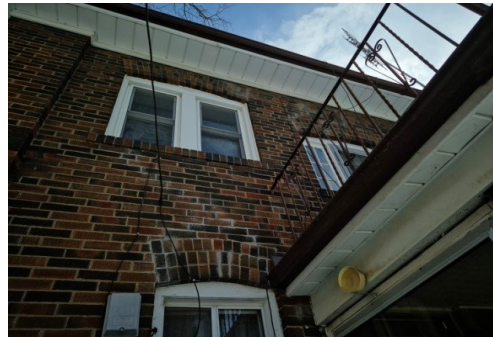
Masonry Arches: typical settlement cracks - repair, prior repairs typical, monitor

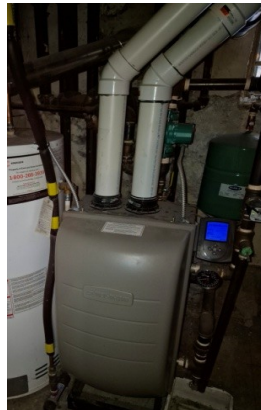
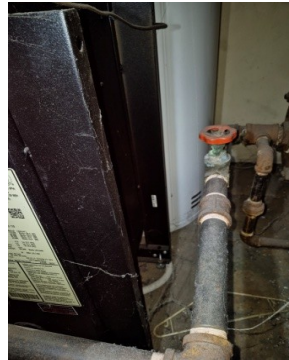
THERMOSTAT: low battery  
 HOT WATER BOILER: service annually  
 recommend obtaining replacement parts/servicing contract  
 valve corroded- repair

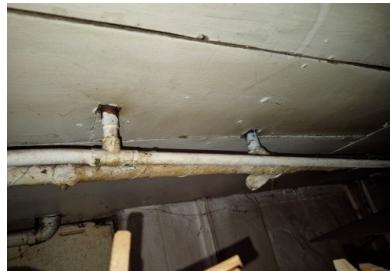
Galvanized Steel: various areas: will require replace typically for insurance purposes
