# Your Inspection Report

30 Woodside Ave  
Toronto, ON M6P 1L7

**PREPARED BY:**  
Jonathan Dube, RHI

RE: Report No. 97098  
30 Woodside Ave  
Toronto, ON  
M6P 1L7

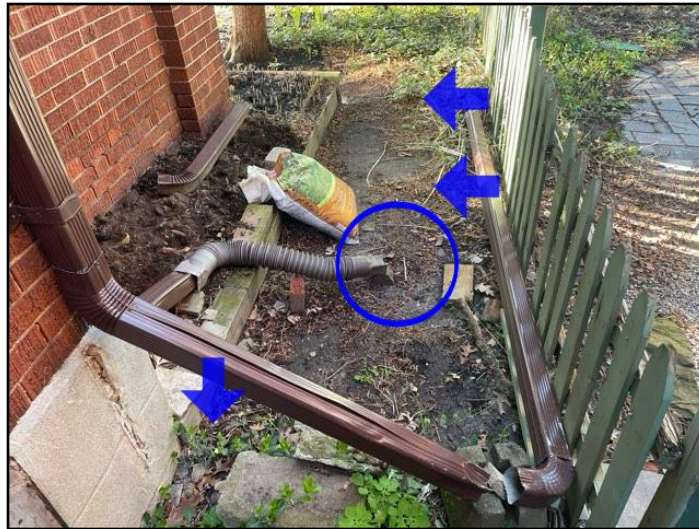
Condition: • [Discharge too close to building](#)

Downspout discharges in an area that slopes towards the foundation, smooth walled metal extensions are preferred over accordion style plastic extensions.

*Discharge too close to building*

Always transfer water as far away from the house as practical. However attention to erosion, tripping hazard, or creating a slippery ice surface should also be considered.

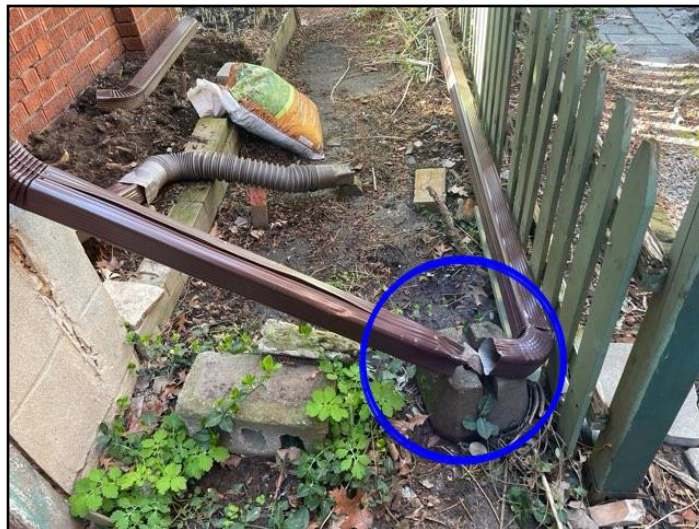
**Location:** Left side - front corner

**Condition:** • Loose

*Loose*

**Task:** Reconnect downspot

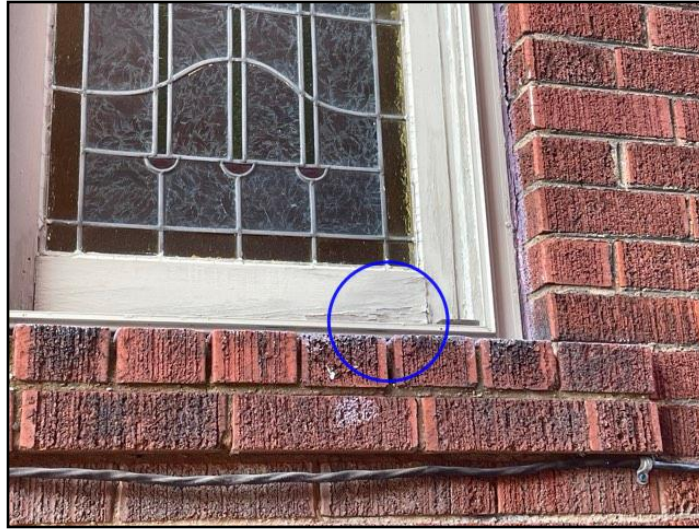
**Condition:** • Regular maintenance needed

Wooden elements require periodic maintenance, such as cleaning, painting and repair/replacement.

*Regular maintenance needed*

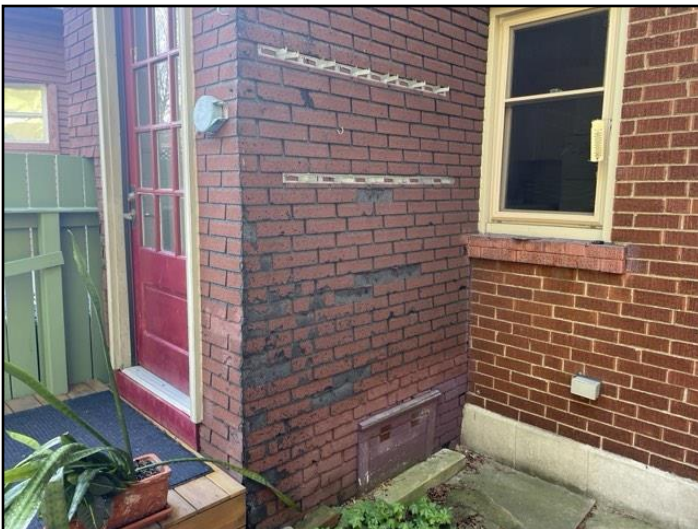
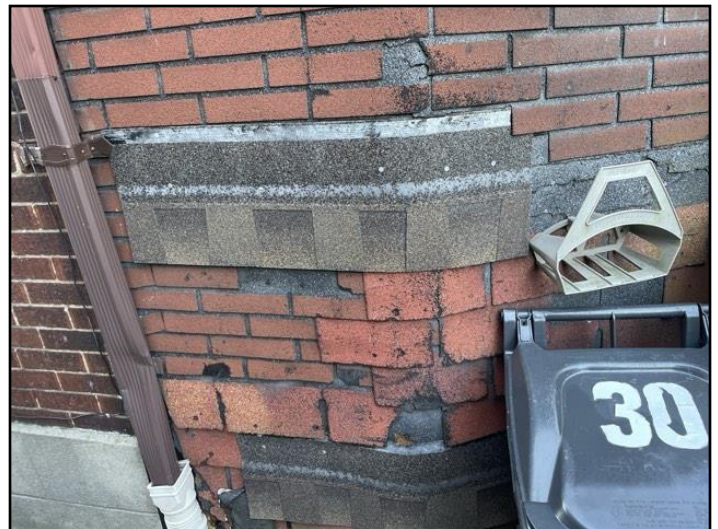
**Condition:** • Deteriorating asphalt shingles

*Deteriorated shingles*

**Task:** Remove and replace siding, (Inspect framing after removal and improve if needed)

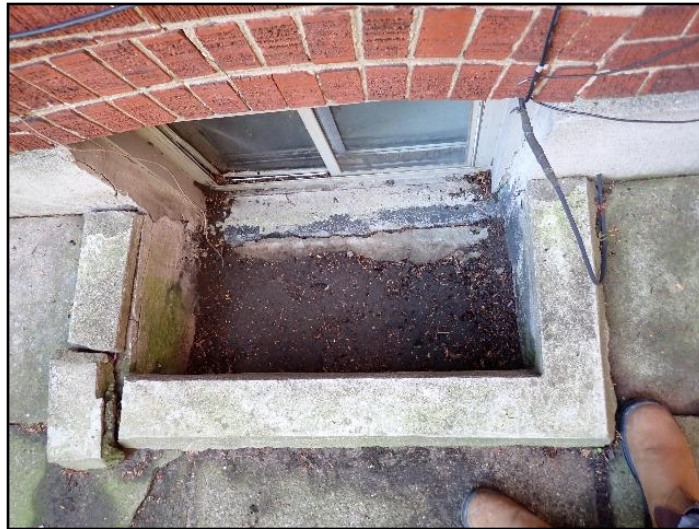
**Condition:** • Clogged

*Clogged*

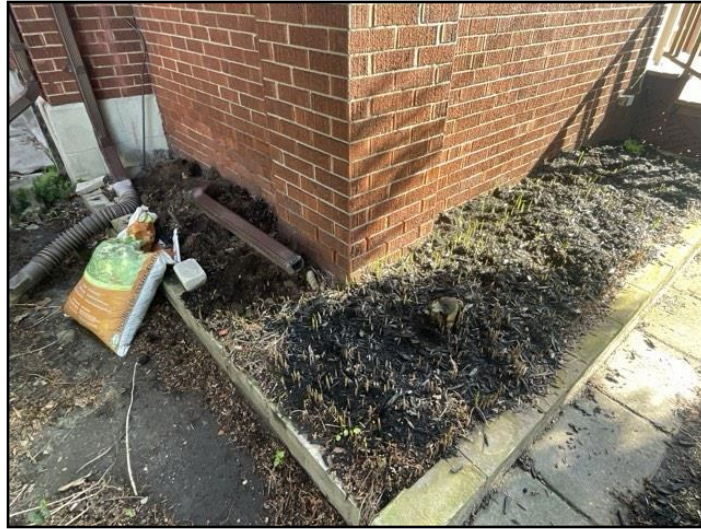
**Condition:** • Raised gardens against the house

*Raised gardens against the house*

**Task:** Monitor and re-arrange if necessary.

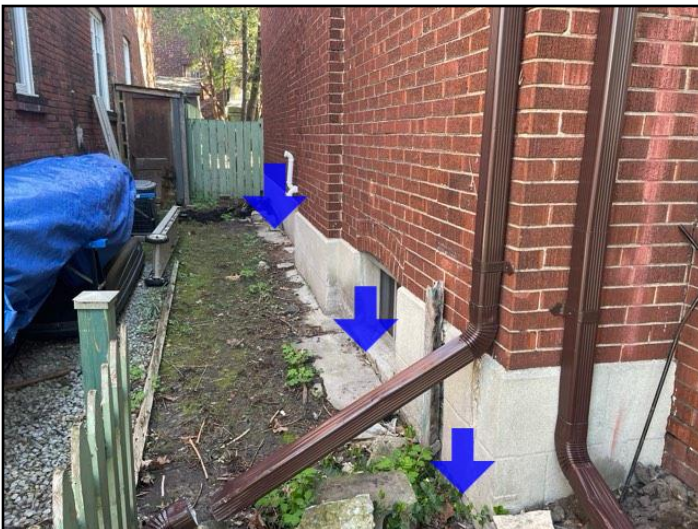
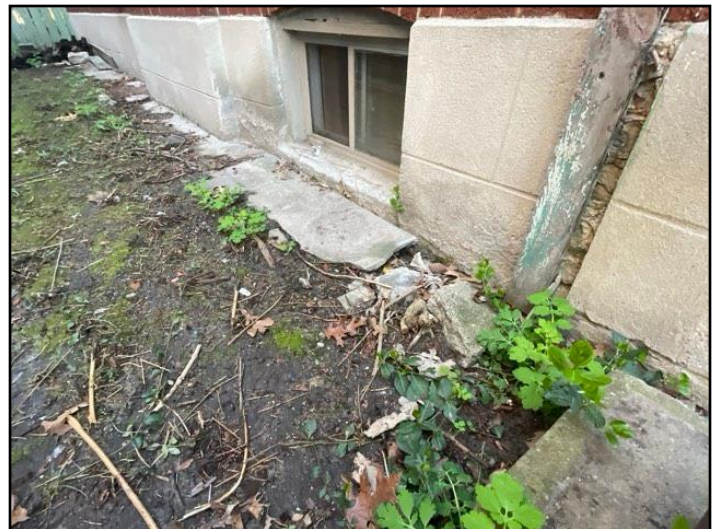
**Condition:** • The ground around some parts of the home does not slope to drain water away from the foundation.

*Lot grading*

**Task:** Improve grading so the ground slopes down at least 1 inch per foot for the first 6 feet away from the home. Note: Less slope is needed on hard surfaces like driveways

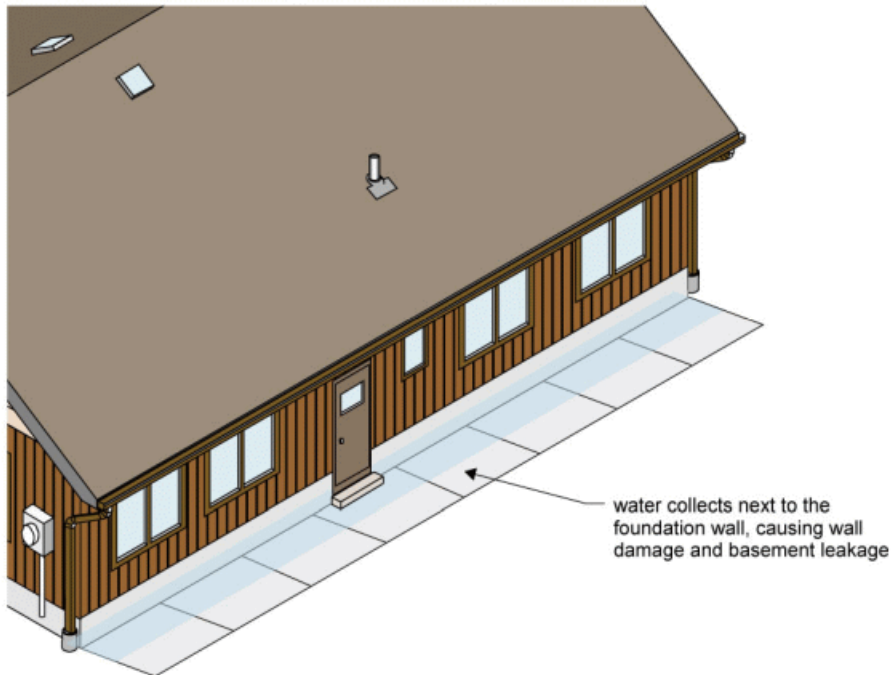
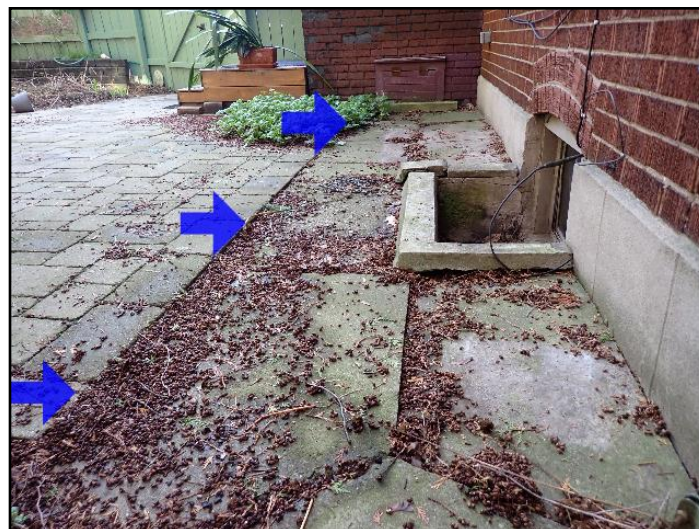
**Condition:** • [Improper slope or drainage](#)

The concrete in this area has settled/eroded over the years, cracks were noted and low spots will retain water close to the foundation.

*Improper slope or drainage*

**Task:** Repair/Re-pour masonry (and improve slope)

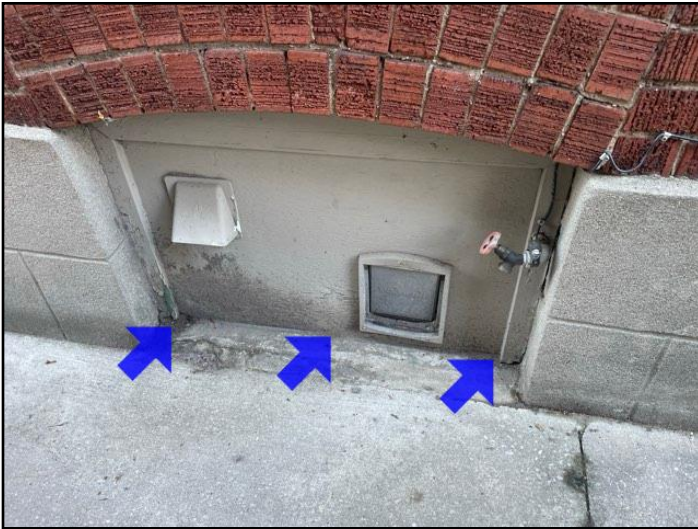
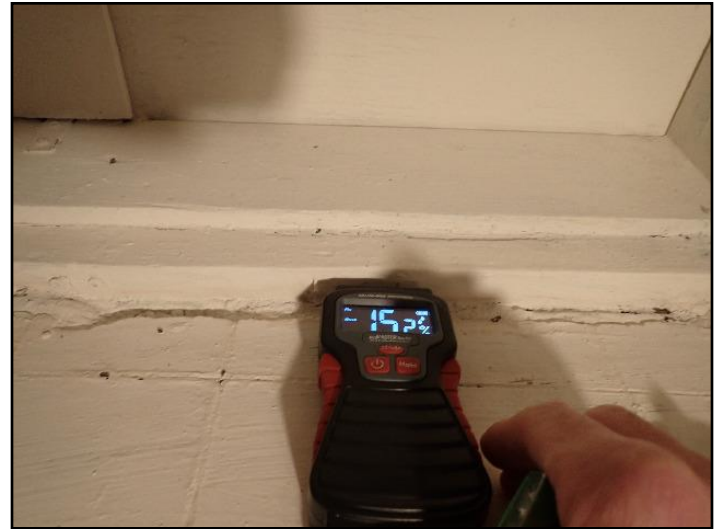
**Condition:** • Wood/ground contact, the edge of the wooden contact with the ground may prematurely rot, elevated moisture was noted on the interior of the window opening.

*Elevated moisture*

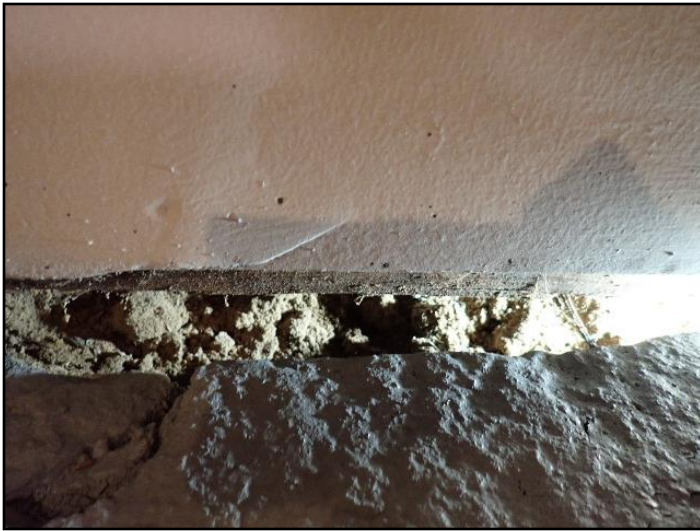
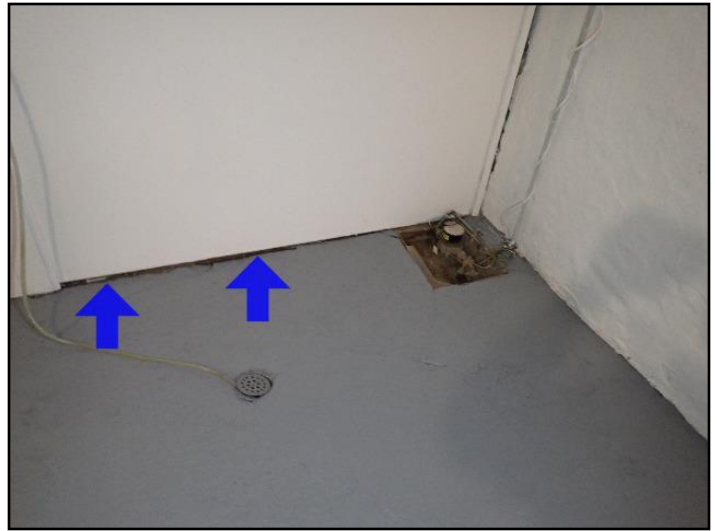
**Condition:** • Gap in slab.

Gap in slab

Gap in slab / beneath wall

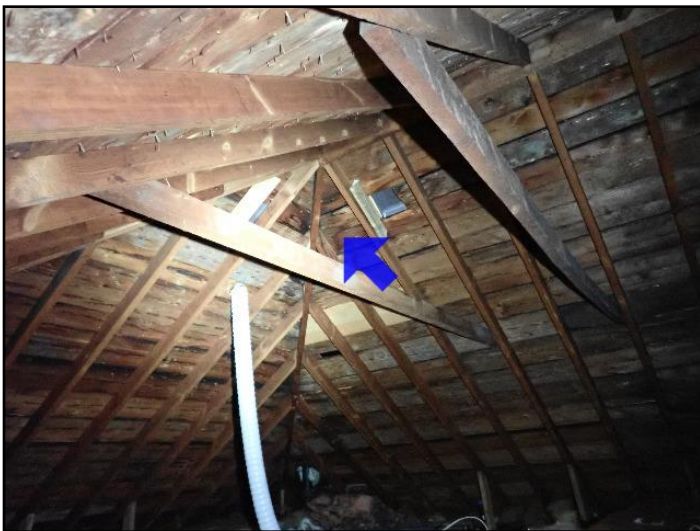
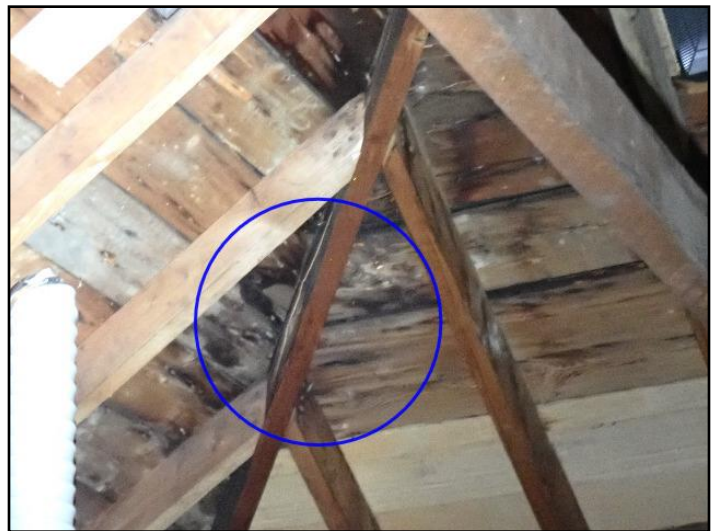
**Condition:** • [Water stains](#)

Water stains on old roof sheathing is common, it is most likely from a past leak but its difficult to tell from one visit.

Water stains

**Task:** Monitor

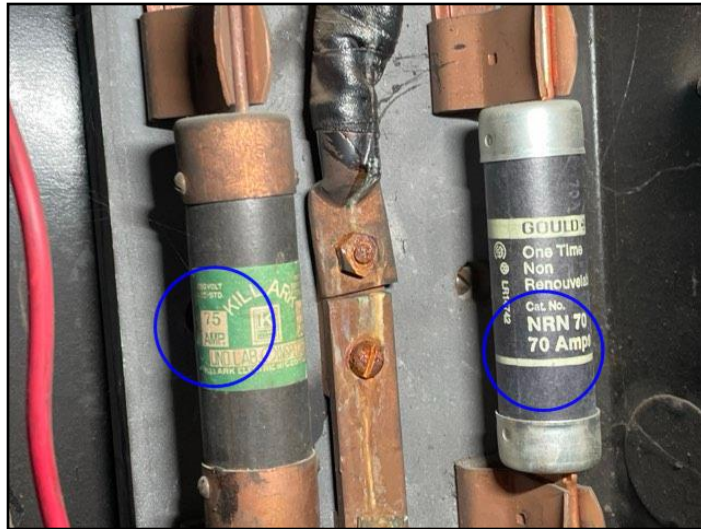
**Condition:** • [Fuse, breaker size in service box mis-matched](#)

75Amp / 70Amp

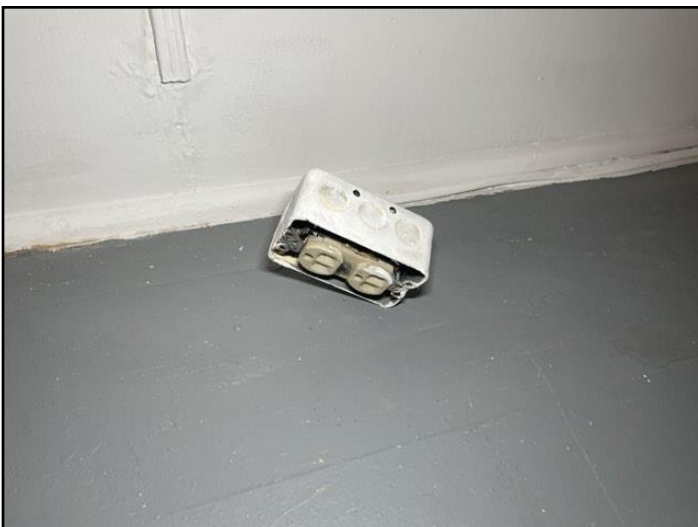
**Condition:** • [Loose](#)

Loose

**Task:** Improve

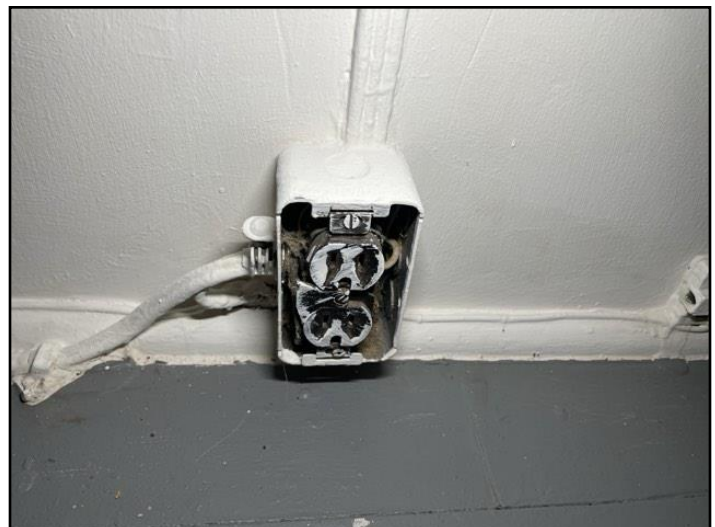
Missing cover plate

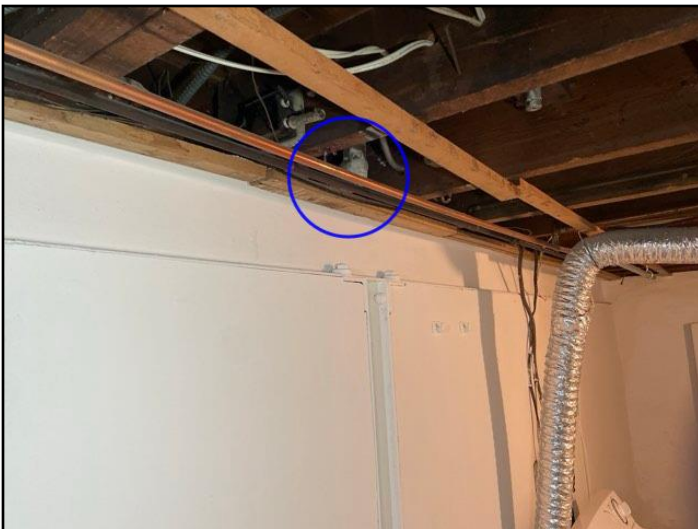
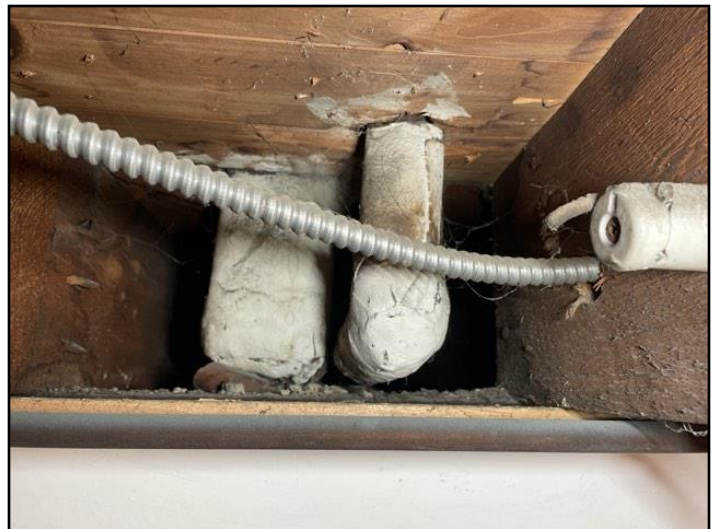
**Location:** Basement

**Condition:** • The insulation on boiler piping may contain asbestos. Health Canada recommends the insulation be left in place undisturbed. If the insulation is damaged or is to be disturbed, and if it contains asbestos (confirm with laboratory test), precautions should be taken that asbestos fibers are not released into the house air during the work.

*Insulation on boiler piping*

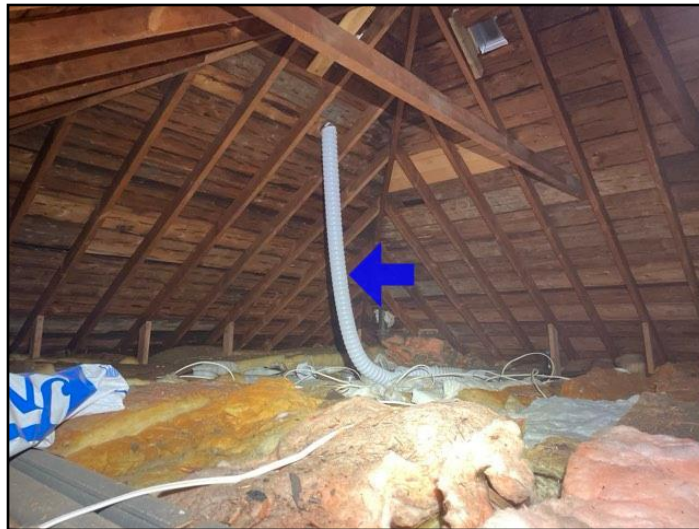
**Condition:** • [Not insulated in unconditioned space](#)

*Not insulated*

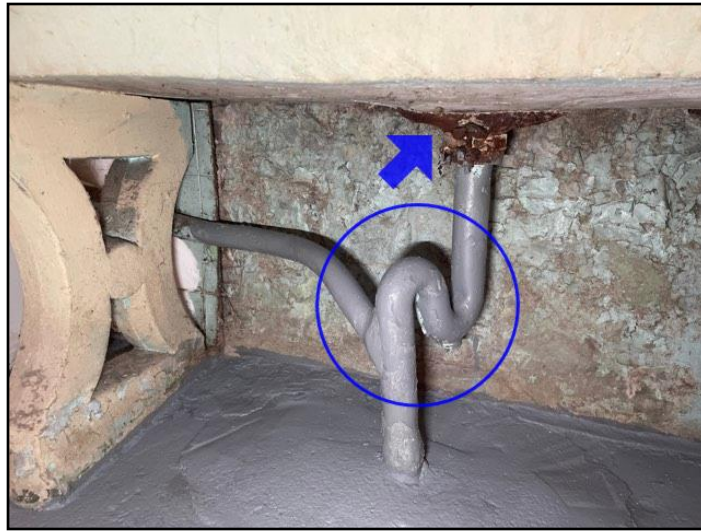
**Condition:** • Piping (Lead) - near end of lifespan / old

Lead traps under the laundry tub is typical of un-finished basements in this neighborhood. The drain of the concrete sink in rusted. no leaks were noted when tested.

*Piping (Lead) - near end of lifespan / old*

**Task:** Replace Trap

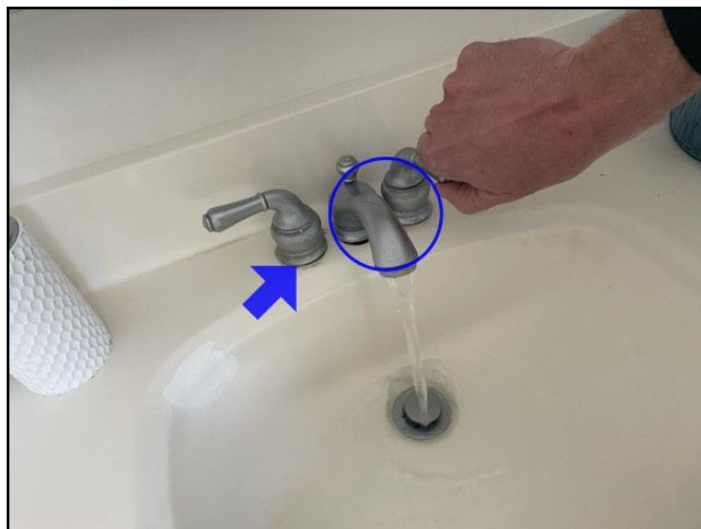
**Condition:** • Loose faucet

*Loose faucet*

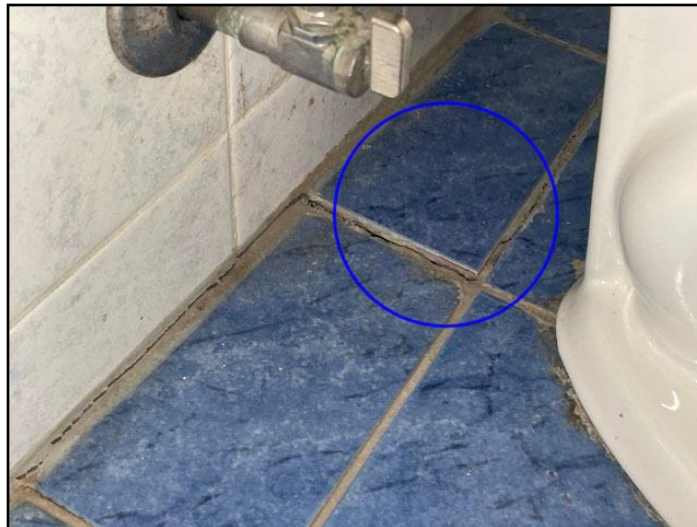
**Condition:** • Loose

Loose

**Task:** Repair/improve

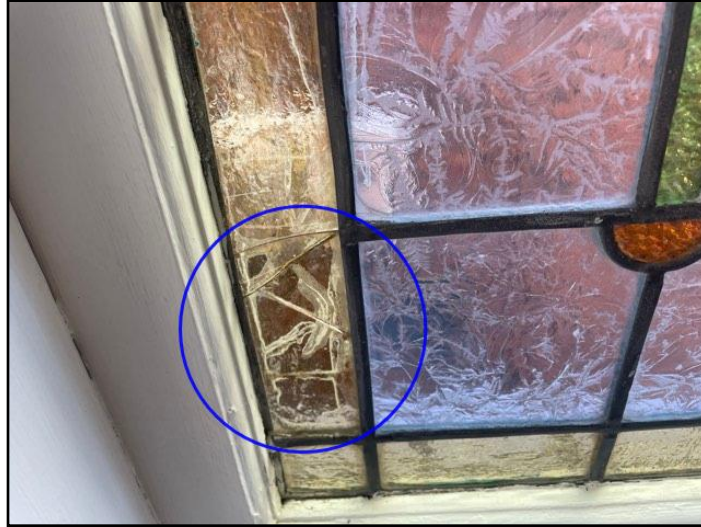
**Location:** Second floor stair well (stained glass window)

**Condition:** • [Cracked](#)

*Cracked*

**Task:** Repair

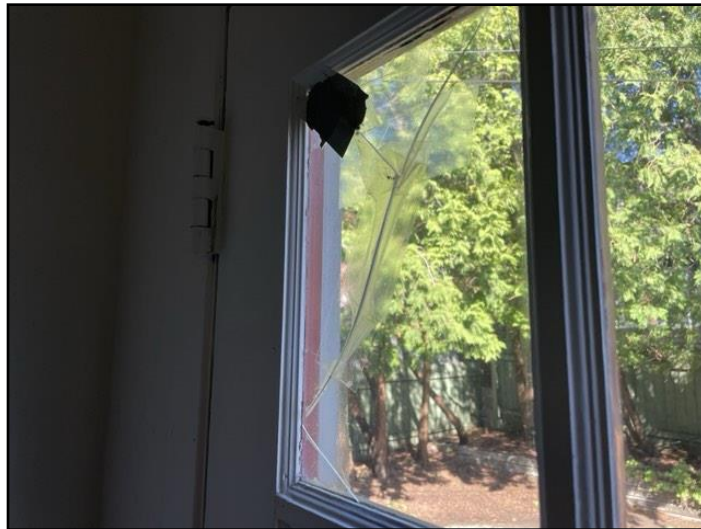
**Condition:** • [Broken](#)

*Broken*

**Task:** Replace pane

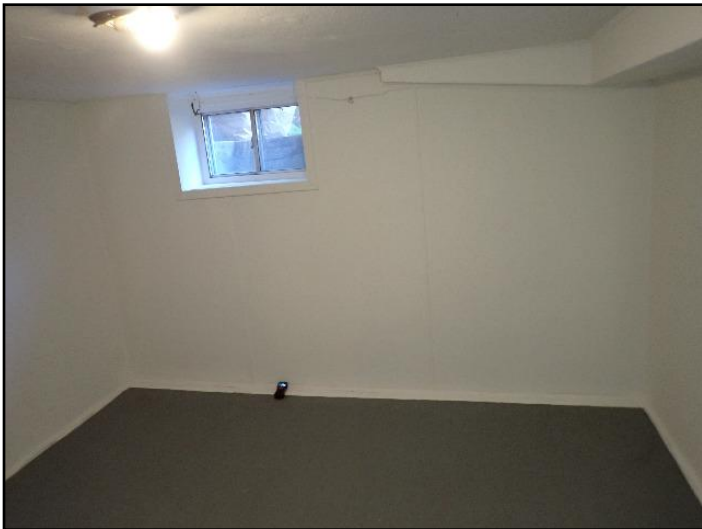
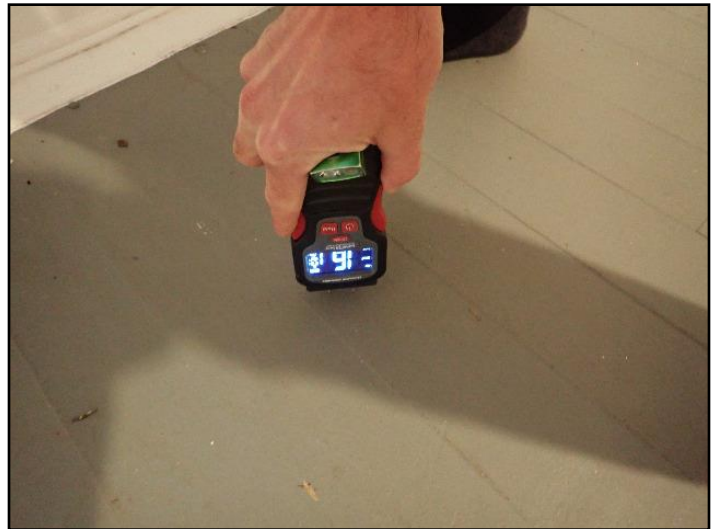
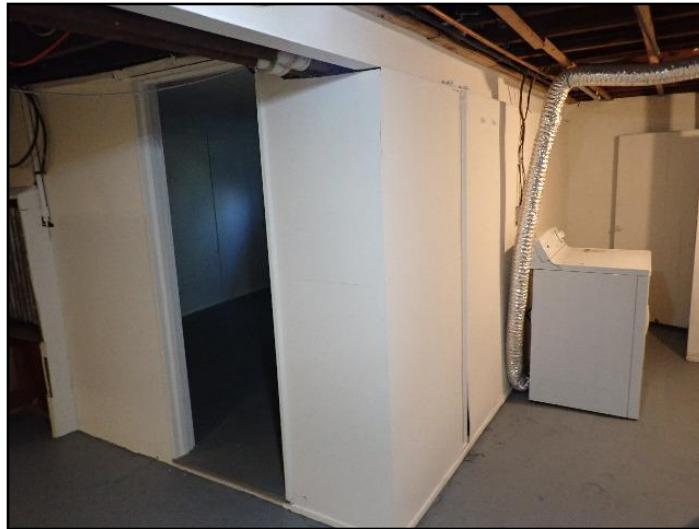
**Condition:** • Evidence of moisture noted

The finished basement room has an elevated wood floor and wood-paneled walls. Wood materials in contact with or close to the ground are prone to absorbing and retaining moisture. Elevated moisture levels were noted at time of inspection.

*Elevated moisture*

*Elevated moisture - floor*

**Task:** Monitor the area for ongoing moisture conditions. Consider removal of the elevated floor and wall panelling to limit moisture retention. Refer to exterior recommendations regarding gutters, downspouts, and lot grading.

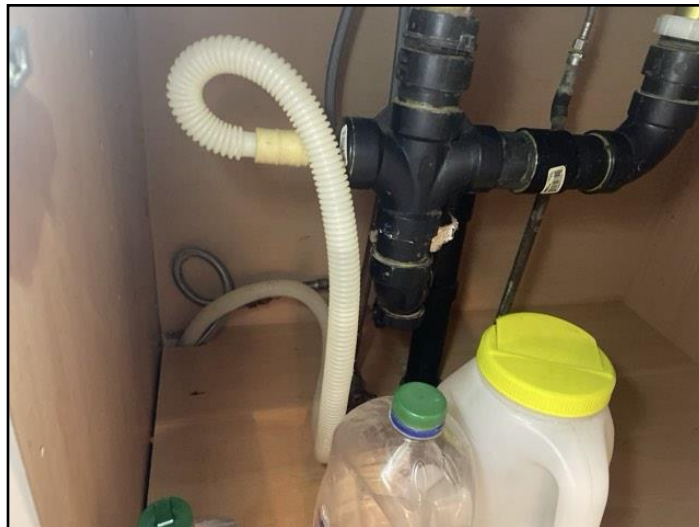
**Condition:** • Backflow prevention high loop missing

*Backflow prevention high loop missing*
