Your Inspection Report

31 Runnymede Rd
Toronto, ON M6S 2Y1

INSPECTION DATE:
Monday, March 23, 2026

RE: Report No. 96580, v.2
31 Runnymede Rd
Toronto, ON
M6S 2Y1

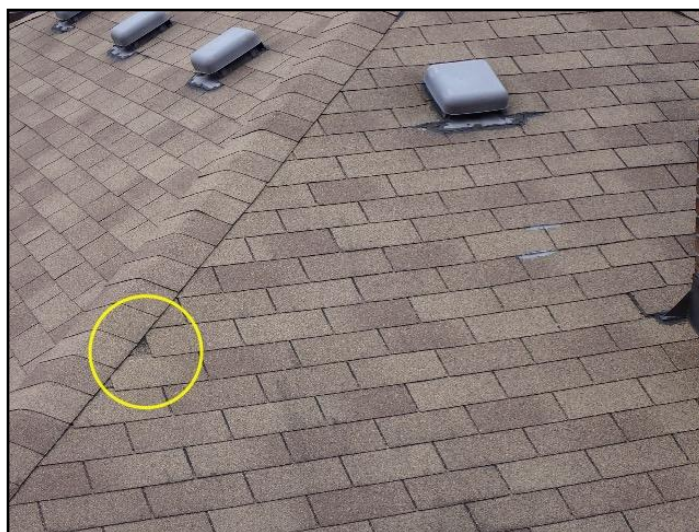
Condition: • Missing

Missing

Task: Repair

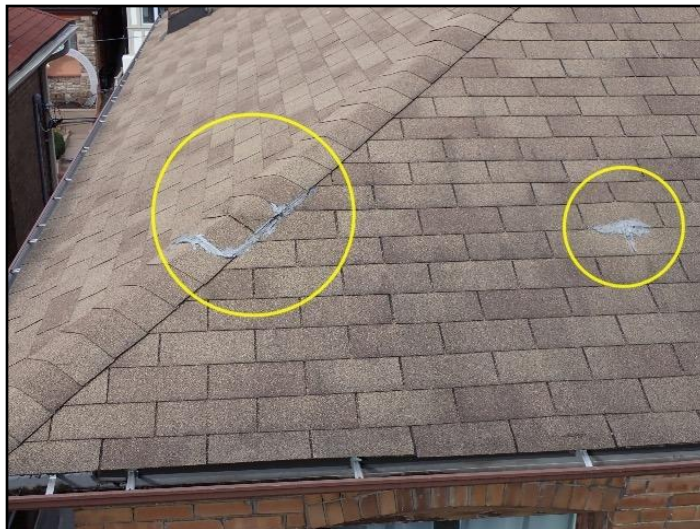
Condition: • Repair

Previous repairs

Repair

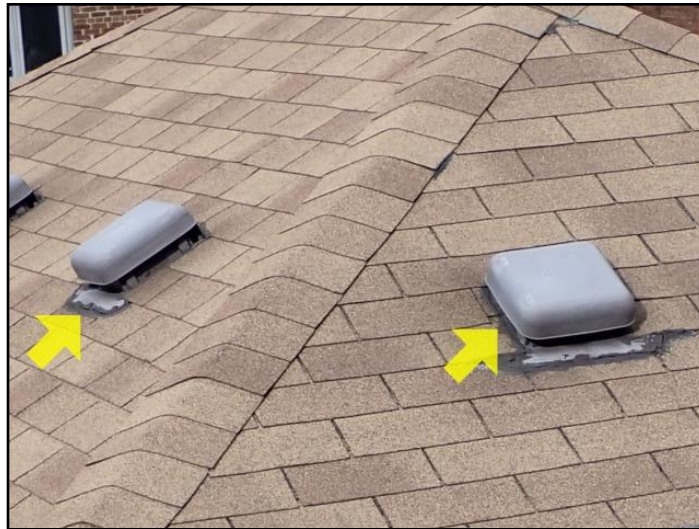
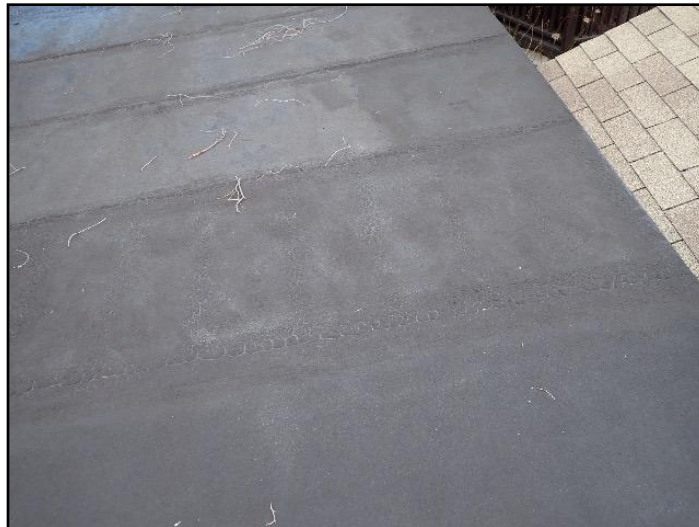
Condition: • At or near end of life

Alligatoring surface, cracking

At or near end of life

Task: Replace

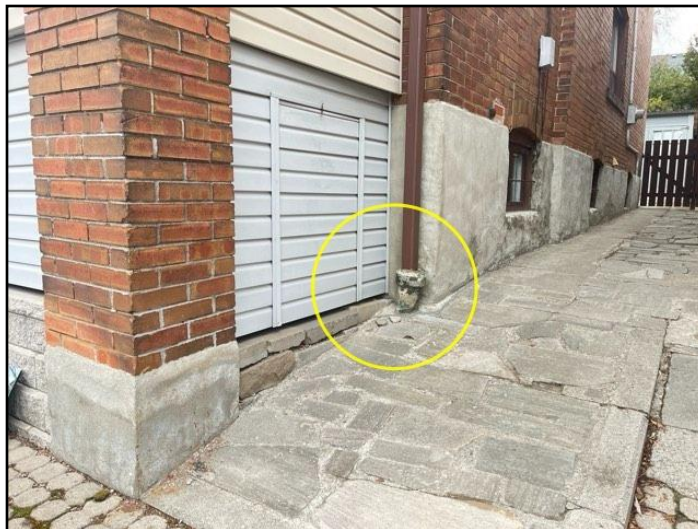
Condition: • [As of Dec 2016, a Toronto by-law requires downspouts to discharge above grade. Exemptions may be available in some cases.](#) Below-grade downspouts may leak or be clogged, resulting in basement leakage. Click the line above for details.

Discharge below grade - See Exemption in Appx

Task: Inspect annually

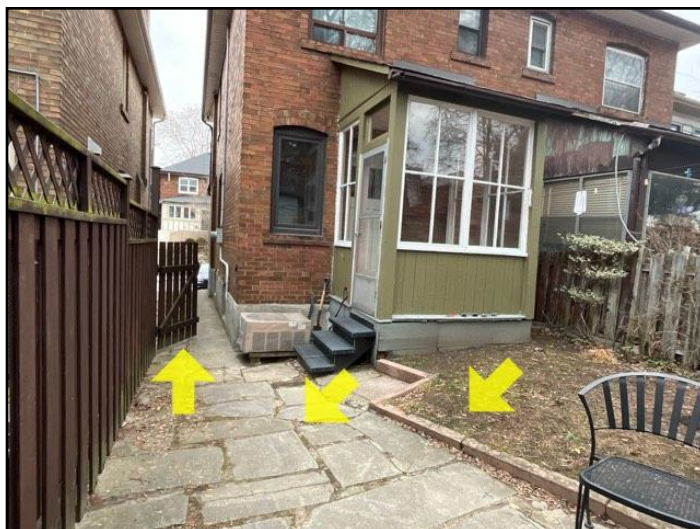
Condition: • The ground around some parts of the home does not slope to drain water away from the foundation.

Lot Grading - Ensure slope away from home

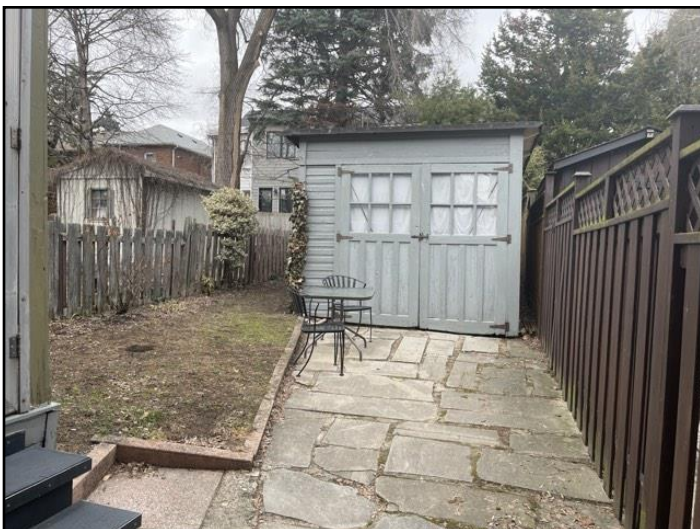
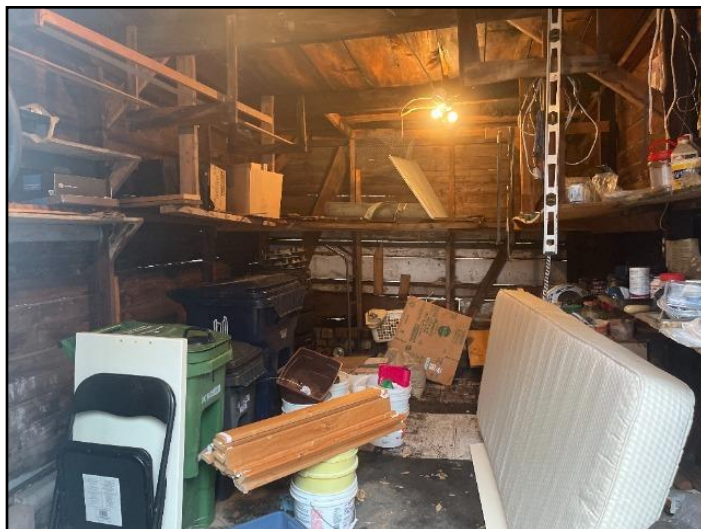
Condition: • Older Garage

Older Garage

Task: Repair / Demolish, Replace

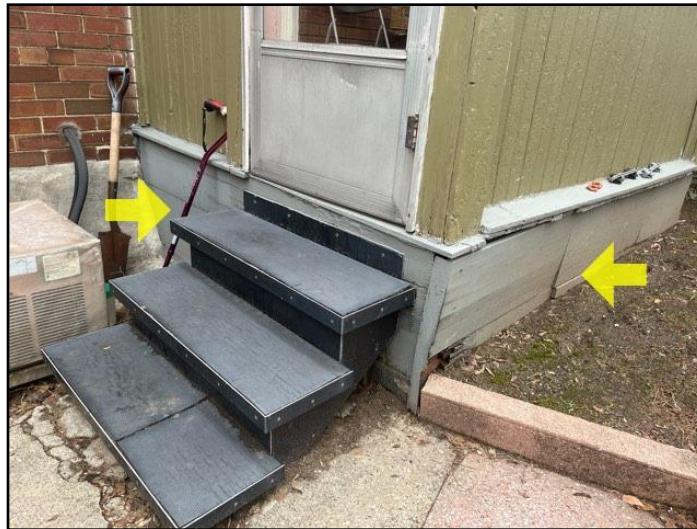
Condition: • No access was gained to the crawlspace.

No access was gained to the crawlspace

Task: Provide access and inspect to verify there are no issues with the structure, heating, plumbing, electrical, insulation, ventilation or moisture problems.

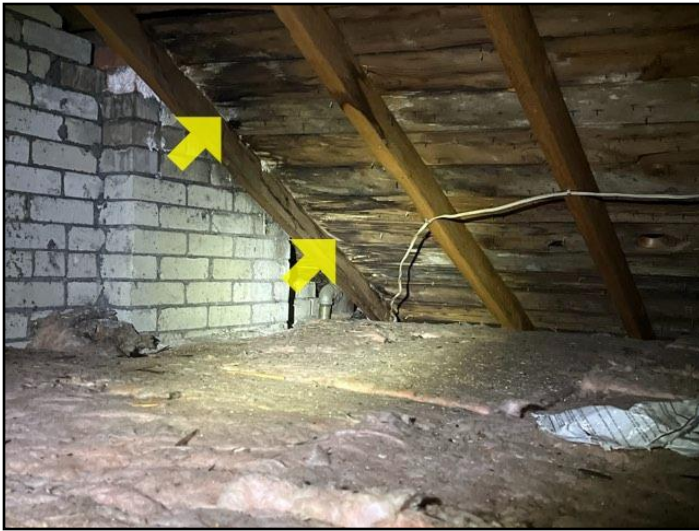
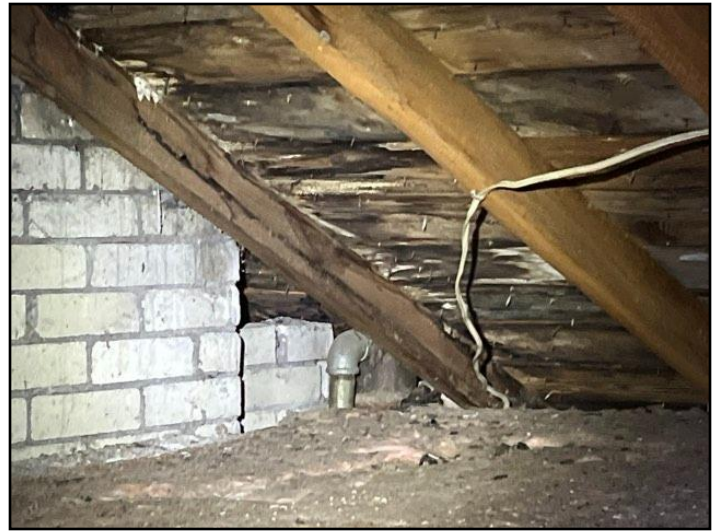
Condition: • [Water stains](#)

Water stains

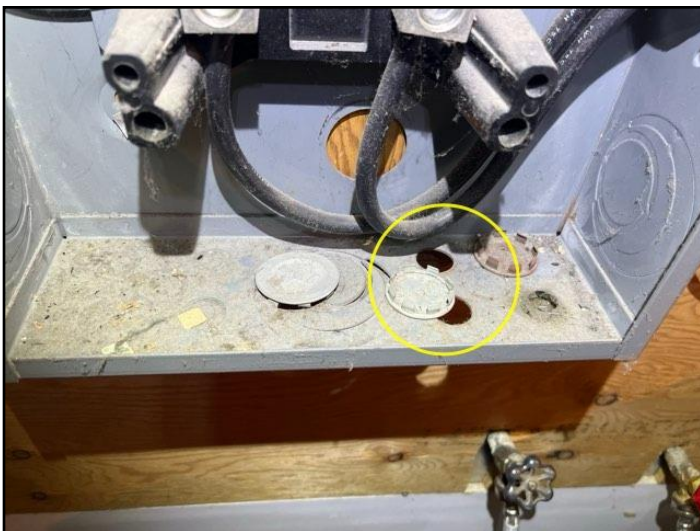
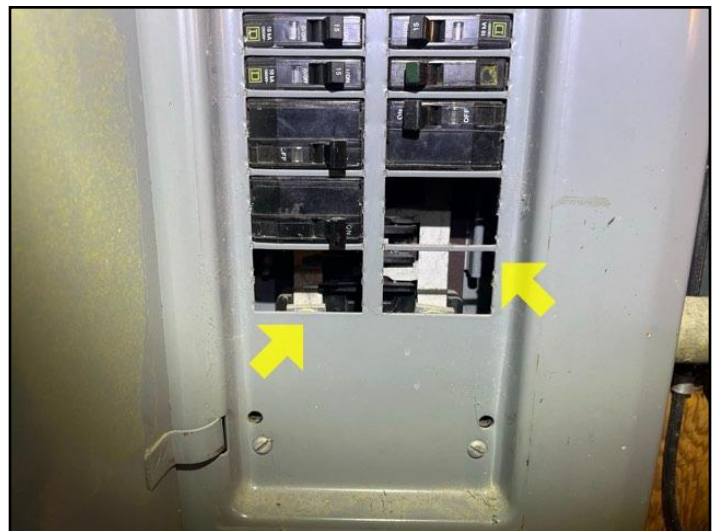
Condition: • [Openings in panel](#)

Openings in panel

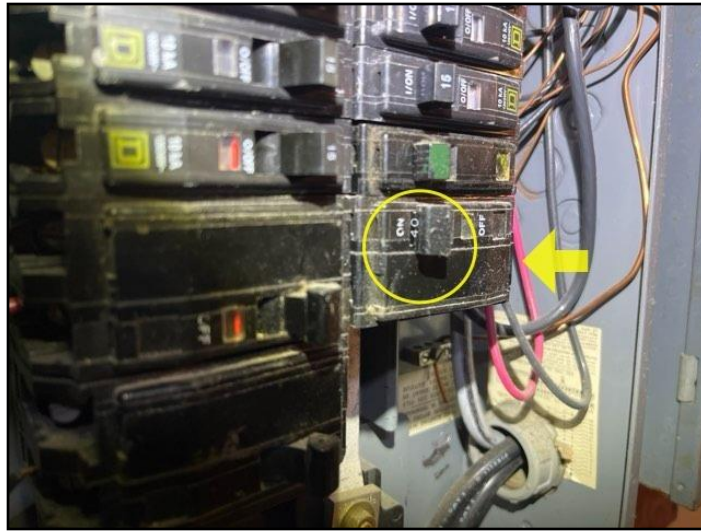
Condition: • [Fuses or breakers too big](#)

Fuses or breakers too big

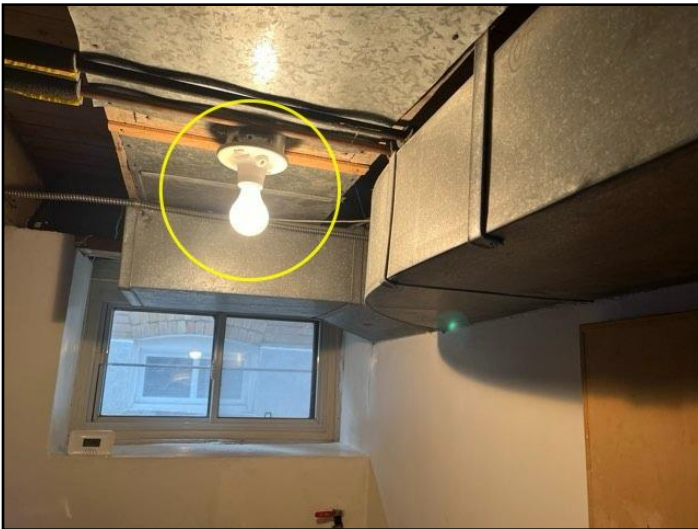
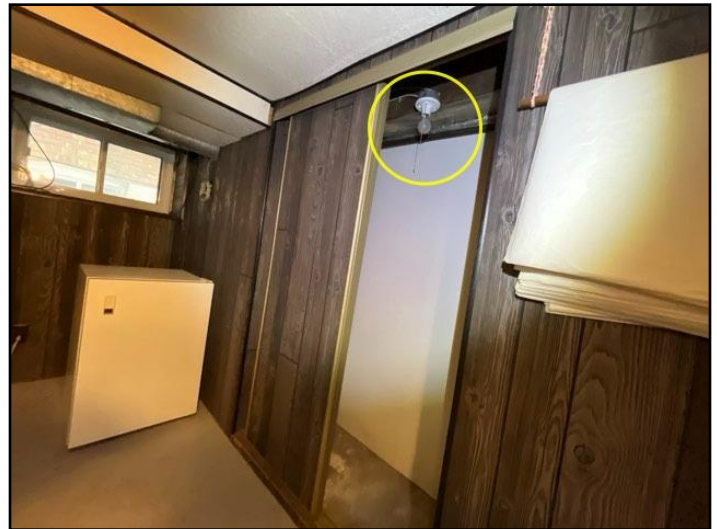
Condition: • Exposed to mechanical damage (No cage or protective lens).

Exposed bulbs: Example, Rear Basement

Exposed bulbs: Example, Front Basement

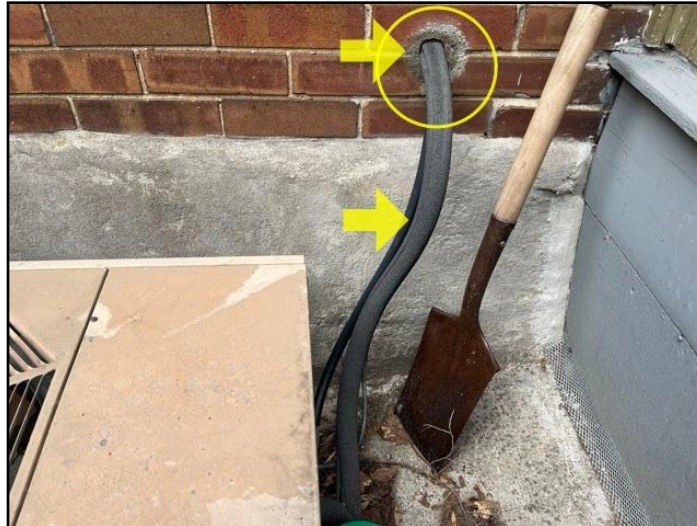
Condition: • [Insulation - missing](#)

Condition: • [Poor seal at building](#)

Insulation - missing; Poor Seal at Building

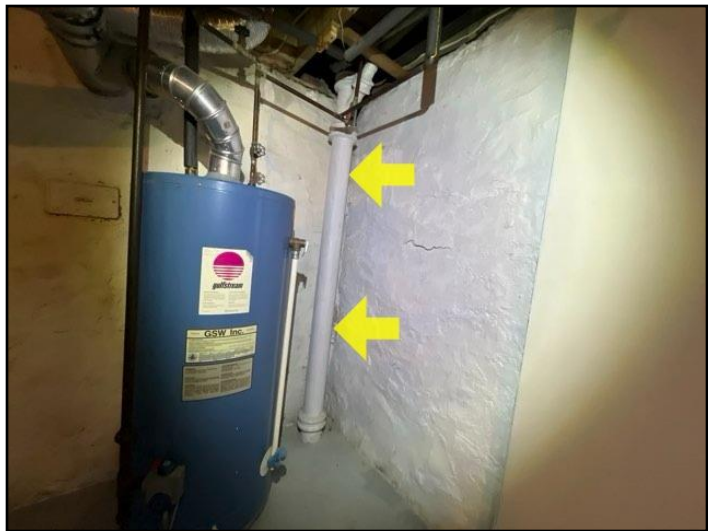
Condition: • Cast iron waste stack

Cast iron waste stack

Condition: • The cast iron waste piping is near the end of its normal life expectancy and is prone to rusting through or splitting. Replacement may be required in the near future.

Task: Monitor / replace

Task: Replace

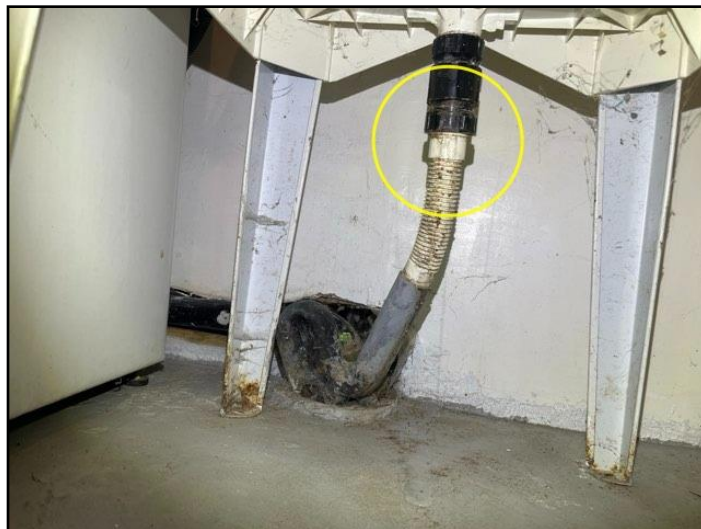
Condition: • [Leak](#)

Leak

Task: Repair

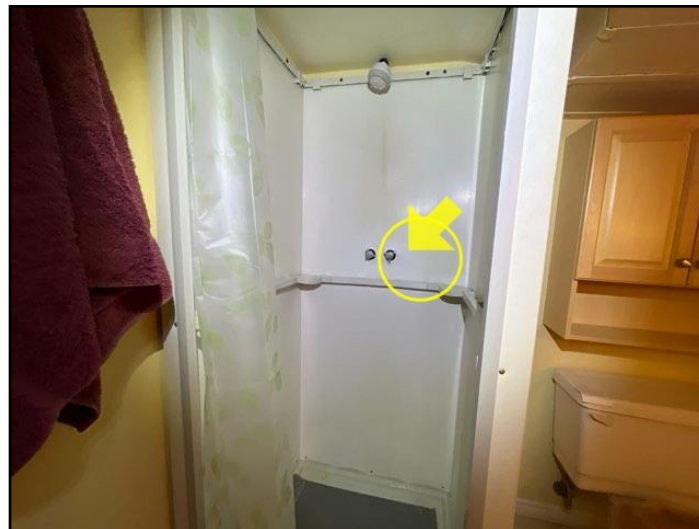
Condition: • Inoperative

Inoperative Knob

Task: Repair

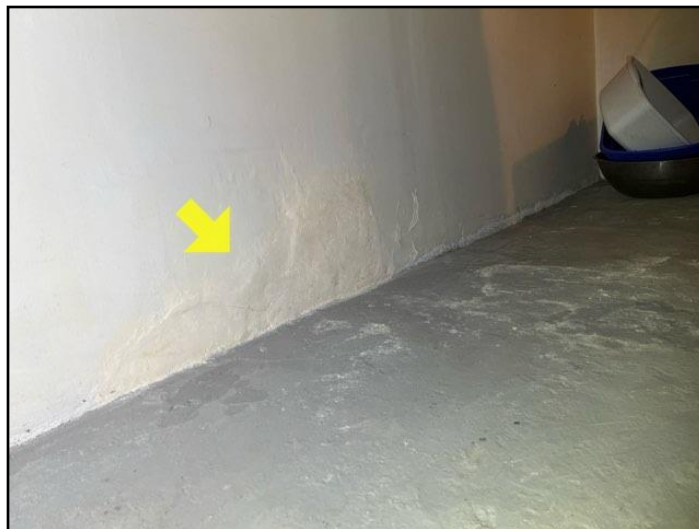
Condition: • Patched

See also \Basement\Leakage and suggestions below.

Patched

Task: Inspect annually / Repair

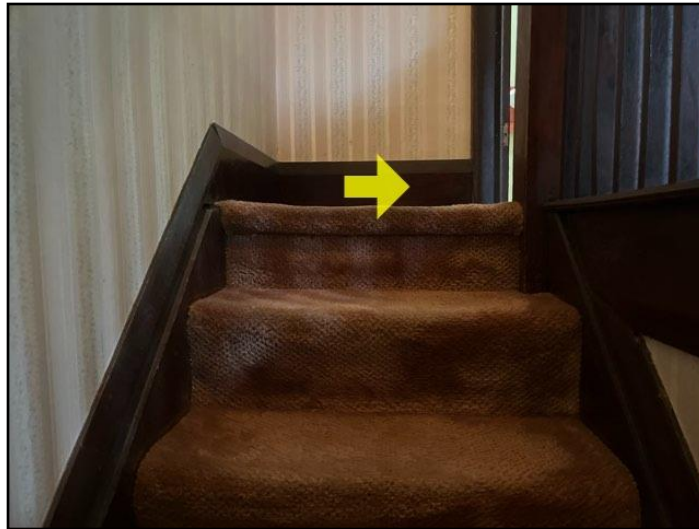
Condition: • Sloped flooring

Sloped flooring

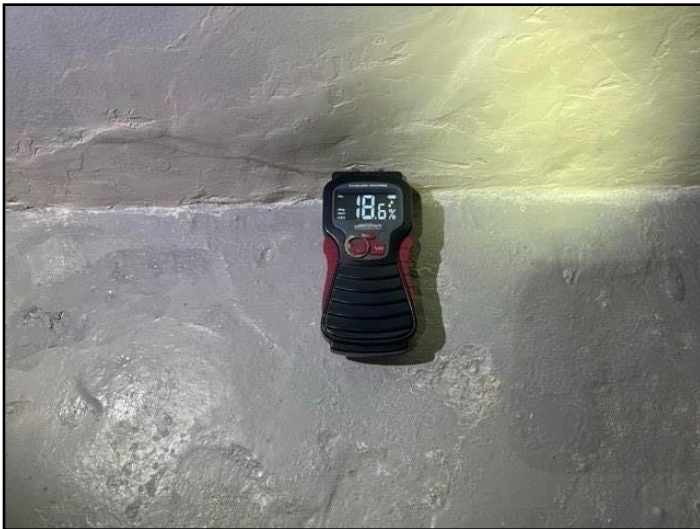
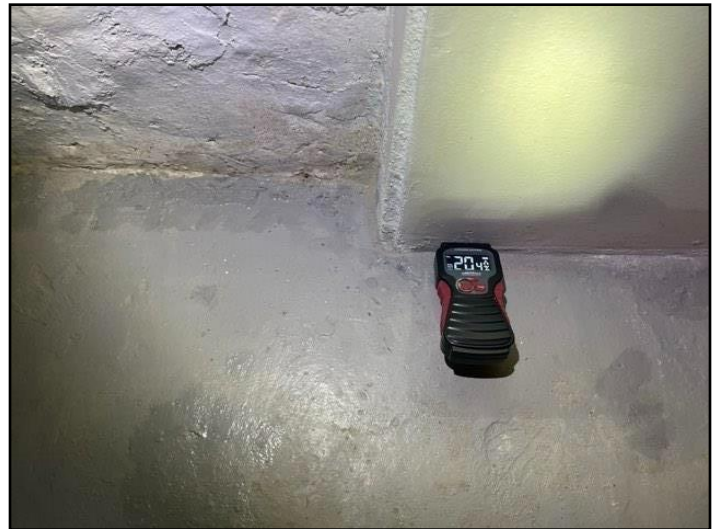
Condition: • Evidence of moisture noted

Elevated moisture meter readings. See also low moisture meter readings above. See \Walls above.

Evidence of moisture noted: Rear Middle

Evidence of moisture noted: Rear Left

Monitor the area for evidence of moisture, particularly in the spring when snow melts or after heavy or persistent rains.

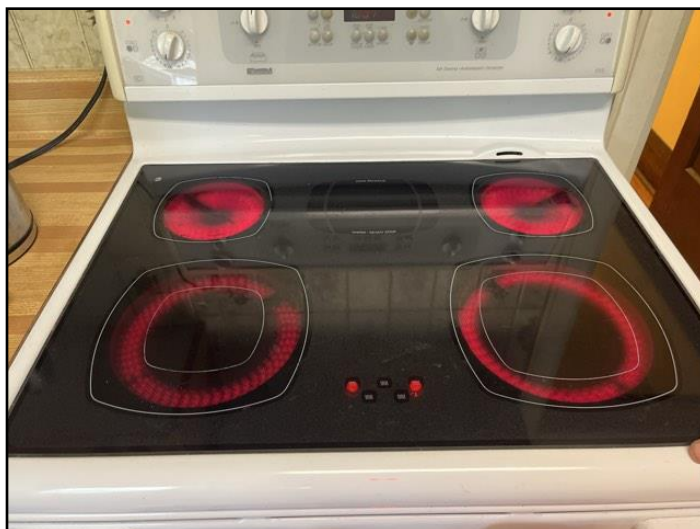
Condition: • Burner inoperative
Inner ring burners on Front L and R. (Outer ring Front Burners L and R ok.)
Task: Repair / Replace
Time: Discretionary
Cost: Not determined

Burner inoperative
