# HOME INSPECTION REPORT

16 Coe Hill Drive  
Toronto

Inspection Date: [March 24 2026](#)

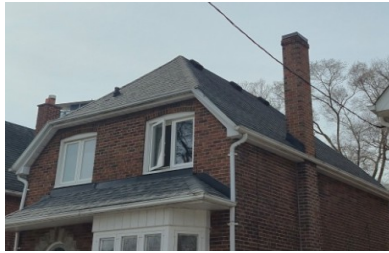
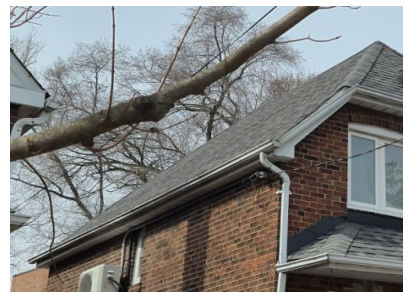
Sloped Surface: [overall surface in good repair](#)  
Chimney: [overall in good repair](#)

Note: [Recommend Annual Maintenance Contract for Roof Surface, Flashing Details and Chimney\(s\)](#)

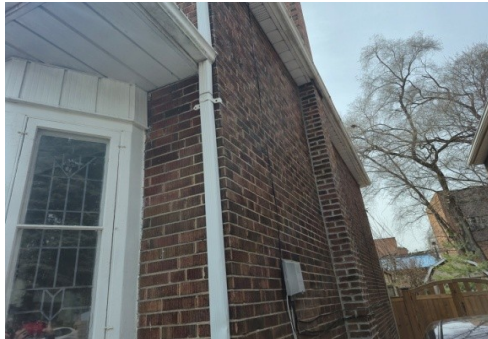
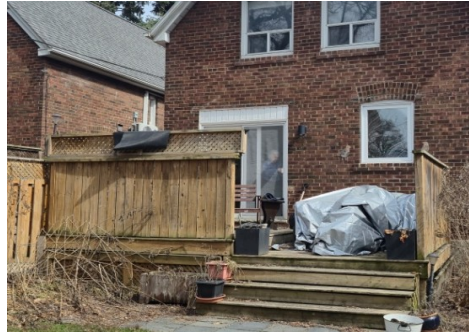
WALL SURFACES: overall in good repair  
 DOORS/WINDOWS: overall in good repair

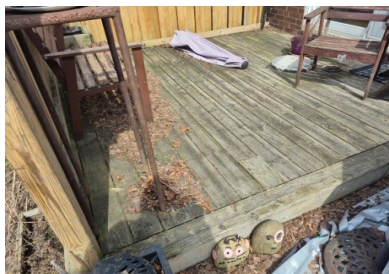
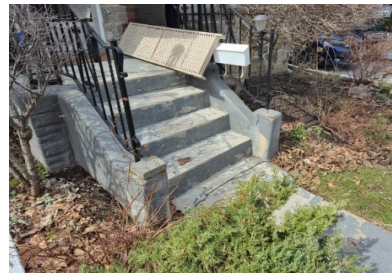
DECK overall in good repair, floor boards- monitor and repair as required  
 PORCH overall in good repair, maintenance as required

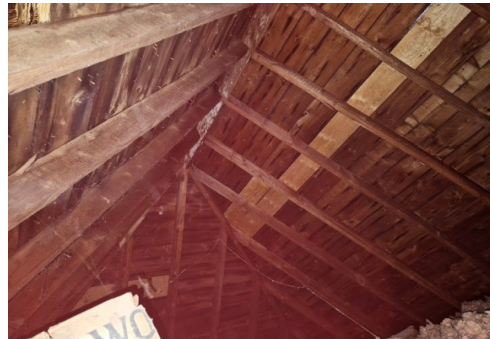
ROOF: overall in good repair

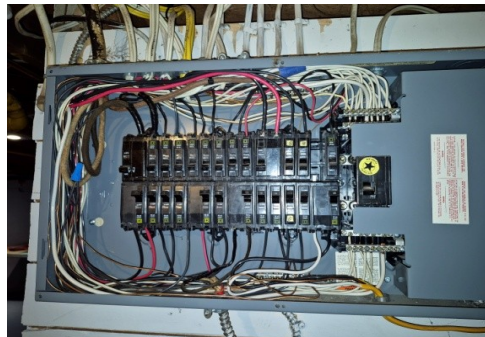
SERVICE ENTRANCE: **overall in good repair**  
 SERVICE PANEL: **overall in good repair**

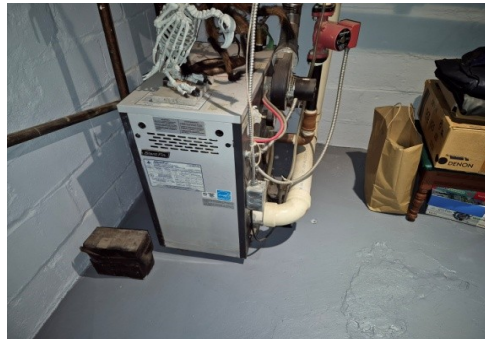
HOT WATER BOILER: [service annually](#)  
[recommend obtaining replacement parts/servicing contract](#)

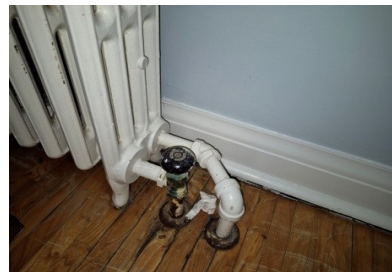
Radiator(s): [monitor/repair valves as required](#)

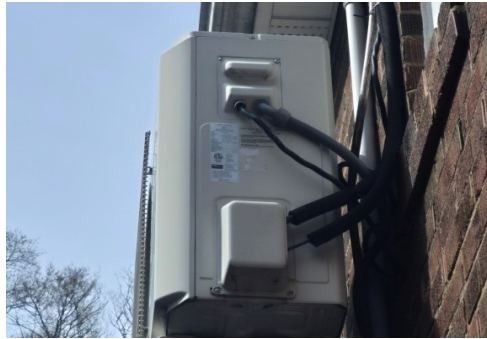
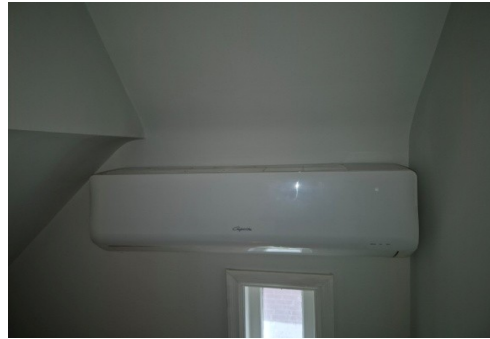
DUCTLESS A/C: not tested: should be serviced before using

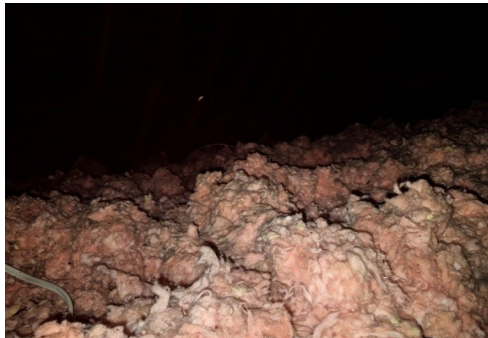
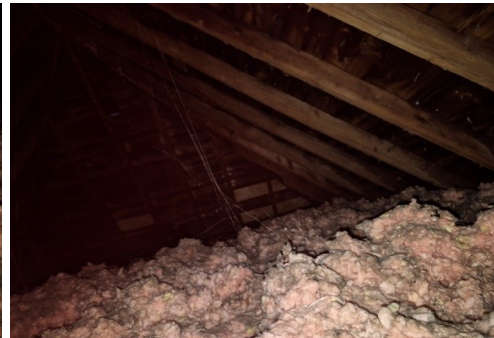
ROOF SPACE: recommend upgrading insulation to improve comfort and efficiency  
Roof Access Hatch: insulate and weather-strip access hatch to roof space

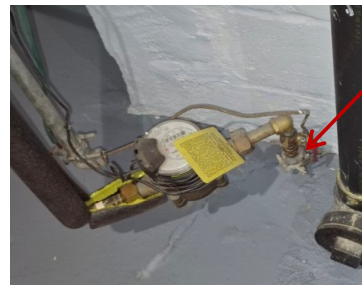
WATERMAIN: appears older - possibly older lead or galvanized steel pipe-  
recommend upgrade to copper  
contact city to arrange replacement

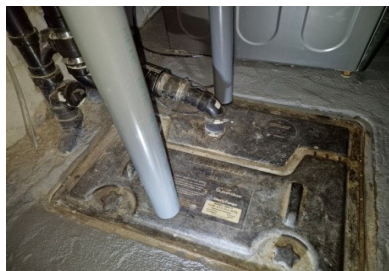
**\*\*Basement Leakage:** presently no leaking detected with moisture meter random sampling  
 foundation damp-proofed to minimize leaking risk  
 service sump pump annually
