HOME INSPECTION REPORT

229 Clendenan Ave
Toronto

Prepared by: Bob Papadopoulos P.Eng., RHI *

Inspection Date: [May 1 2026](#)

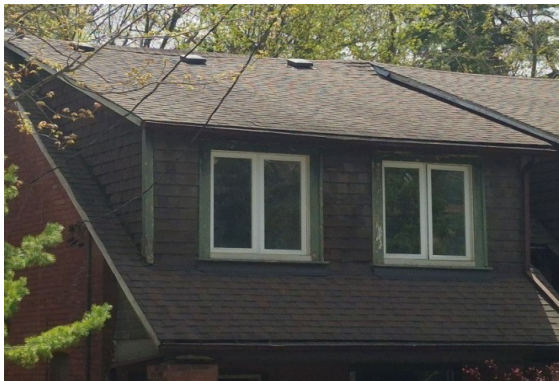
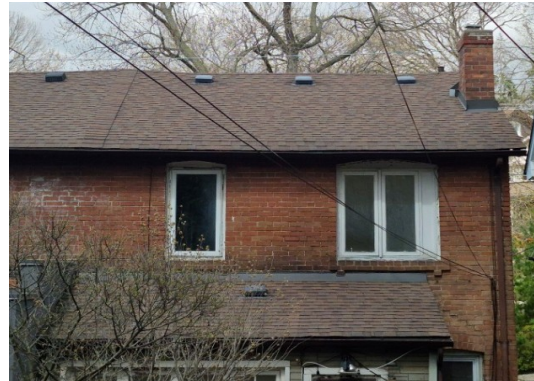
Sloped Surface: [overall surface in good repair](#)

Note: [Recommend Annual Maintenance Contract for Roof Surface, Flashing Details and Chimney\(s\)](#)

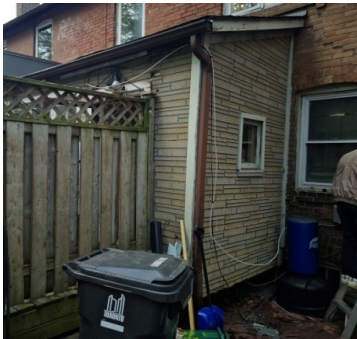
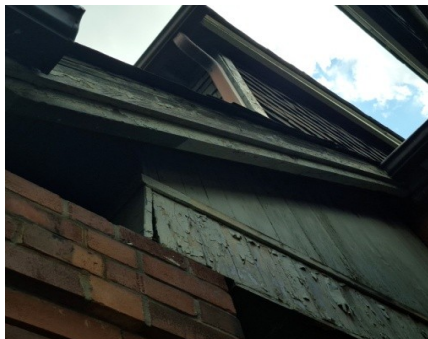
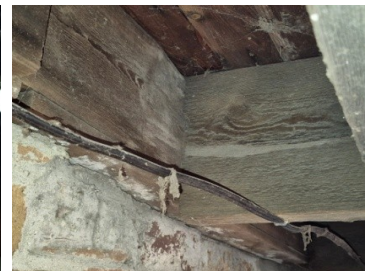
Comments: rear extension overhang: underside should insulated and sealed

**Driveway(s): service drain, seal gaps along foundation wall

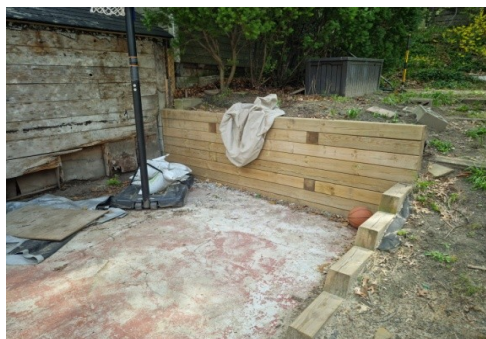
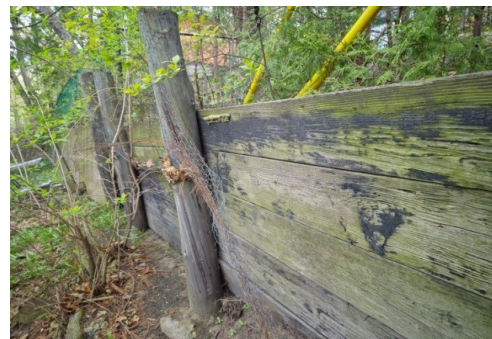
RETAINING WALL(s): lower unit: newly built, upper unit: old, damaged, monitor and budget to replace

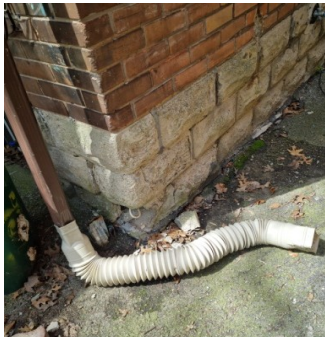
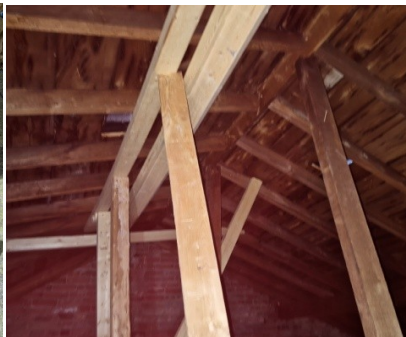
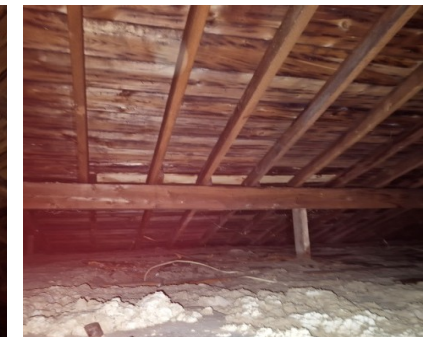
FOUNDATIONS: general repairs at rear corner

ROOF: sagging though appears to be old condition, structure has been reinforced

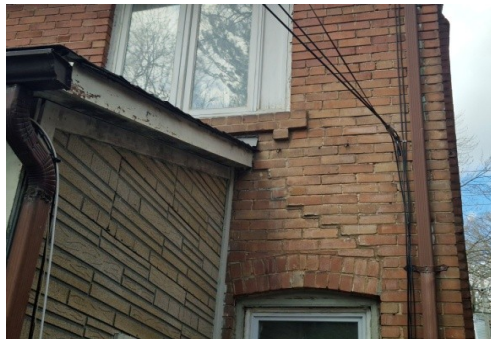
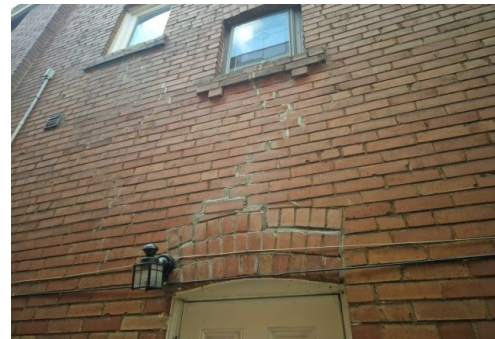
WALLS:
Masonry Arches: typical settlement cracks, prior repairs, monitor and repair as required

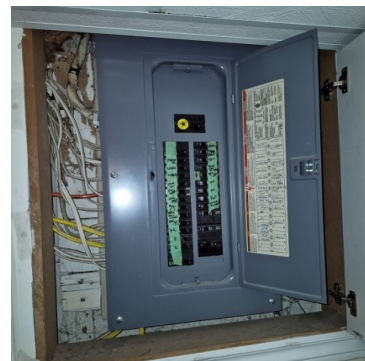
SERVICE ENTRANCE: overall in good repair, older mast
 SERVICE PANEL: overall in good repair

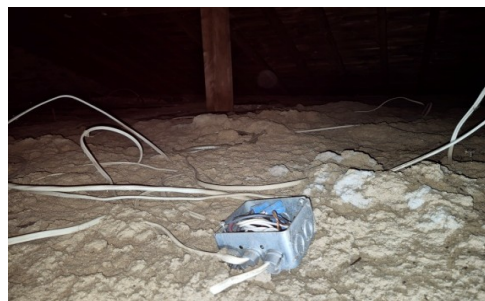
BRANCH WIRING: random sampling determined the wiring has been upgraded throughout
 roof space: loose wires/open junction boxes - secure properly

Note 1: All recommendations are safety issues - Treat them as high priority.

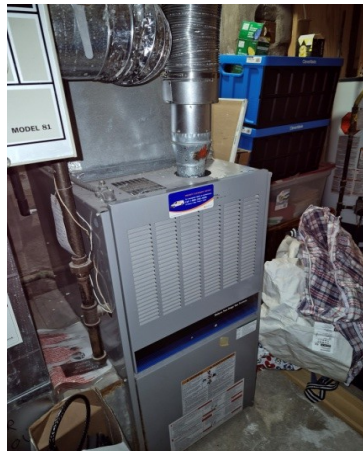
FORCED AIR FURNACE: [service annually](#)
[continue servicing until replacement becomes necessary](#)
Humidifier: [old, replace](#)

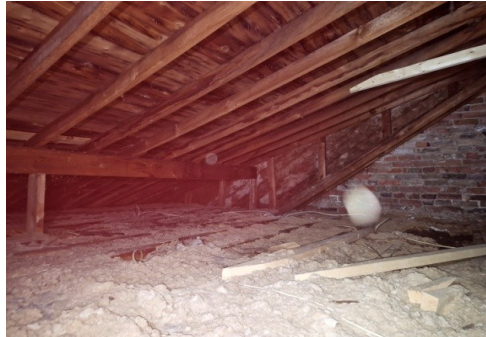
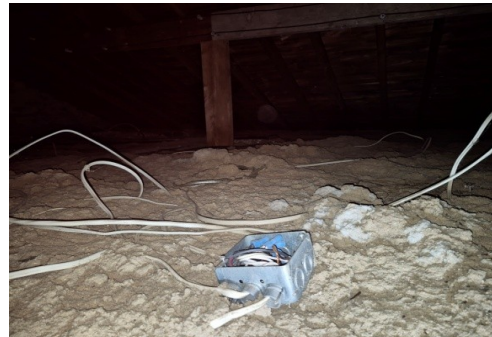
ROOF SPACE: recommend upgrading insulation to improve comfort and efficiency
see Electrical
