# HOME INSPECTION REPORT

383 Armadale Ave

Prepared by: Bob Papadopoulos P.Eng., RHI \*

Inspection Date: [May 14 2026](#)

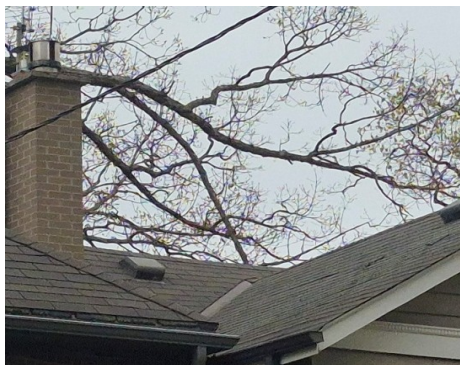
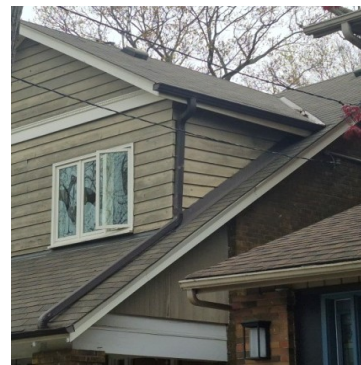
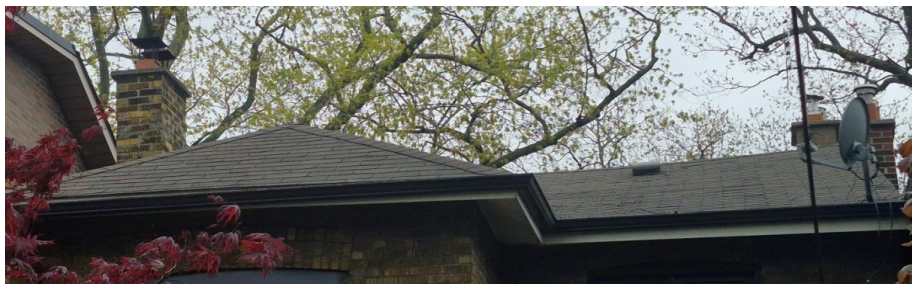
Sloped Surface: [overall surface in good repair](#)  
Chimney: [overall in good repair](#)

[Note: Recommend Annual Maintenance Contract for Roof Surface, Flashing Details and Chimney\(s\)](#)

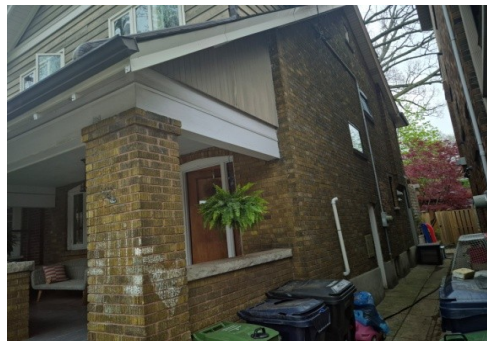
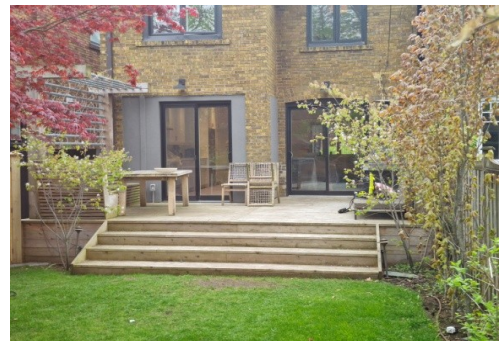
WALL SURFACES: overall in good repair  
 DOORS/WINDOWS: overall in good repair  
 DECK overall in good repair

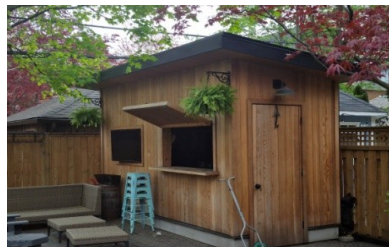
STRUCTURES backyard shed: overall well built

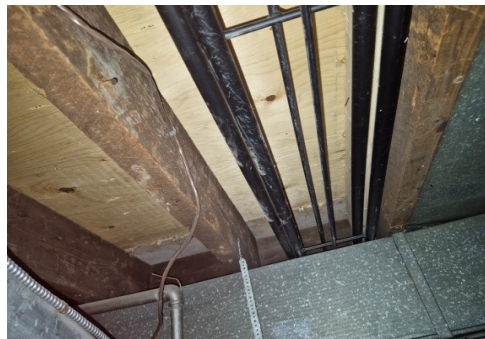
FLOORS: as observed from underside - appears to be newer subfloor installations on main level

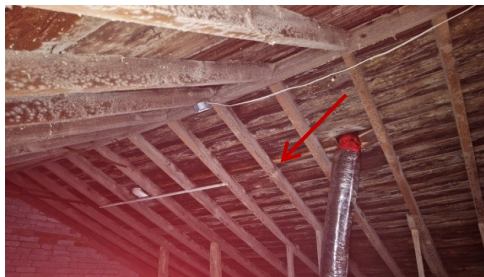
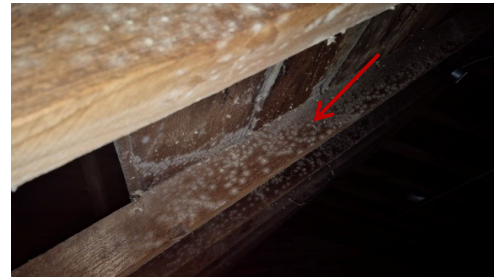
ROOF: overall in good repair  
 minor sagging at rear though no signs of distress, rafters somewhat shored up, ideally should install additional supports i.e. collars ties, consult with qualified framer

Comments: underside shows signs of mould though no damage observed  
 recommend further evaluation by specialist

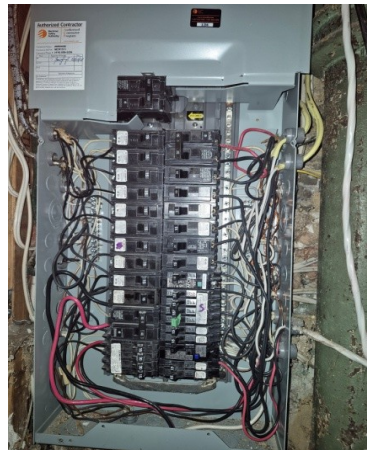
SERVICE ENTRANCE: **overall in good repair**  
 SERVICE PANEL: **overall in good repair**

BRANCH WIRING: **random sampling determined the wiring has been upgraded throughout various loose wires/exposed junction box wires**

Note 1: All recommendations are safety issues - Treat them as high priority.

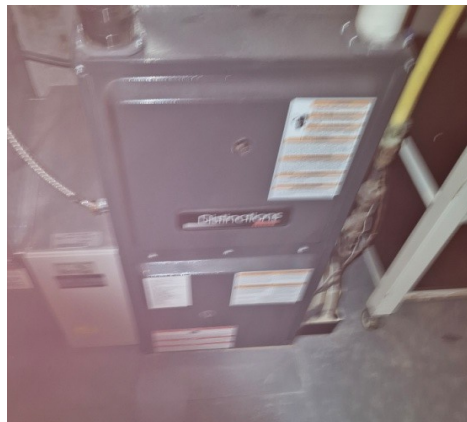
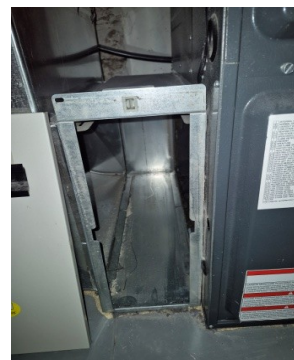
FORCED AIR FURNACE: [service annually](#)  
[recommend obtaining replacement parts/servicing contract](#)  
Filter: [missing](#),  
[replace 1-per-6 to 12 months](#)

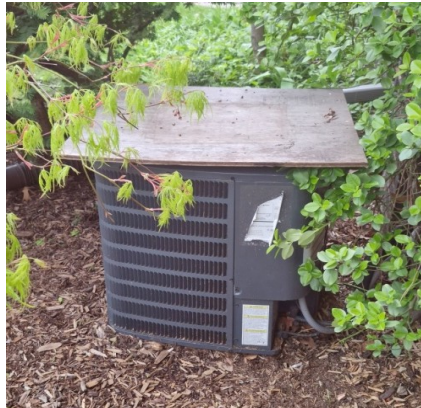
AIR CONDITIONER: not tested: should be serviced before using
