HOME INSPECTION REPORT

64 Gilmour Ave
Toronto

Prepared by: Bob Papadopoulos P.Eng., RHI *

Inspection Date: [April 23 2026](#)

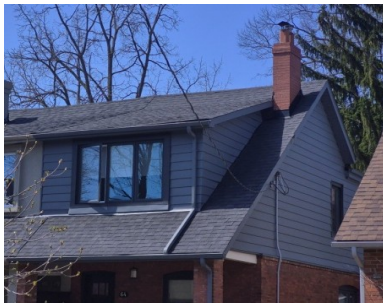
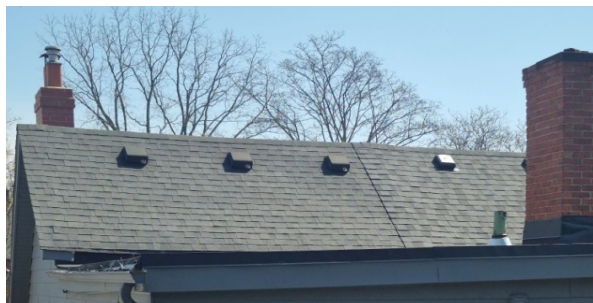
Chimney(s): [overall in good repair](#)

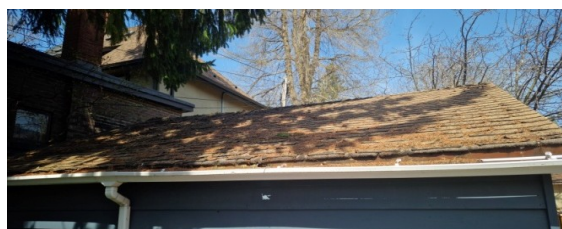
Garage: [old shingles, replace](#)

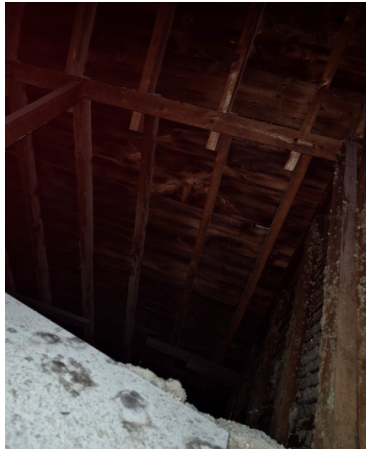
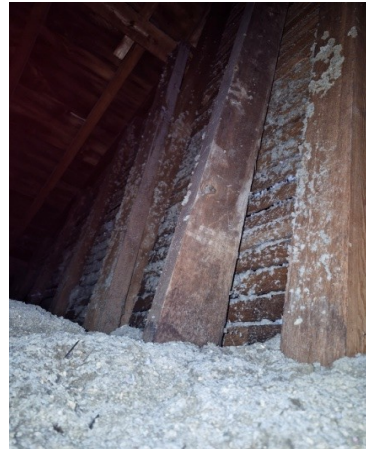
Party (Fire) Walls: recommend covering framing with fire rated drywall

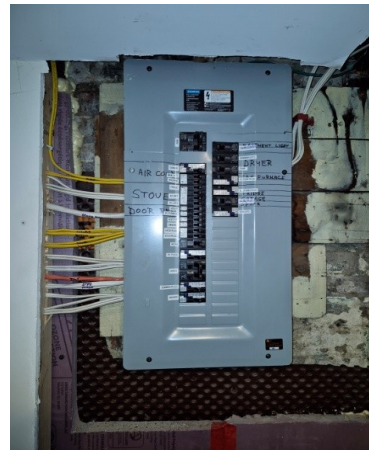
SERVICE ENTRANCE: overall in good repair
 SERVICE PANEL: overall in good repair

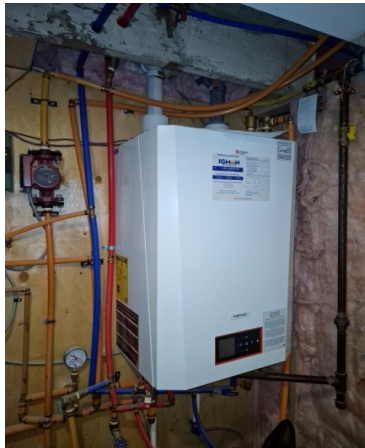
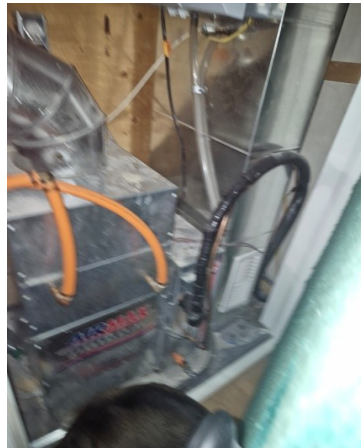
HOT WATER BOILER: service annually, presently drip tube requires maintenance
 Air Handler: boiler provides hot water to heat exchange located in 2nd level closet
 Filter: replace 1-per-3 months

COMBINATION SYSTEM: provides house heating and domestic hot water

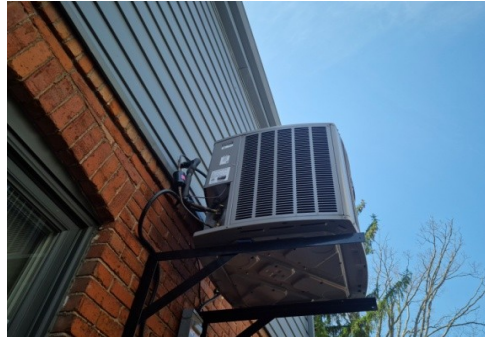
AIR CONDITIONER: not tested: should be serviced before using

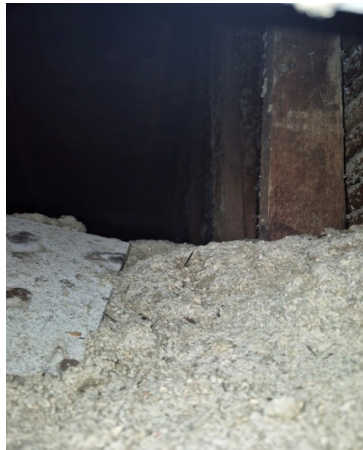
ROOF SPACE: insulation and ventilation is adequate
