# HOME INSPECTION REPORT

82 Howard Park Rd  
Toronto

Prepared by: Bob Papadopoulos P.Eng., RHI \*

Inspection Date: [May 20 2026](#)

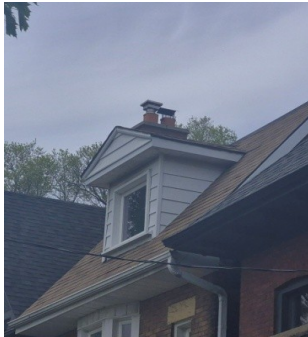
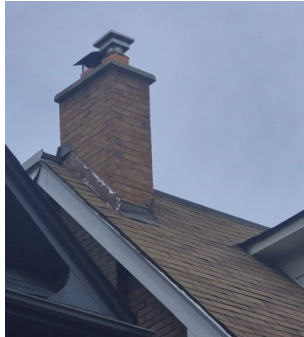
Sloped Surface: [overall surface in good repair](#)

Chimney(s): [overall in good repair](#)

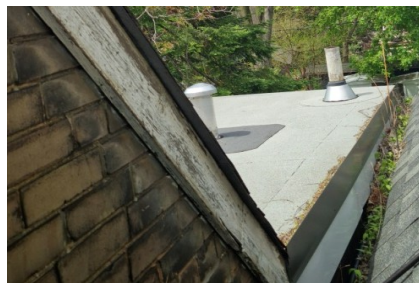
2nd Flat: [lower rear flat: limited observation from edge, in good repair](#)

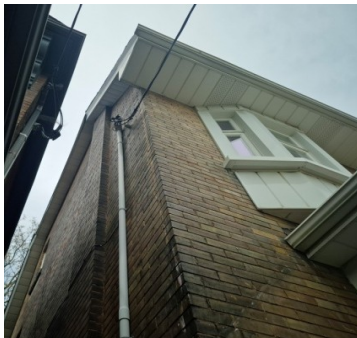
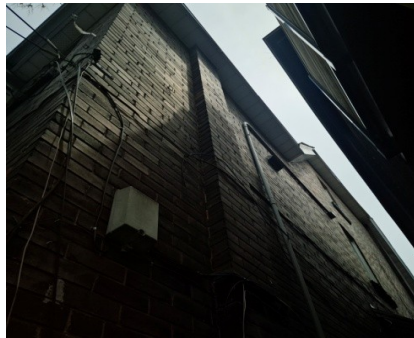
- Brick: overall in good repair
- Vinyl Siding: overall in good repair
- Soffit & Fascia: east side: requires maintenance/cleaning

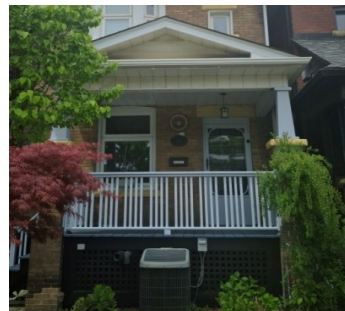
**PORCH overall in good repair**

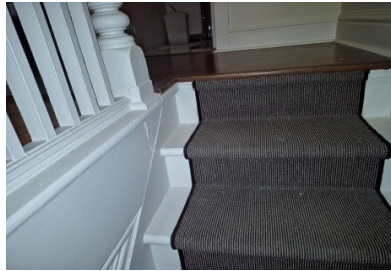
FLOORS: minor sagging around stair areas though typical for older house

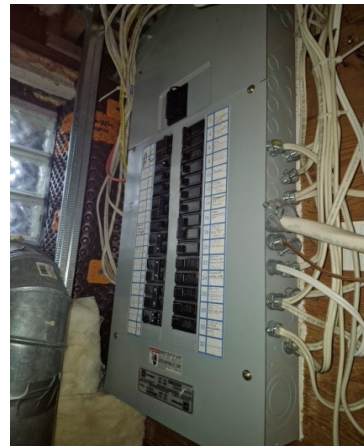
SERVICE ENTRANCE: **overall in good repair**  
 SERVICE PANEL: **overall in good repair**

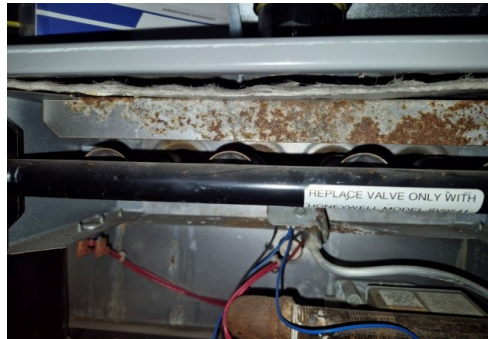
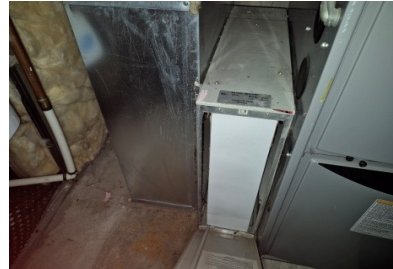
FORCED AIR FURNACE: [service annually, rusting noted](#)  
[rusting can reduce life expectancy](#)  
[continue servicing until replacement becomes necessary](#)  
Filter: [replace 1-per-6 to 12 months](#)

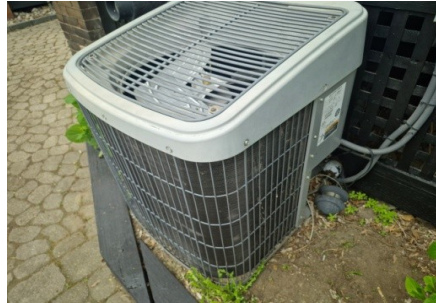
AIR CONDITIONER: aging unit, continue servicing until replacement becomes necessary  
not tested: should be serviced before using

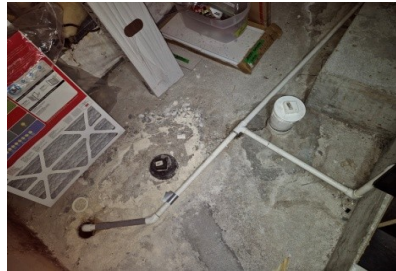
Stack: [rear basement: rusting, replace if required](#)

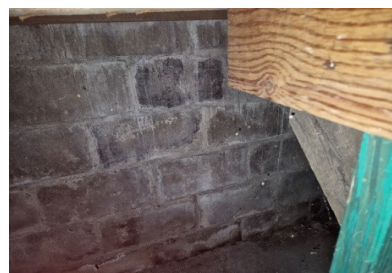
\*\*Crawlspace Leakage: typical efflorescence, staining and dampness for older foundation
