HOME INSPECTION REPORT

187 Ellis Ave

Prepared by: Bob Papadopoulos P.Eng., RHI *

Inspection Date: May 12 2026

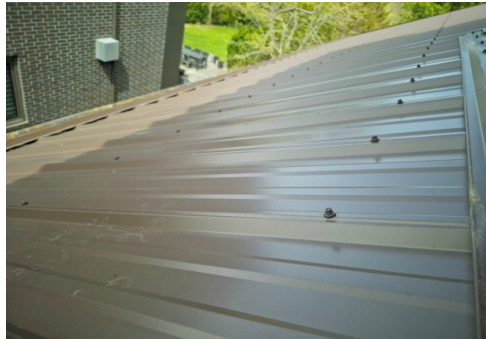
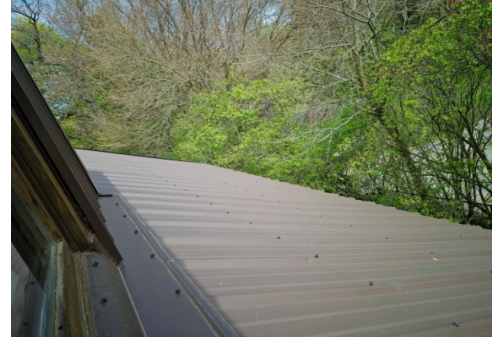
Sloped Surface: [overall surface in good repair](#)

Tree Branches: [retain arbourist for annual monitoring/trimming](#)

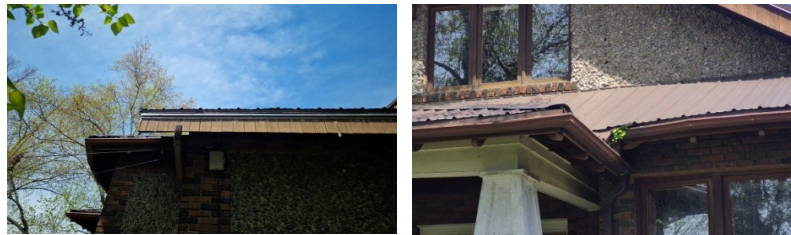
****Gutters/Downspouts:** requires maintenance/cleaning
missing on south side

Soffit & Facia: requires general repairs and painting maintenance

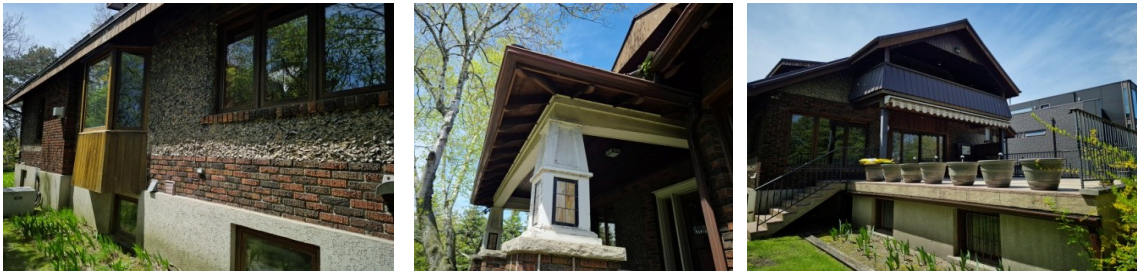
ATTACHED GARAGE: old car door opener, replace with auto reverse sensors for safety
interior door: replace with fire rated door and requires auto closer

PORCH requires general repairs and maintenance, brick repairs

DECK south: provide hand railings for safety, provide sealant on decking

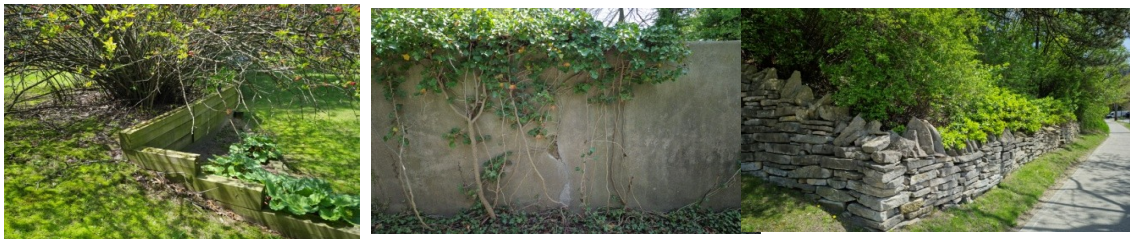
RETAINING WALL(s): older wood walls: monitor repair/budget to replace
masonry: typical settlement cracks - repair and monitor
stone: general repairs

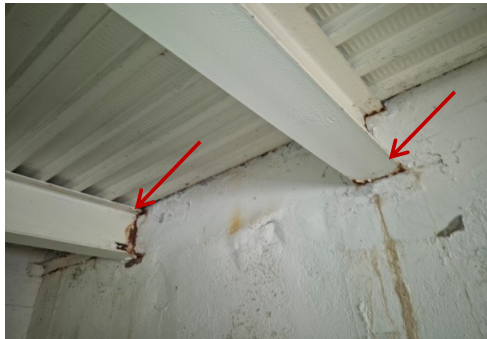
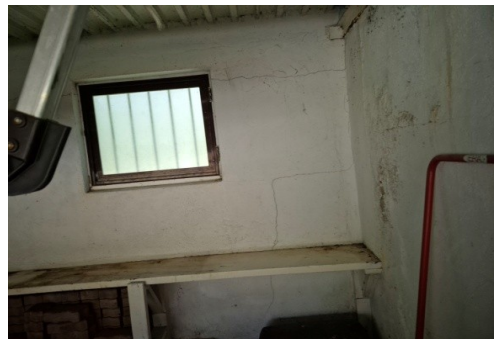
Concrete Floors: rear deck (above garage), continue to seal surface to minimize moisture penetration,

Comments: some rusting noted at steel beam supports in garage- apply anti-rust paint

also paint underside of steel decking

WALLS: garage: minor cracks typical

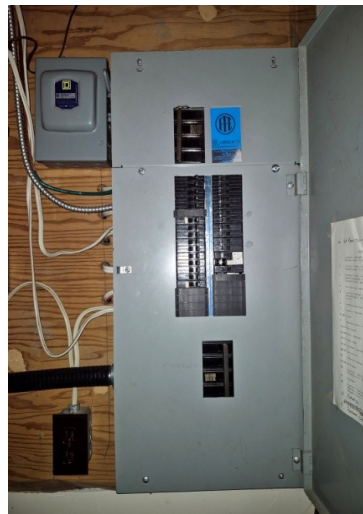
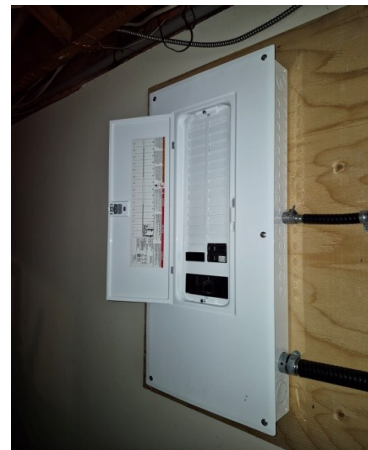
SERVICE ENTRANCE: overall in good repair
 SERVICE PANEL: overall in good repair
 Auxiliary Panel: overall in good repair

BRANCH WIRING: random sampling determined the wiring has been upgraded throughout
 some loose wires, wires connect with ducts, open junction box
 GFCI: provide to washroom outlets
 overall minor repairs

Note 1: All recommendations are safety issues - Treat them as high priority.

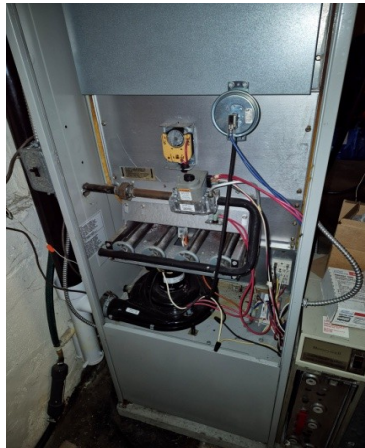
Description:	Efficiency:	Rated Input:	Approx. Age:	Life Expectancy:	Fuel Type:	Shut Off at:
Forced Air Furnace:	High	100 x1000BTU/hr	33 yrs.	20+ yrs.	Gas	Meter-Exterior

FORCED AIR FURNACE: [continue servicing until replacement becomes necessary](#)
Electronic Filter: [old, service, replace if required or disconnect power to unit, use disposable filter - replace 1-per-6 to 12 months](#)

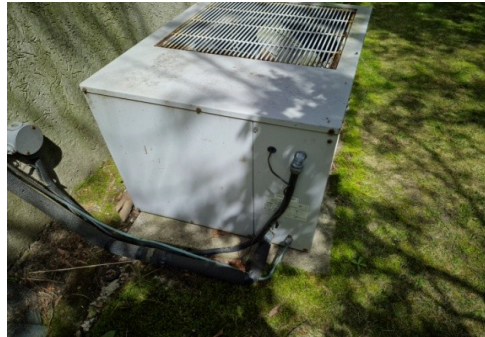
Description:	Cooling Capacity:	Approx. Age:	Typical Life Expectancy:
Air Conditioner (air-cooled):	42 x1,000 BTU/hr	20+ yrs. old	15 to 20 yrs.

AIR CONDITIONER: not tested: should be serviced before using old unit, continue servicing until replacement becomes necessary consider replacing with new unit for improved efficiency
