# HOME INSPECTION REPORT

3 Humbercrest Blvd  
Toronto

Prepared by: Bob Papadopoulos P.Eng., RHI \*

Inspection Date: [May 28 2026](#)

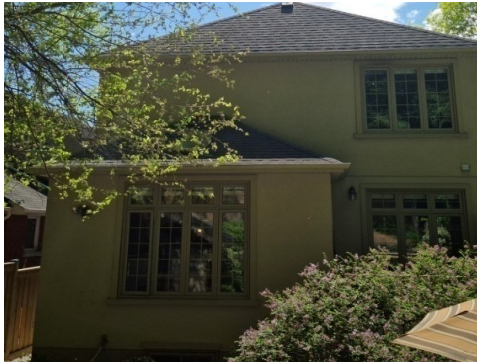
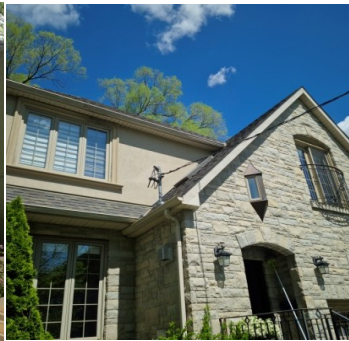
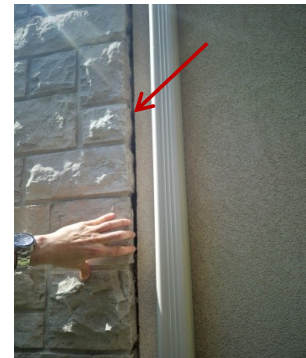
WALL SURFACES: overall in good repair, southwest: seal seam with caulking  
 DOORS/WINDOWS: overall in good repair  
 DECK overall in good repair  
 PORCH overall in good repair

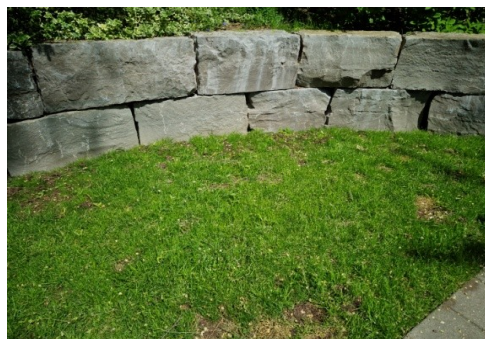
RETAINING WALL: overall in good repair

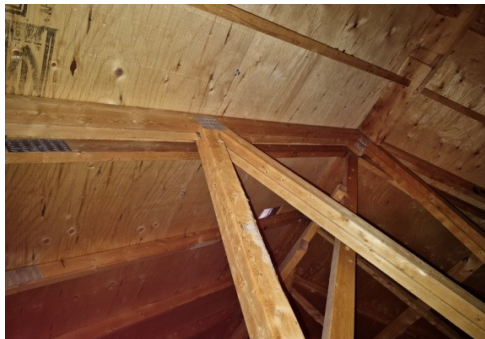
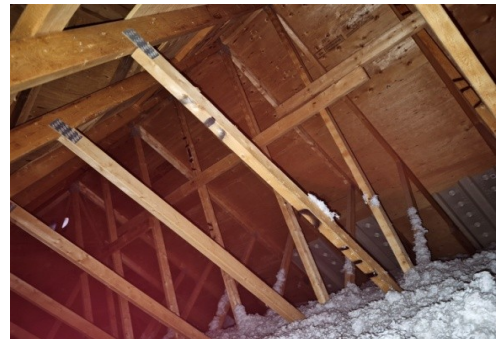
ROOF: overall in good repair

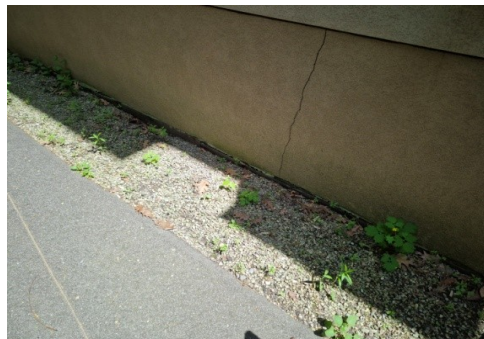
FOUNDATIONS: north side: typical settlement crack

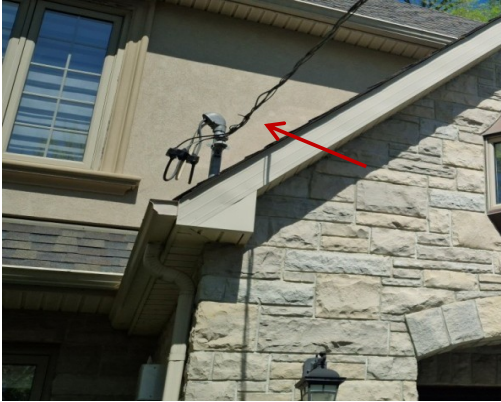
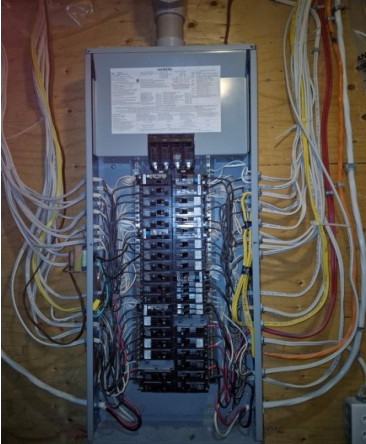
Ref#*	<p>SERVICE ENTRANCE: <b>overall in good repair</b>                  Clearance: <b>wires close to roof: might require extending mast - contact utility</b>                  SERVICE PANEL: <b>overall in good repair</b></p> <div style="display: flex; justify-content: space-around;">

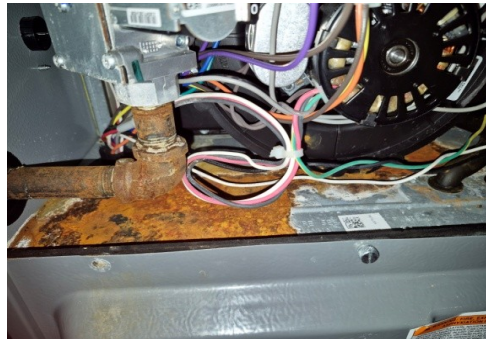
FORCED AIR FURNACE: [service annually](#)  
[some rusting noted which can reduce life expectancy of unit,](#)  
[service before next heating season](#)

Filter: [replace 1-per-3 months](#)

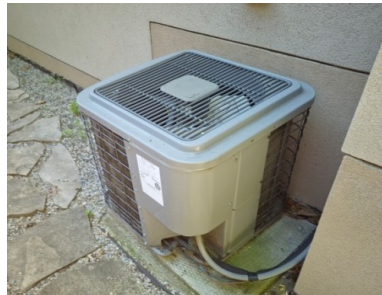
Description:	Cooling Capacity:	Approx. Age:	Typical Life Expectancy:
Air Conditioner (air-cooled):	30 x1,000 BTU/hr	22 yrs. old	10 to 15 yrs.

AIR CONDITIONER: old unit, continue servicing until replacement becomes necessary

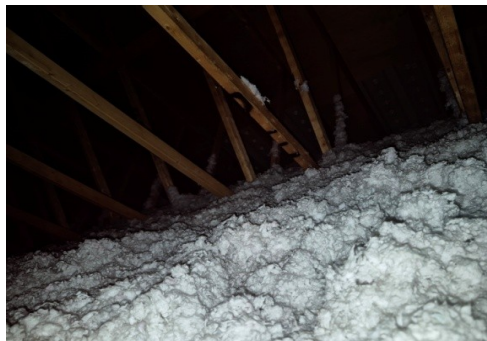
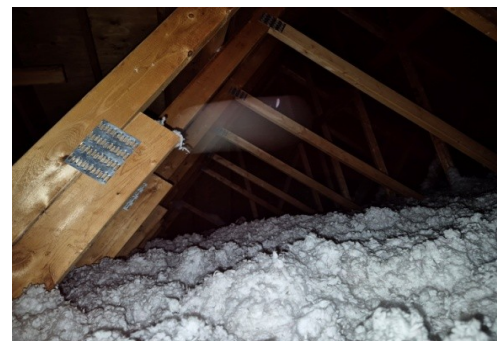
ROOF SPACE: insulation and ventilation is adequate
