311 Armadale Avenue, Toronto, Ontario

SUMMARY INSPECTION REPORT

INSPECTION REPORT

PROPERTY: 311 Armadale Avenue, Toronto, Ontario

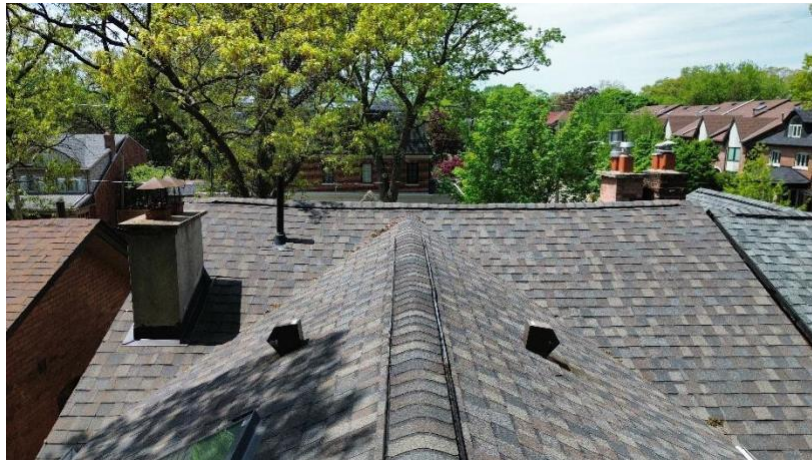
2.03 A Asphalt roofing shingles: The asphalt shingles are in good condition and were inspected using a drone. The roof was inspected using a drone. *The original house roof shingles were*

upgraded in 2012. Those above the addition were installed in 2016. There is one layer of asphalt shingles present on all sides. This type of roofing material typically lasts upwards of 20 years.
