HOME INSPECTION REPORT

33 Halford Ave
Toronto

Prepared by: Bob Papadopoulos P.Eng., RHI *

Inspection Date: [June 5 2026](#)

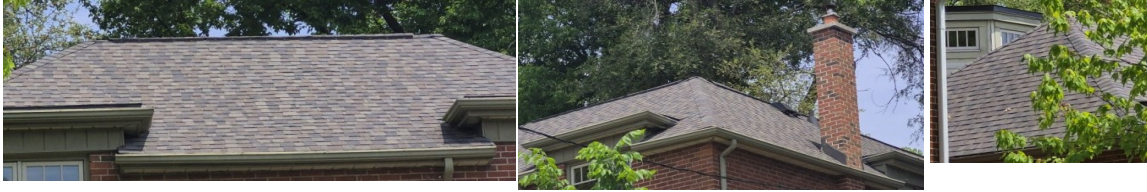
REFERENCE LINK		http://redbrickinspections.ca/docs/2_Roofing_Reference_Guide.pdf		
33 Halford Ave		ROOFING/Chimneys		June 5 2026
Description				
Roofing Material:	Location:	Leakage Probability:	Chimney(s) Type:	Location:
Asphalt Shingles:	West Slope:	Low	Brick:	South
Asphalt Shingles:	East Slope:	Medium		
Limitations				
Roof Inspected By:	Access Limited By:	Chimney Access Limited By:		
From Edge	Height	Height		
From Grade	Tree			
Observations/Recommendations				
<p>West Slope: overall surface in good repair Chimney: rebuilt and in good repair</p>

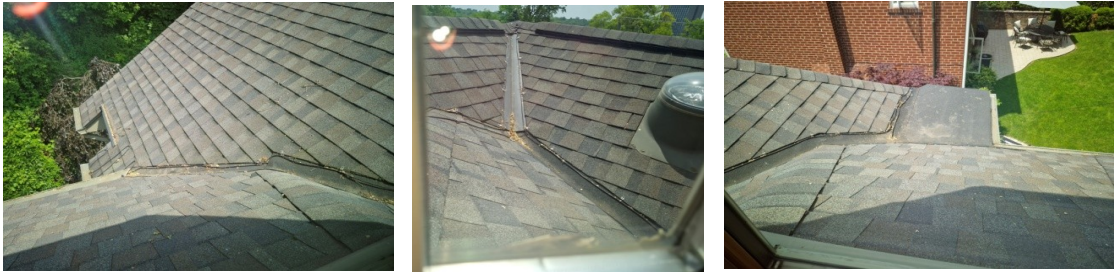
<p>East Slope: overall surface in good repair Ice Dams: various areas use heating cables- monitor performance</p>

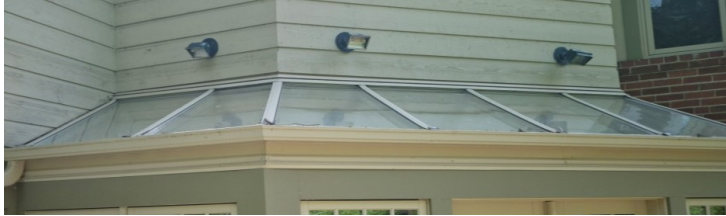
<p>Solarium: overall in good repair</p>

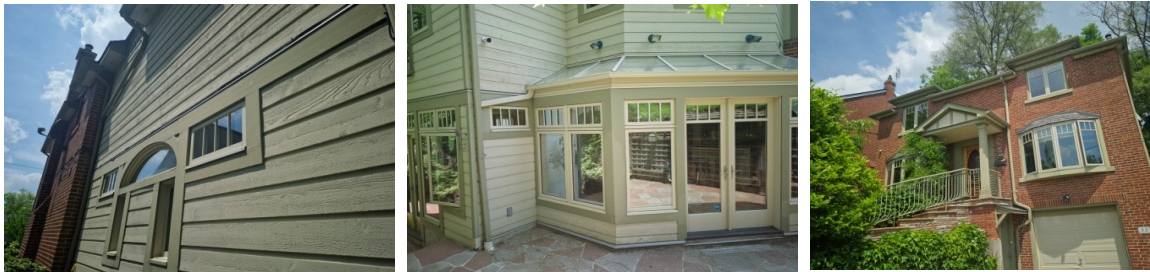
DOORS/WINDOWS: overall in good repair

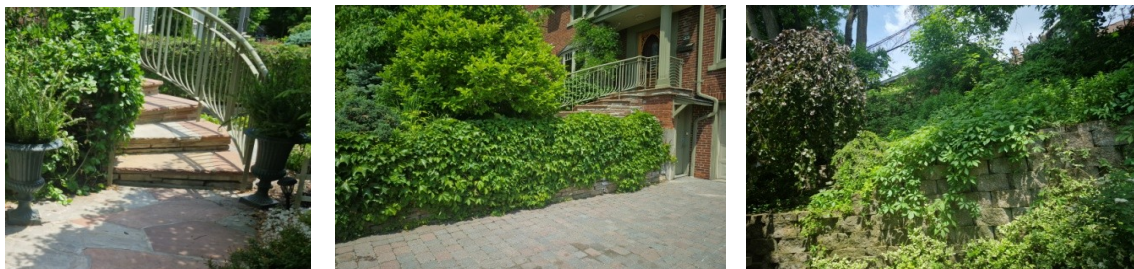
RETAINING WALL(s): overall in good repair

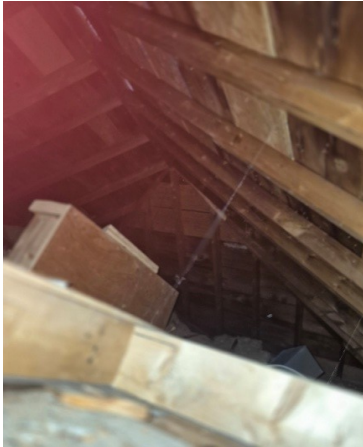
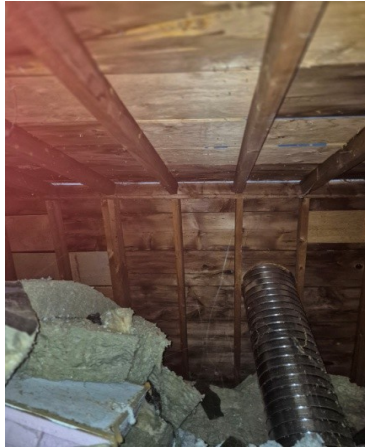
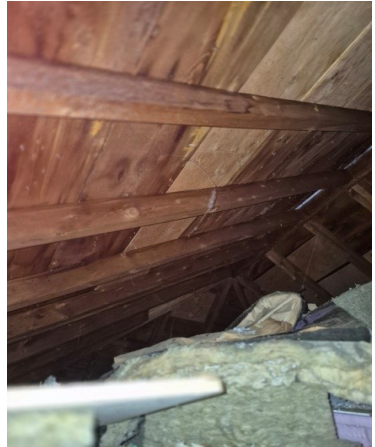
ROOF: overall in good repair
(portions obstructed)

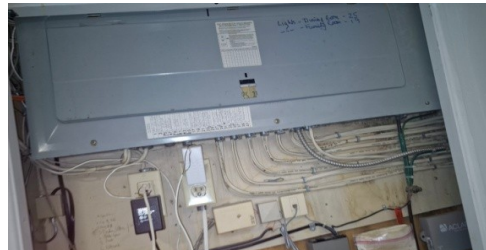
SERVICE ENTRANCE: **overall in good repair**
 SERVICE PANEL: **overall in good repair**
panel obstructed by cabinet - cover not removed

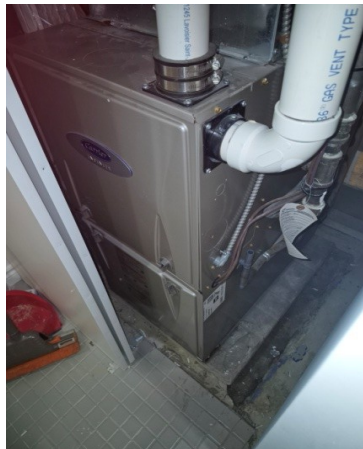
FORCED AIR FURNACE: [service annually](#)
[recommend obtaining replacement parts/servicing contract](#)
Filter: [replace 1-per-3 months](#)

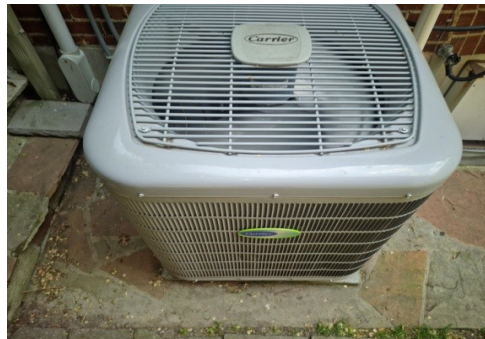
AIR CONDITIONER: [service annually](#)

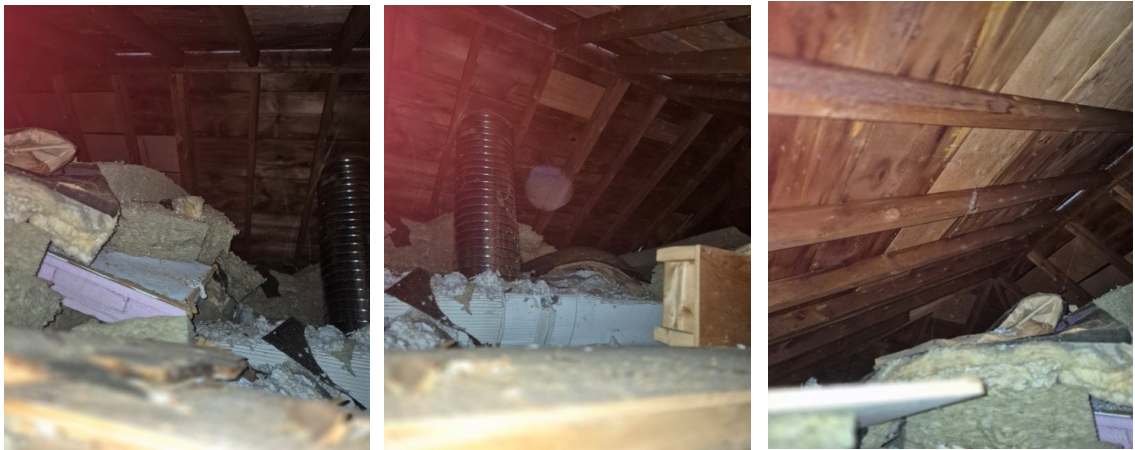
ROOF SPACE: west: uneven distribution of insulation - improve/add insulation
 remove debris

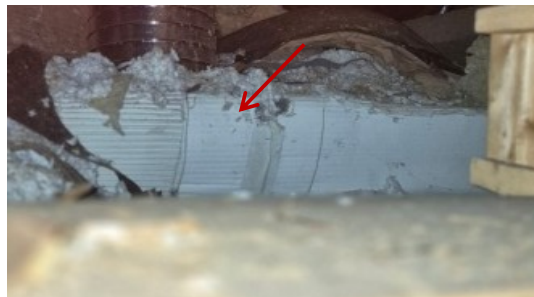
Comments: material in roof space: may contain asbestos
 since material located in roof outside of building envelope - low risk
 encapsulating the insulation is often the best approach
 Environmental Consultants can assist if this is a concern

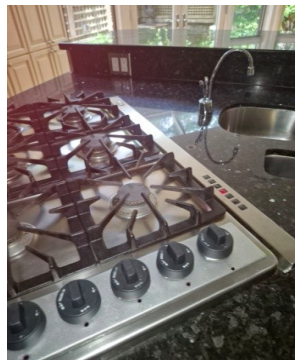
Kitchen(s) overall in good repair
auto extraction vent: could not get to work- further evaluation
