HOME INSPECTION REPORT

497 Keele St
Toronto

Inspection Date: [June 11 2026](#)

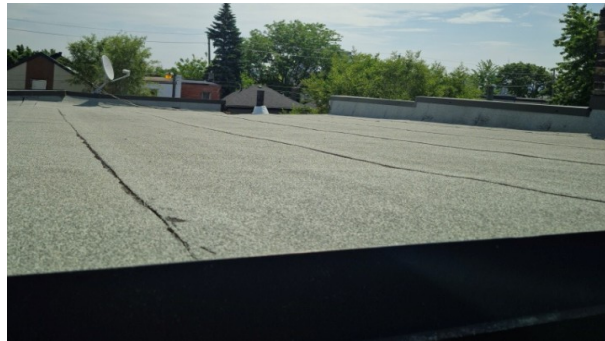
Flat Surface: [overall surface in good repair](#)

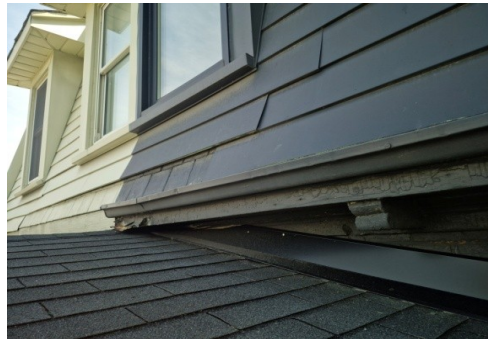
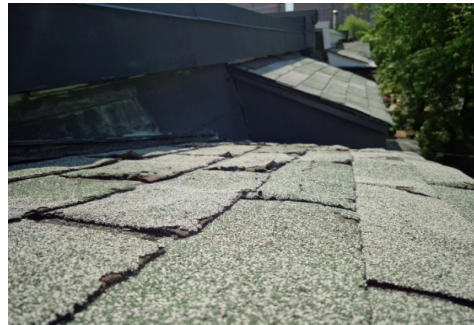
Porch(s): [overall in good repair](#)

Dormer(s): [aging surface, budget to replace within 5 yrs.](#)

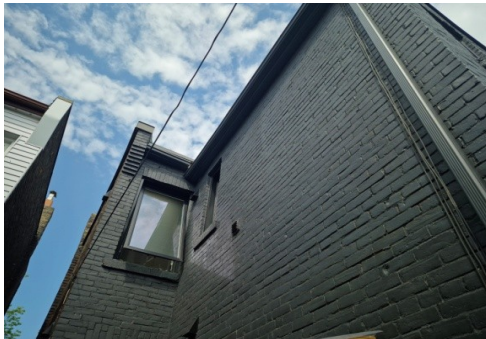
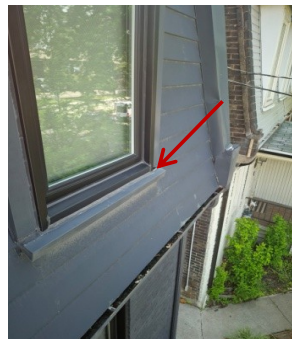
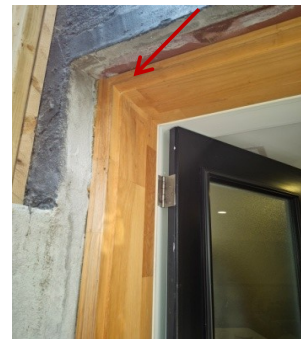
DOORS/WINDOWS: overall in good repair, basement walkout: should caulk/paint

Windows: front upper: open flashing seams - seal to avoid wood framing damage

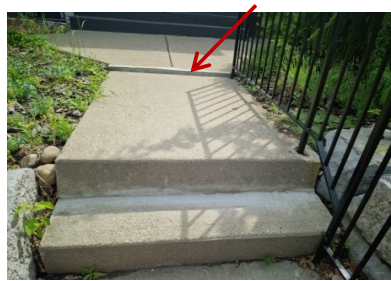
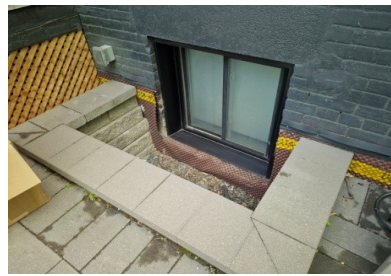
****Walk(s):** overall in good repair, somewhat trip hazard

****Window wells:** recommend window well covers

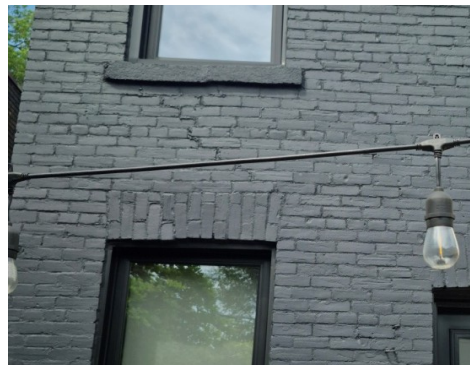
Masonry Arch: prior typical settlement cracks typical, monitor

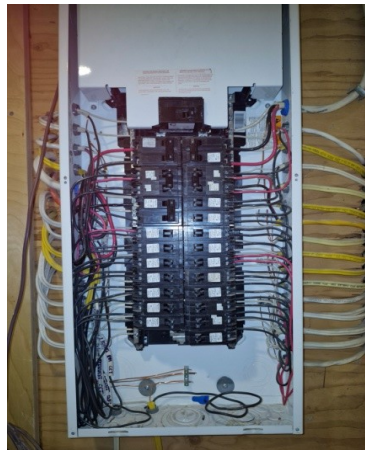
SERVICE ENTRANCE: **overall in good repair**
 SERVICE PANEL: **overall in good repair**

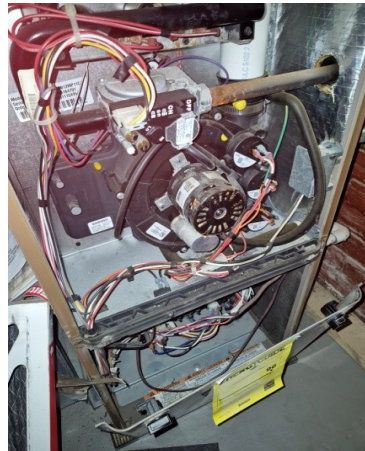
FORCED AIR FURNACE: [service annually](#)
[recommend obtaining replacement parts/servicing contract](#)
Filter: [replace 1-per-3 months](#)

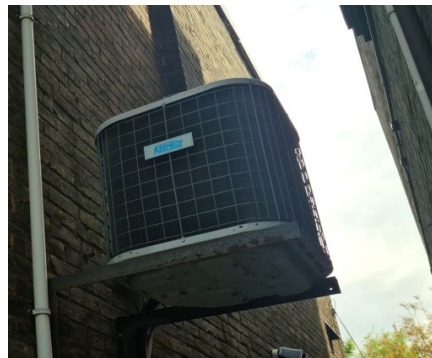
AIR CONDITIONER: [service annually](#)
