Your Inspection Report

23 Teignmouth Ave
Toronto, ON M6E 1S6

INSPECTION DATE:
Wednesday, May 13, 2026

RE: Report No. 97455, v.3
23 Teignmouth Ave
Toronto, ON
M6E 1S6

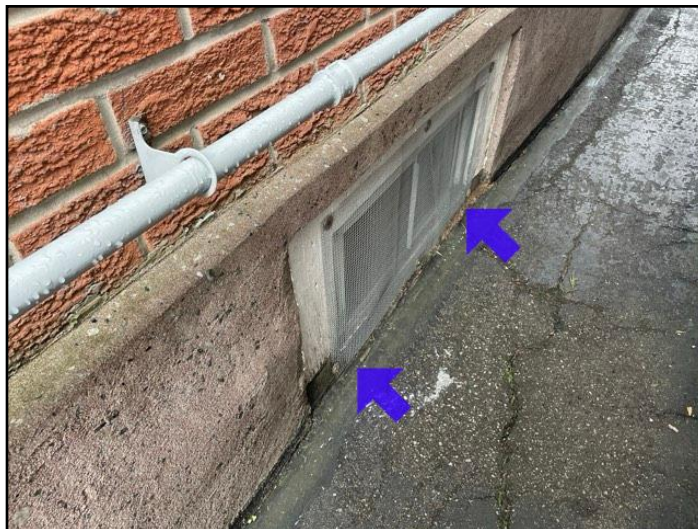
EXTERIOR \ Window wells

Condition: • Missing

Missing

It may be impractical to put a window well in this location, consider replacing the window with a smaller one to increase the sill height, or removing the window and filling with glass block or masonry.

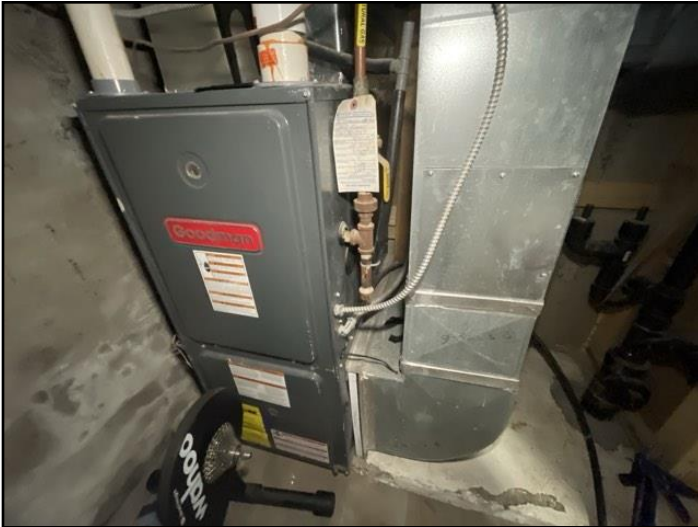
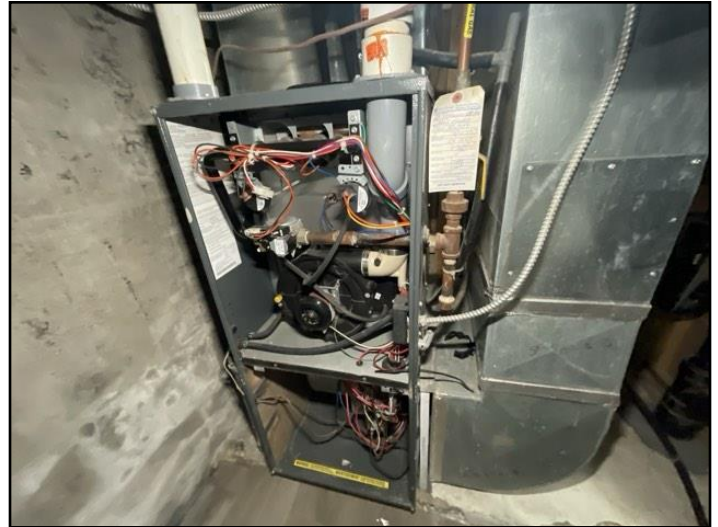
Approximate age: • [19 years](#)

Typical life expectancy: • Furnace (high efficiency) 15 to 20 years

FURNACE \ Life expectancy

Condition: • Near end of life expectancy

Although the furnace is close to the end of its life, continue to use and maintain the unit until it fails. Be prepared to replace the furnace at any time.

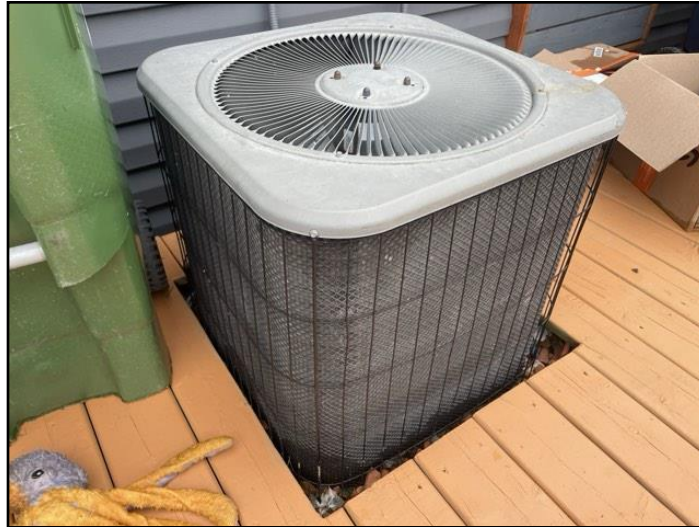
Compressor approximate age: • 19 years

Typical life expectancy: • 10 to 15 years

AIR CONDITIONING \ Life expectancy

Condition: • Air conditioner past typical life expectancy

Be prepared to replace at any time.

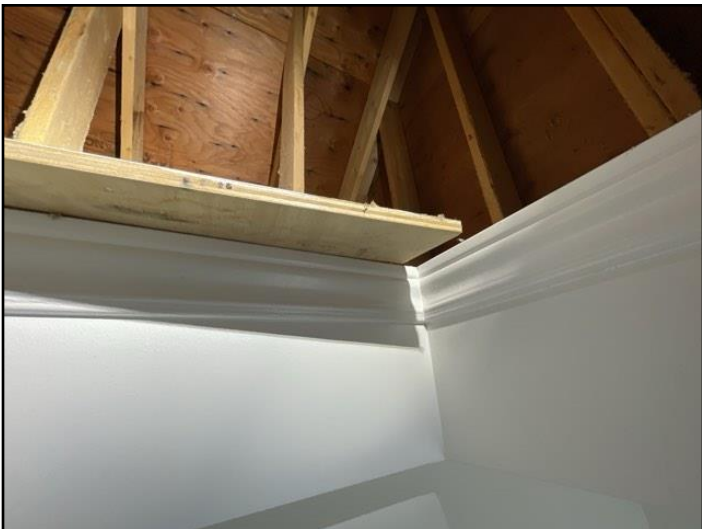
Condition: • [Not insulated and not weatherstripped](#)

Neither access door is insulated or weatherstripped, Improvements will help reduce heating and cooling loss through the hatch

Not insulated and not weatherstripped

Task: Improve

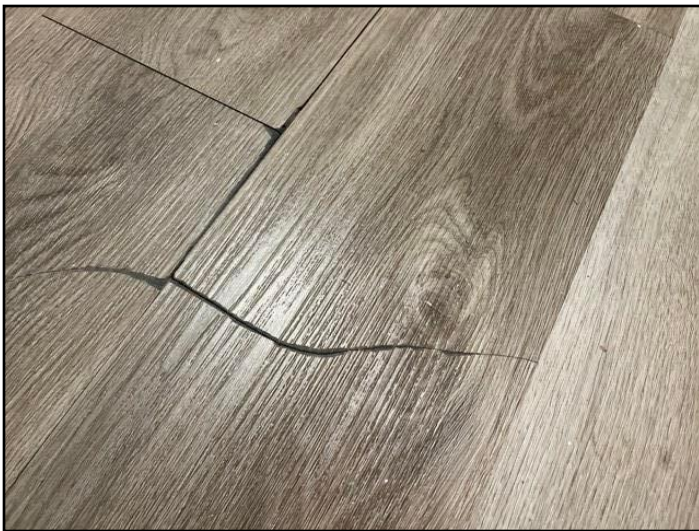
The flooring appears to have been installed over a somewhat uneven substrate. As a result, some stress at the interlocking joints was noted, with loose boards, minor gaps, and localized damage observed at time of inspection. These conditions may progress with normal use and could result in further wear or minor tripping concerns over time.

Crack

Task: Repair/Replace

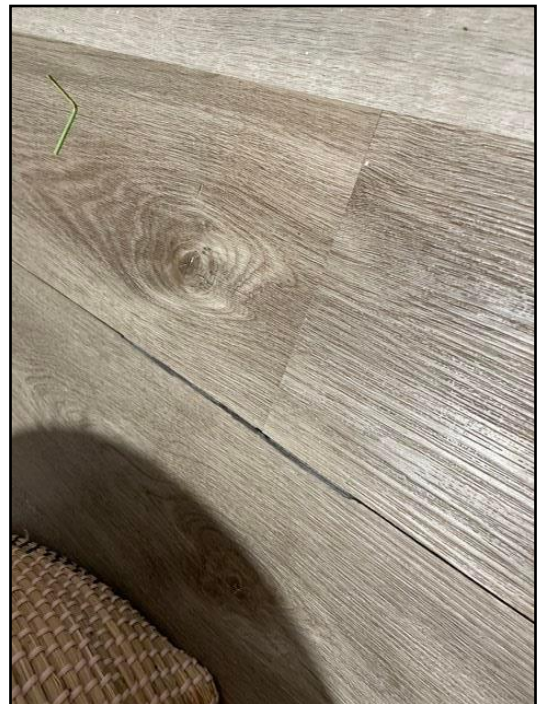
Broken tabs

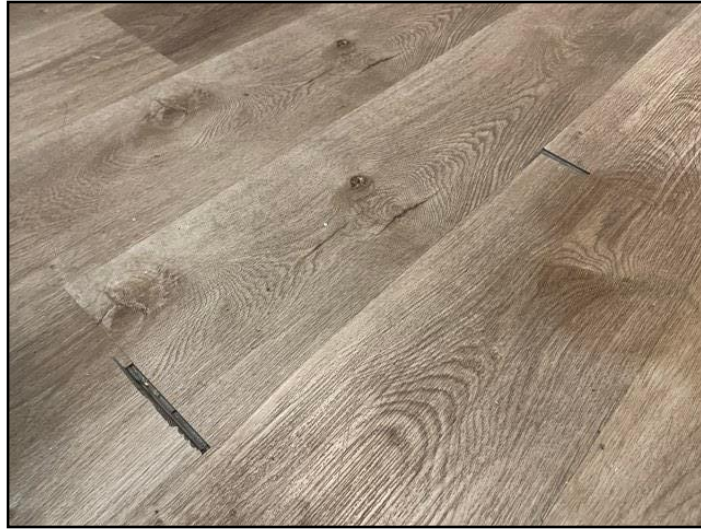
Gaps

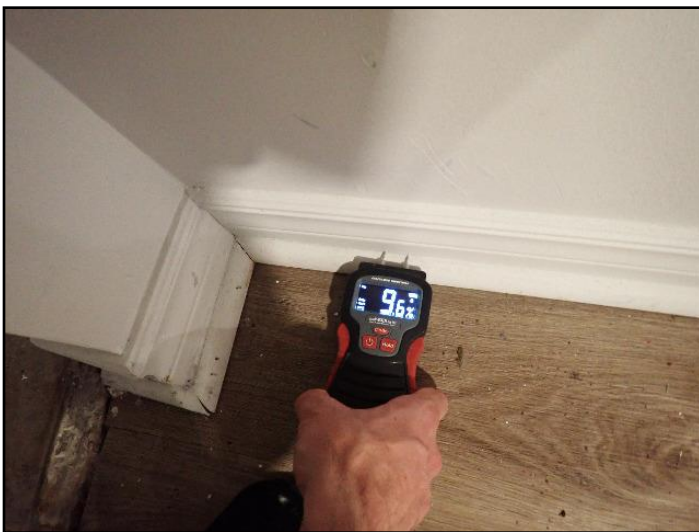
Front - Typical reading noted - Dry

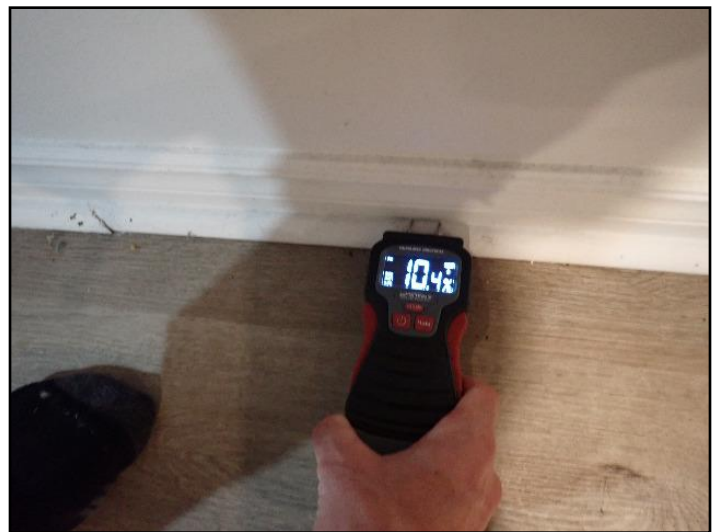
Right side Typical reading noted - Dry

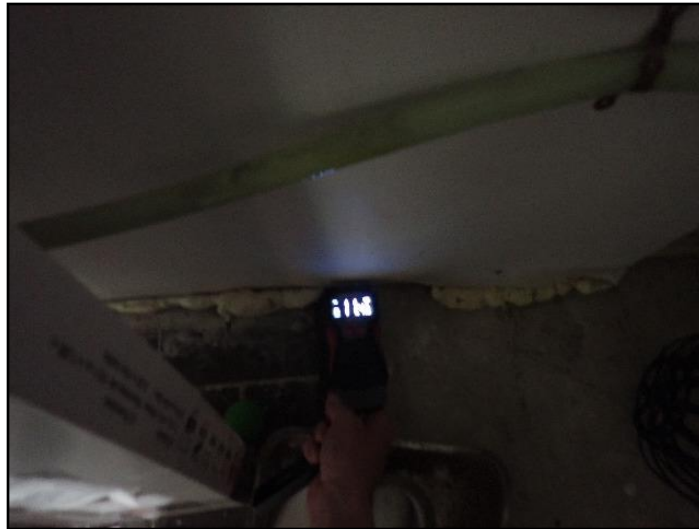
Rear - Typical reading noted - Dry

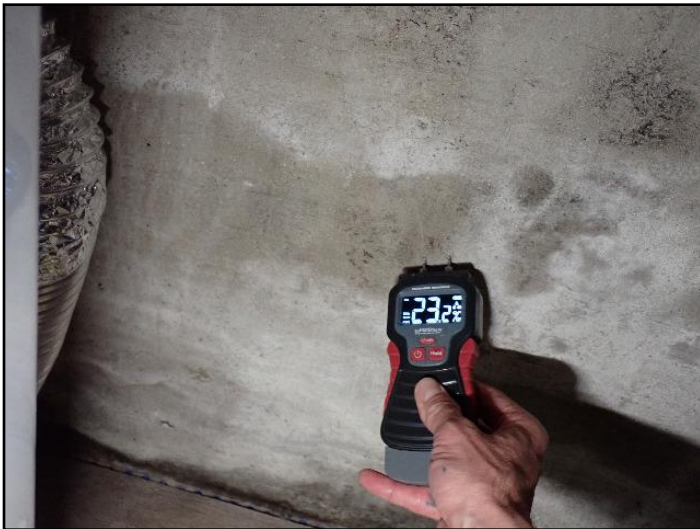
Condition: • Evidence of moisture noted

During the pre-listing inspection, localized moisture was observed along the left side of the basement (near furnace). This was suspected to be related to the neighbour's downspout discharging below grade, which may have been clogged or improperly draining. The downspout has since been extended above grade to improve drainage away from the foundation. This corrective action should help reduce the potential for moisture intrusion. Recommend monitoring the area for any signs of recurrence

Elevated readings

Task: Monitor
