# **PROPERTY CONDITION ASSESSMENT**

## 247 & 249 High Park Ave

Prepared by: Bob Papadopoulos P.Eng Oct 2, 2024

Oct 2, 2024 Ref#:C020924

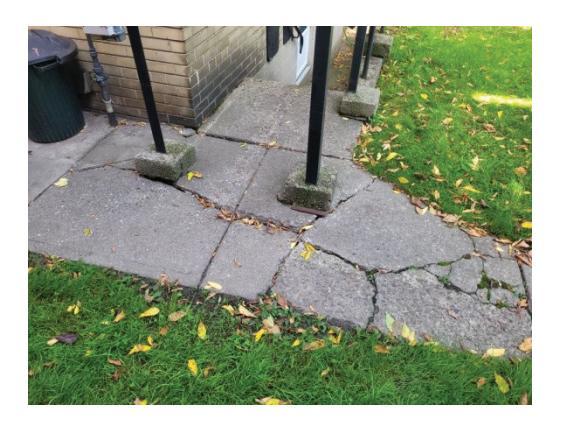
#### Pic 1 Concrete Walkway

The front walkway is uneven and potentially a trip hazard which should be repaired.

The concrete southeast walkways and parking areas are cracked/damaged in some areas and should be repaired. Overall recommend budgeting to replace/re-surface.

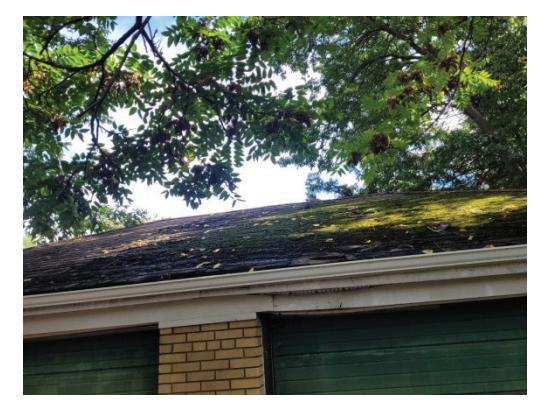
Pic 2 Garage roof

Overall the garage shingles are in poor condition and require replacement including some repairs to the roof structure.

Recommendations	Costs	Time Frame
Garage roof replacement	\$10,000 and up	immediate

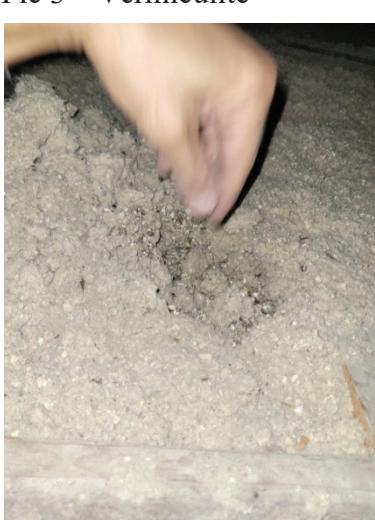
Pic 3 Vermiculite

The Vermiculite insulation in the roof spaces requires further evaluation to determine if asbestos is present.

Typically leaving the insulation undisturbed is the best approach. Contact environmental remediation specialist for best approach.

Recommendations	Costs	Time Frame
Vermiculite Insulation-further evaluation	depends	immediate

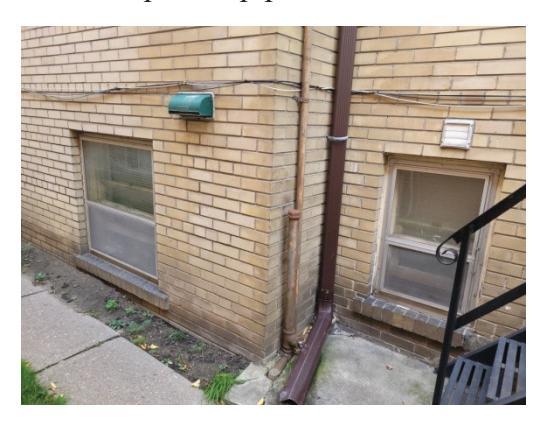
#### Pic 4 Sample Oil pipes/buried oil tank

Further evaluation is required to determine if two buried oil tanks are present. The two boilers are older.

Recommendations	Costs	Time Frame
Replacement	\$5,000 to \$7,000 each	Within 5-yrs
Two Buried oil tanks- further evaluation	depends	Immediate

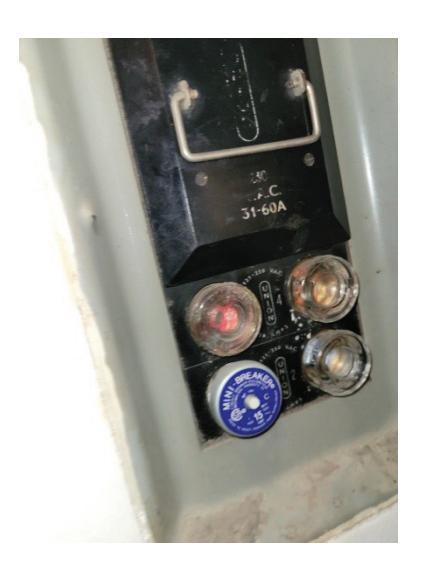
Pic 5 Sample panel

The general maintenance of the electrical system is required. Deficiencies noted at the distribution equipment are as follows:

- Ungrounded outlets should have GFCI (ground fault circuit interuptors)
- Trim vines away form exterior service drop/masts
- Panels require properly sized fuses
- Ground-fault Interrupters should be provided to washroom and kitchen outlets where none.

Recommendations	Costs	Time Frame
Electrical distribution equipment repairs	\$1,500 to \$3,000	Immediate

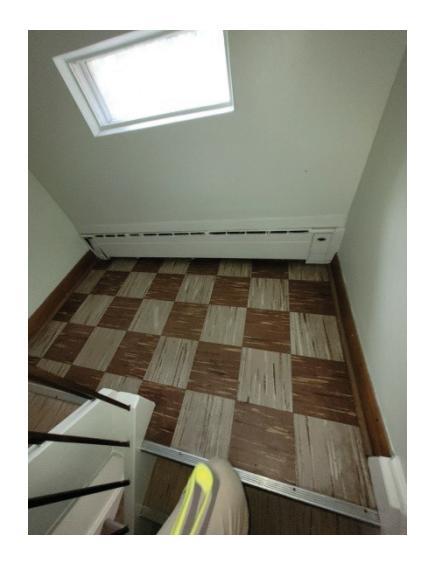
Pic 6 Sample old floor tile

The resilient tile is older and may contain asbestos which is typical for building of this age. This requires further evaluation with lab testing to determine. Leaving the tile undisturbed and/or covering is often the best approach. Consult with environmental specialist for best approach.
