19 Galley Avenue, Toronto, Ontario

SUMMARY INSPECTION REPORT

INSPECTION REPORT

PROPERTY: 19 Galley Avenue, Toronto, Ontario

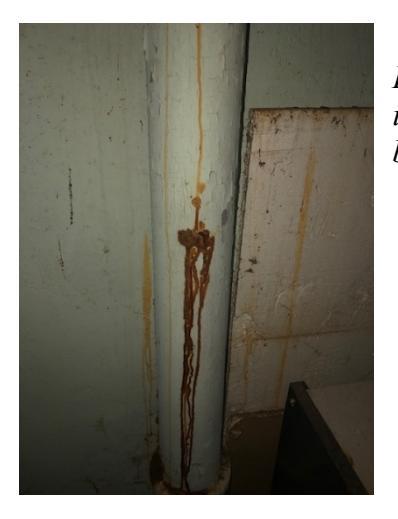
P: perforations, caused by corrosion, exist in the visible main cast iron stack along the west basement wall. This section of pipe should be replaced.

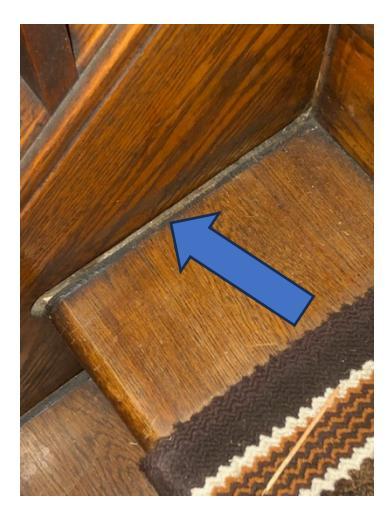
P: the loose treads (horizontal wood boards) for the staircase between the main and second floor (lower level) have separated form the side stringers and should be secured.
