# Your Inspection Report

530 Runnymede Rd  
Toronto, ON M6S 2Z7

**INSPECTION DATE:**  
Thursday, February 26, 2026

RE: Report No. 96257, v.2  
530 Runnymede Rd  
Toronto, ON  
M6S 2Z7

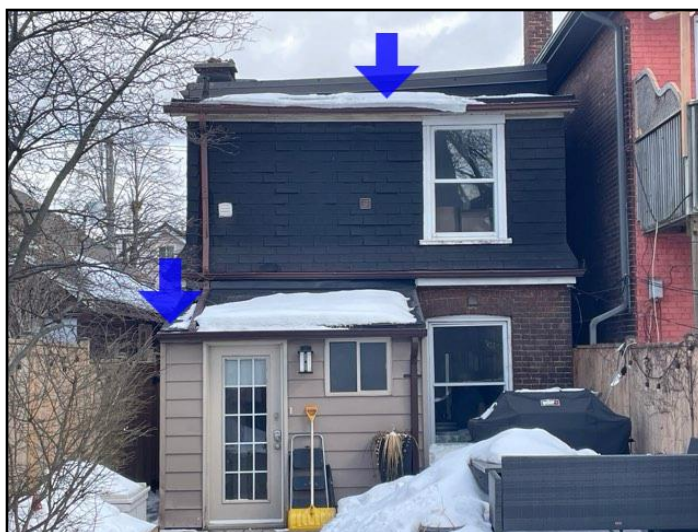
Condition: • [Improper slope, ponding](#)

*Improper slope, ponding*

Time: As soon as practical

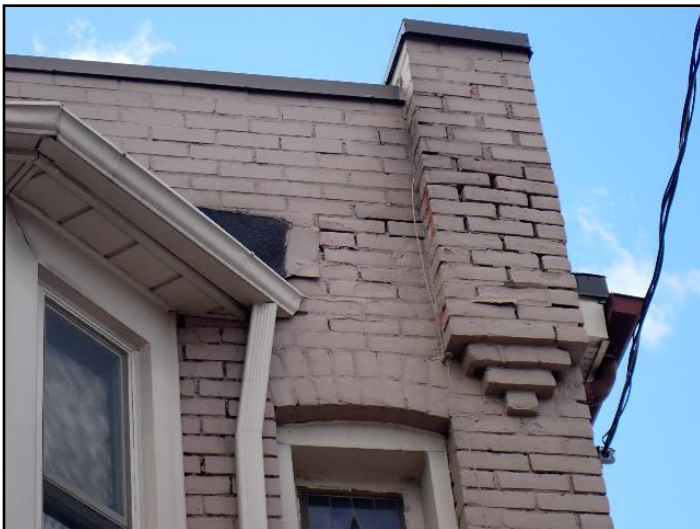
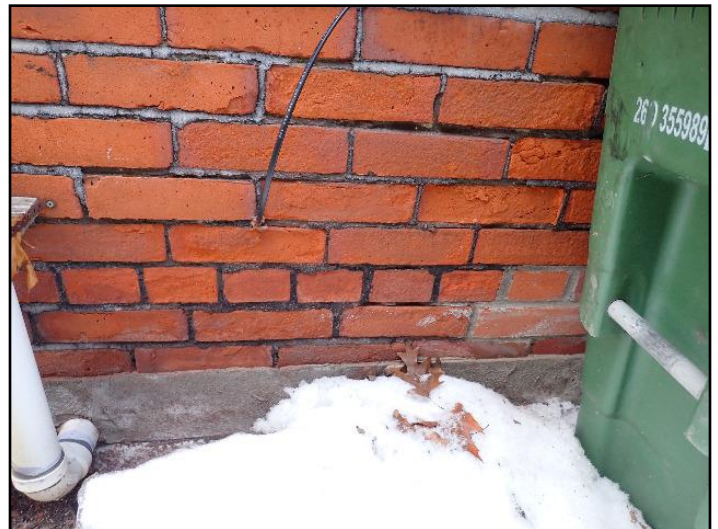
Condition: • [Mortar deterioration](#)

Mortar deterioration

Task: Repair

Time: As needed

Cost: \$1,000 and up

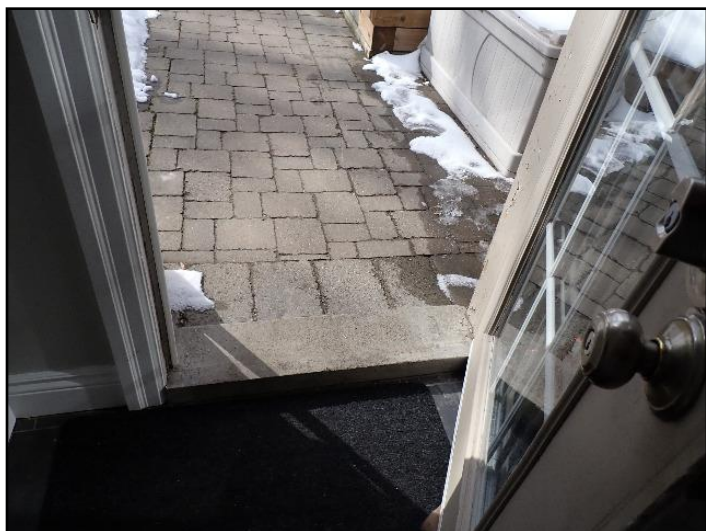
**Condition:** • Threshold - ineffective

*Threshold - ineffective*

**Task:** Improve / keep area clear of accumulated snow

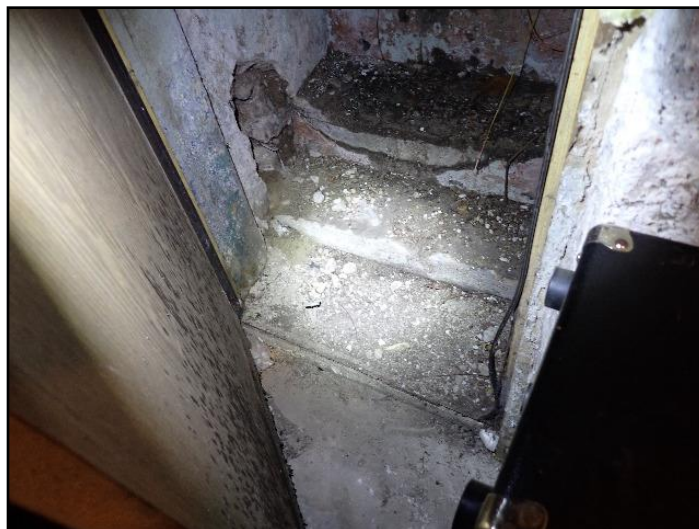
**Condition:** • Threshold - ineffective

*Basement walkout*

**Task:** Improve

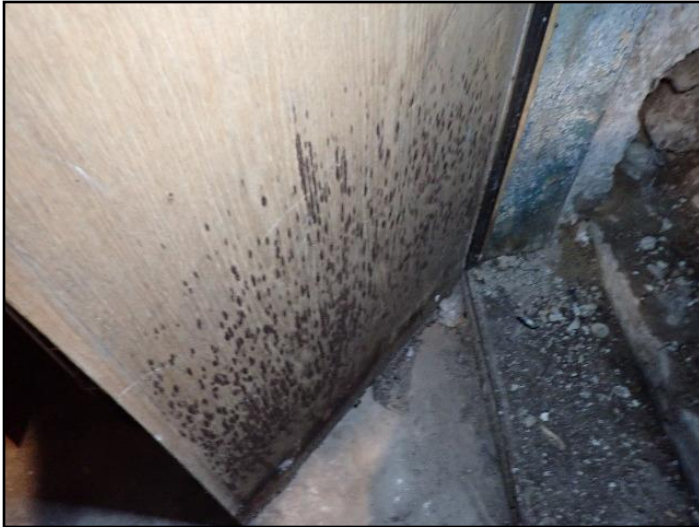
Rear basement walkout has been covered by a deck and is not in use. The parging on the walls is loose and crumbling. The base of the door has moisture damage

Moisture damage at bottom of door

**Task:** Clean and repair.

**Cost:** \$2,000-\$4,000 (to replace the door and repair the parging)

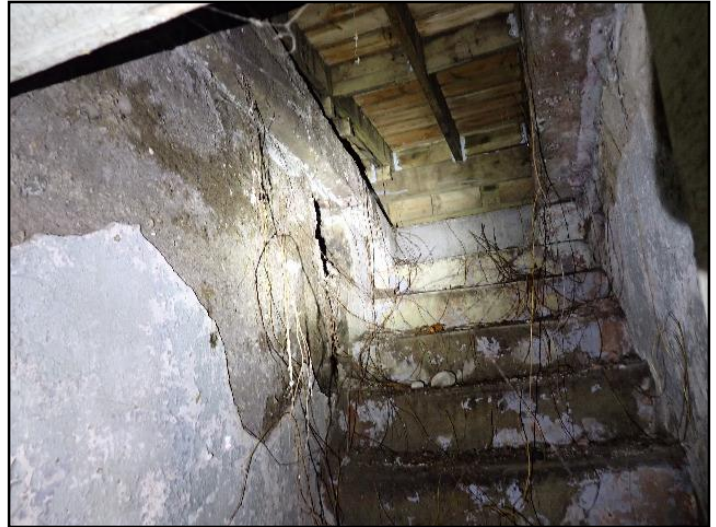
**Condition:** • Walls - spalling

Walls - spalling

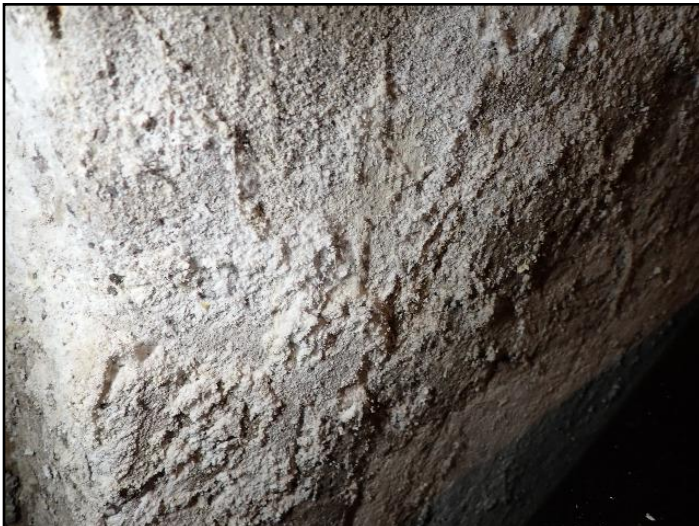
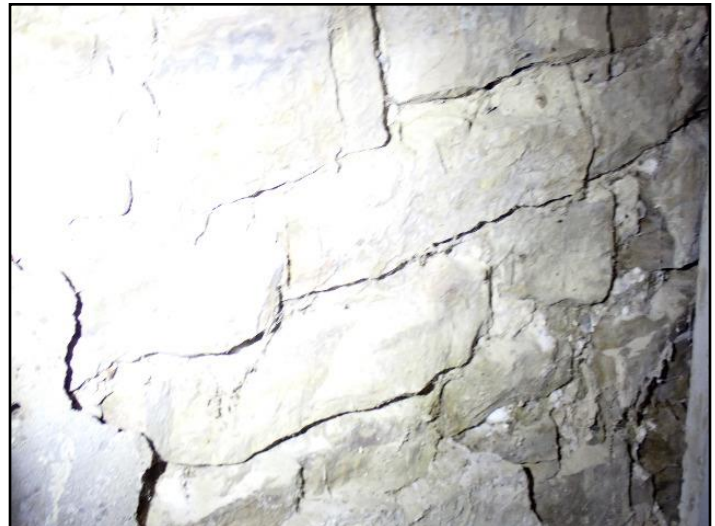
**Condition:** • [Efflorescence](#)

Efflorescence was noted with some mortar deterioration. which is typical for a brick foundation of this age. (100 years)  
Basement walls were dry when tested with a moisture meter (at the time of inspection).  
(see exterior section for more recommendations.)

*Efflorescence*

**Task:** Clean efflorescence/ Repair mortar / Monitor for reoccurrence / See exterior recommendations.

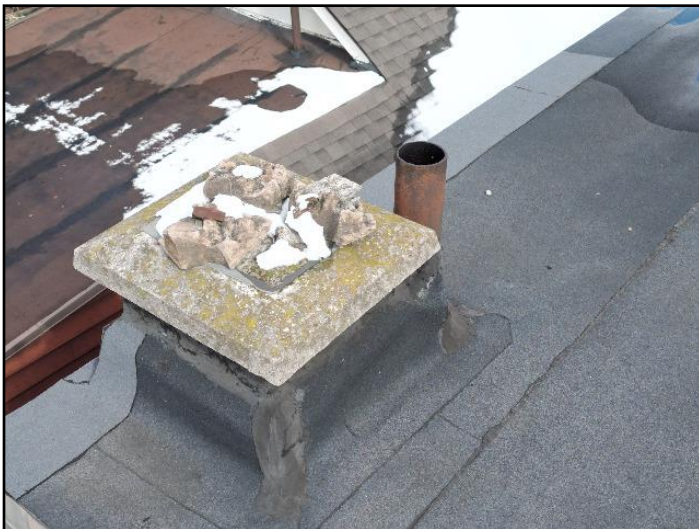
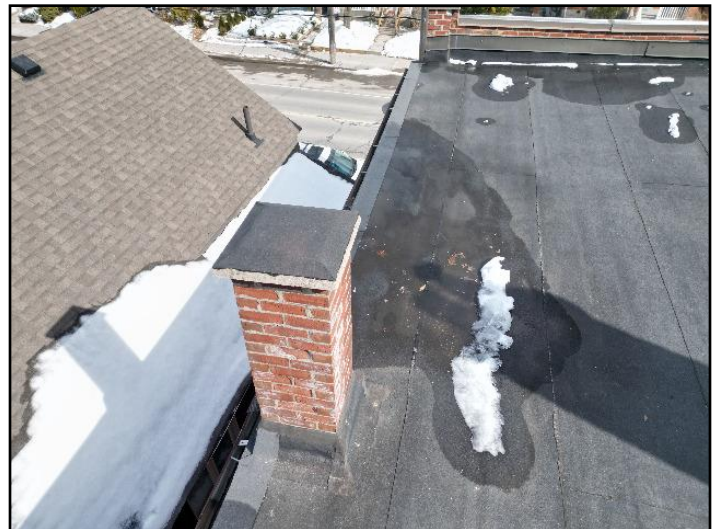
**Condition:** • Abandoned chimney

Abandoned chimneys have been sealed from above, the rear chimney appears to have loose masonry on top, making it difficult to see if it has been fully covered from rain. when weather permits, further investigation is recommended.

Abandoned chimney

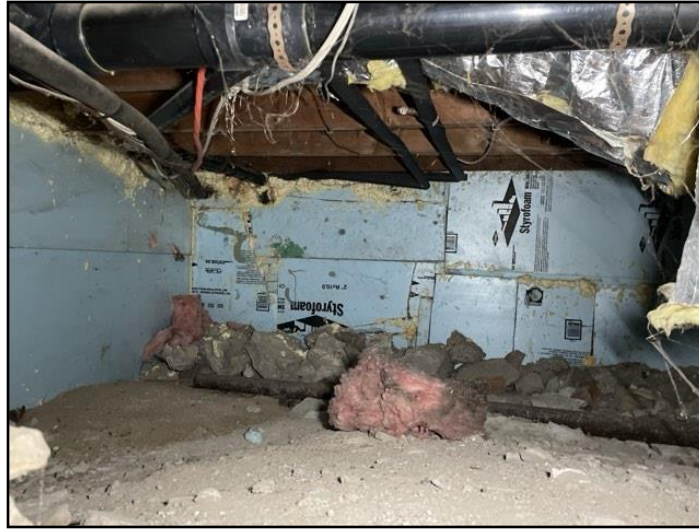
- Condition:** • Exposed combustible insulation
- Location:** Crawlspace rear
- Task:** Cover/improve
- Time:** As soon as practical
- Cost:** Not determined

*Exposed combustible insulation*

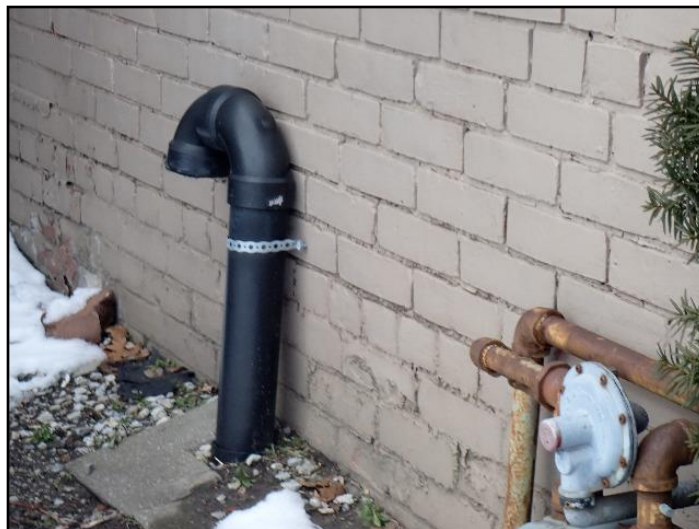
**Condition:** • Pipe is suspected to be a waste vent. Waste vent pipes should terminate above the roofline.

*Suspected waste vent*

**Task:** Further evaluation/Improve

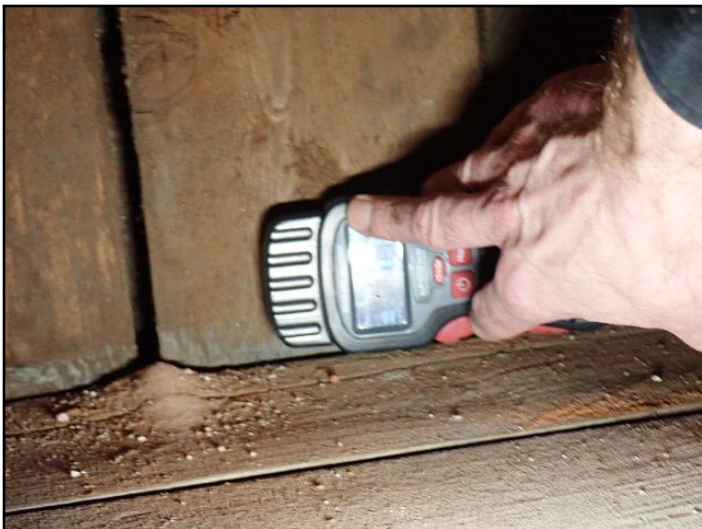
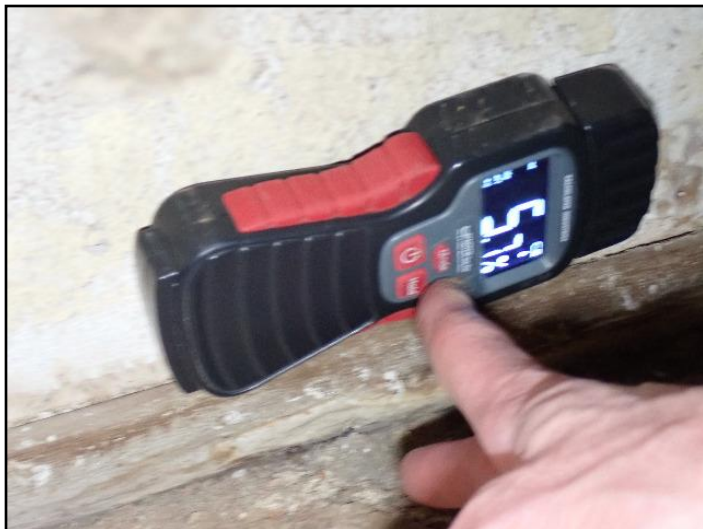
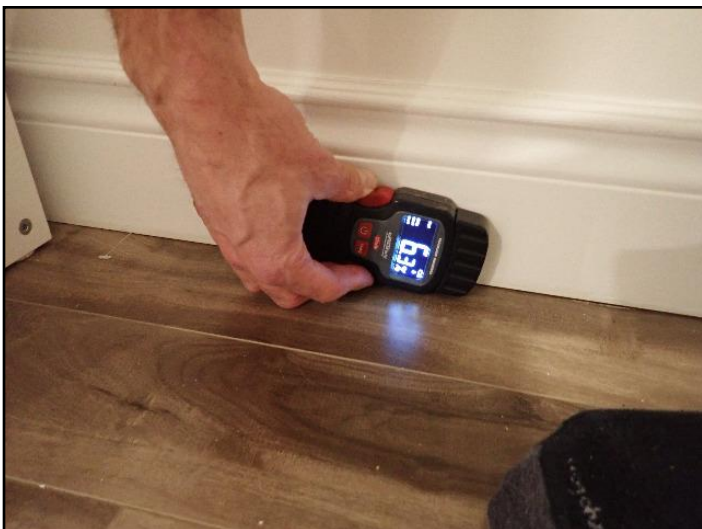
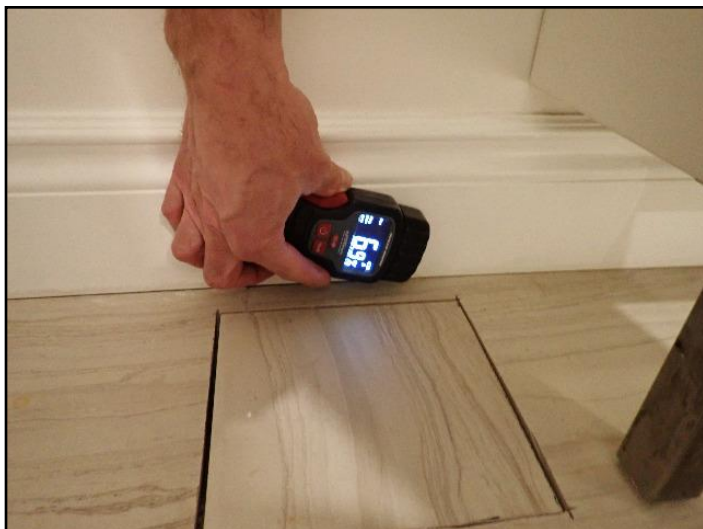
**Condition:** • Typical reading noted with meter during inspection.

Typical reading noted - Dry

Right side - Typical reading noted - Dr

Front - Typical reading noted - Dr

Left side - Typical reading noted - Dr

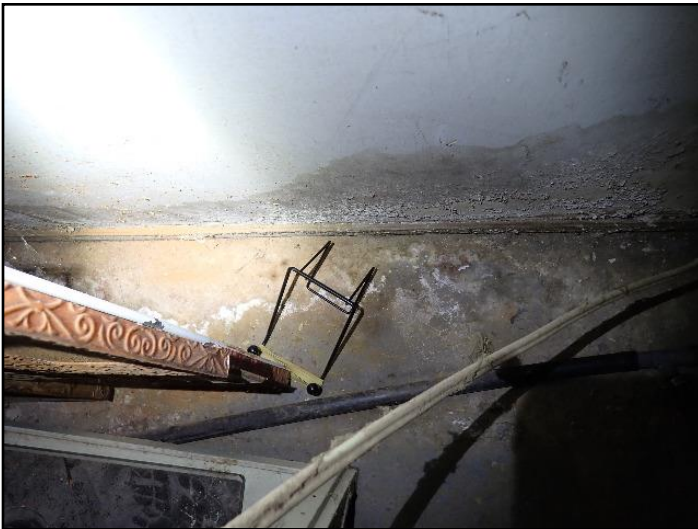
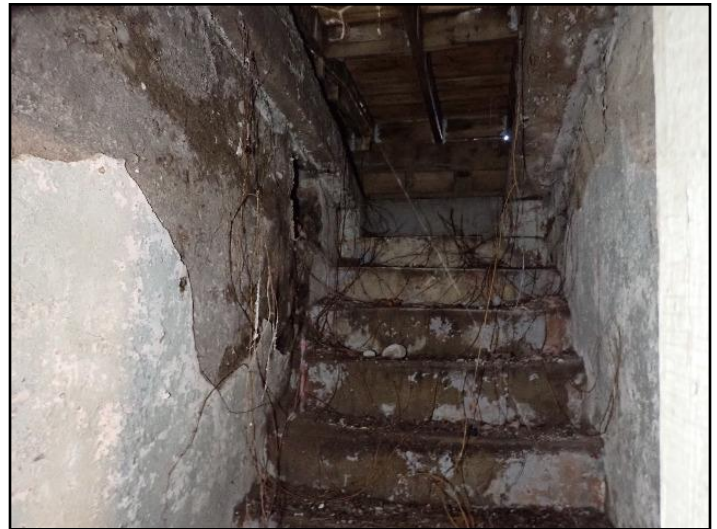
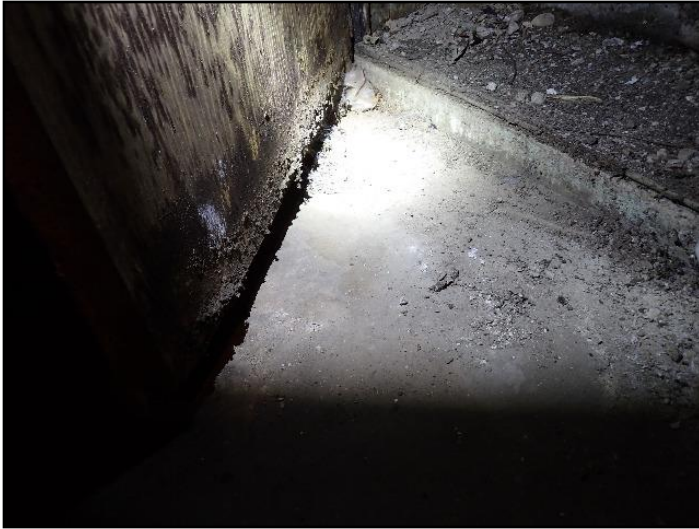
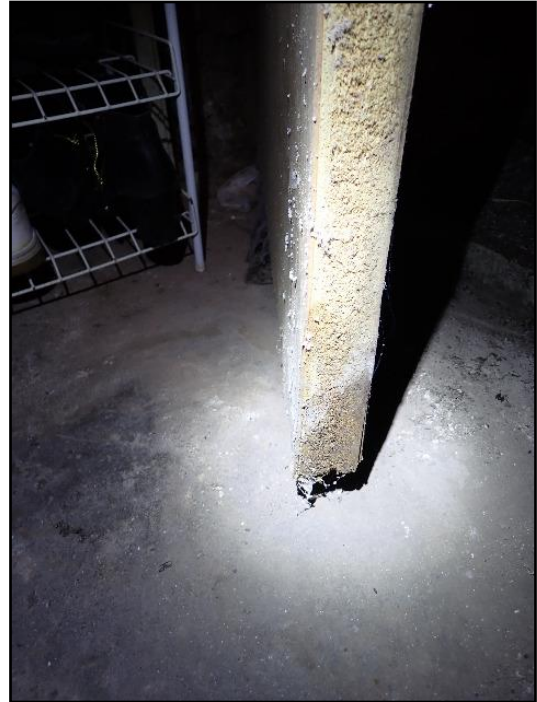
**Condition:** • [Crumbling plaster, dry wall or concrete walls](#)

The abandoned basement walkout is covered by a deck, which allows melting snow and rain to pass through the deck boards and saturate the dust and debris in the stairwell, without any airflow this moisture doesn't evaporate quickly and when overwhelmed likely flows into the unfinished portion of the basement causing the water stains. The basement is dry overall but the unfinished portion contains a large volume of stored items. This restricted access to some components and may impede proper ventilation, which can contribute to dampness.

Water stains (inside)

Crumbling concrete(outside)

*Moisture damage at bottom of door*

*Absorption line, MDF door (absorbant)*

**Task:** Clean the stairwell of all dust/debris, Replace the basement door, protect the stairwell from above. Improve gutters, downspouts and lot grading so that water is directed away from the home.
