# Your Inspection Report

349 Windermere Ave  
Toronto, ON M6S 3L1

**INSPECTION DATE:**  
Wednesday, January 28, 2026

RE: Report No. 95913  
349 Windermere Ave  
Toronto, ON  
M6S 3L1

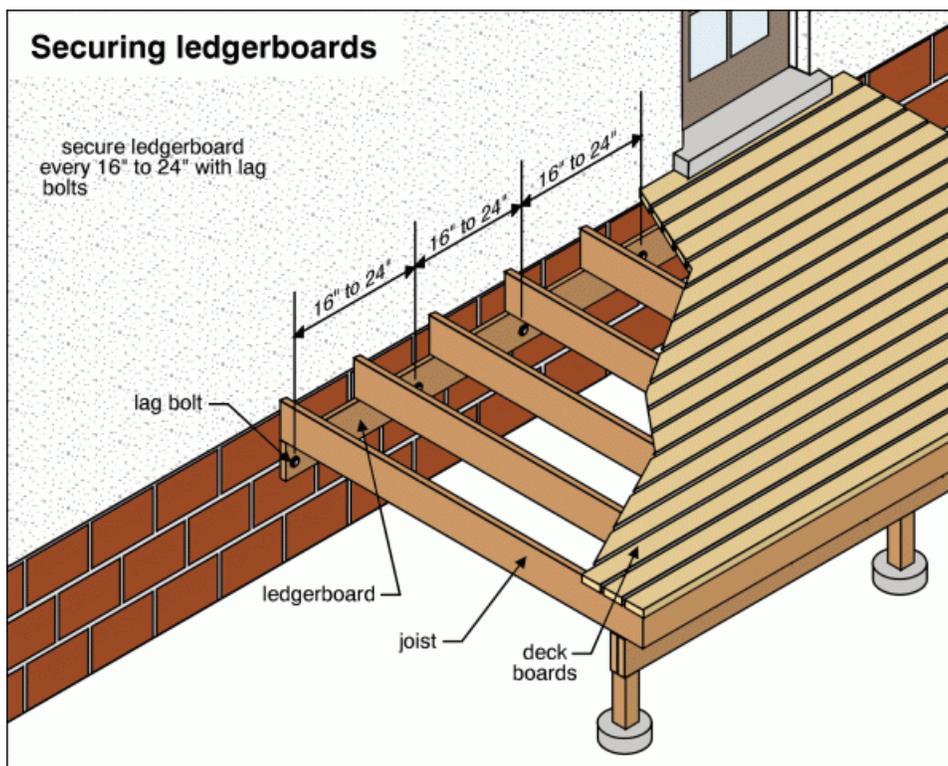
**Condition:** • The quality of the connection of a deck to the building is a common issue. This cannot be verified during a home inspection, but you should understand this is a potential weak spot in any deck system.

**Task:** Inspect Annually  
**Time:** Ongoing

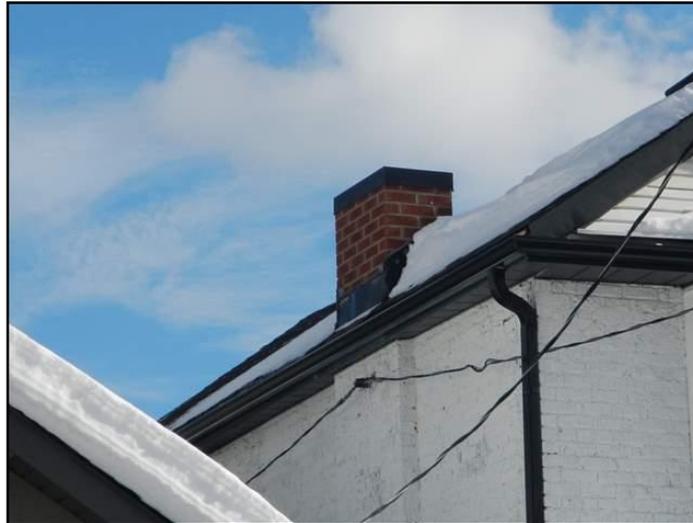
*Masonry*

It has been reduced in height, and capped-off.

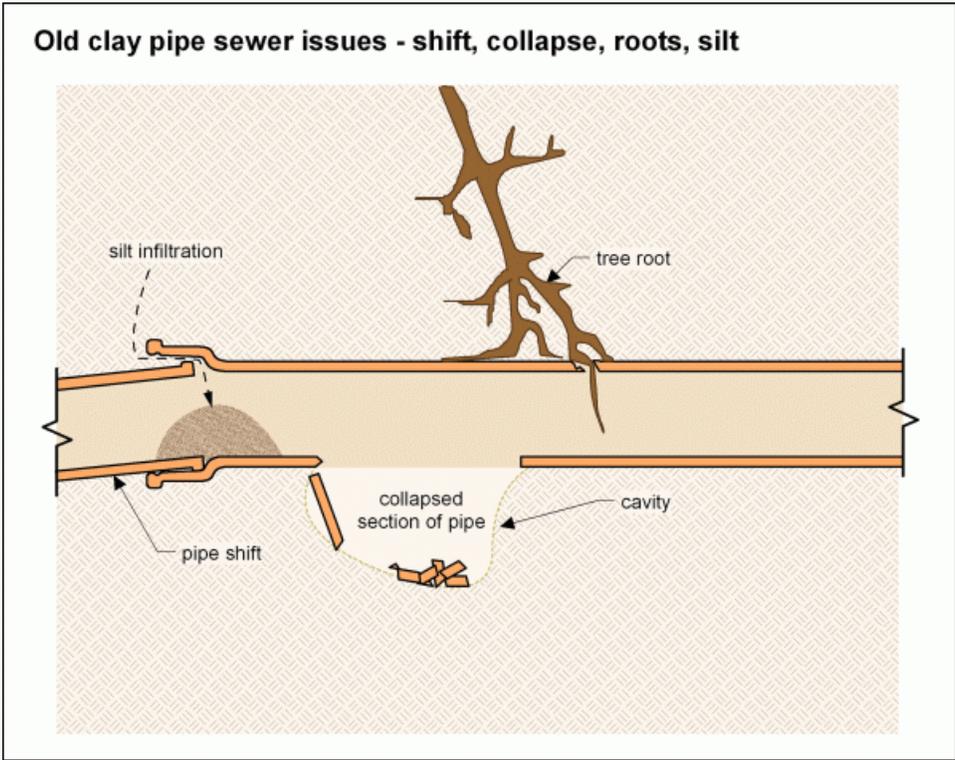
**Condition:** • The cast iron waste piping is near the end of its normal life expectancy and is prone to rusting through or splitting. Replacement may be required in the near future.

**Task:** Further evaluation Replace
