Your Inspection Report

31 Runnymede Rd
Toronto, ON M6S 2Y1

INSPECTION DATE:
Monday, March 23, 2026

RE: Report No. 96580, v.2
31 Runnymede Rd
Toronto, ON
M6S 2Y1

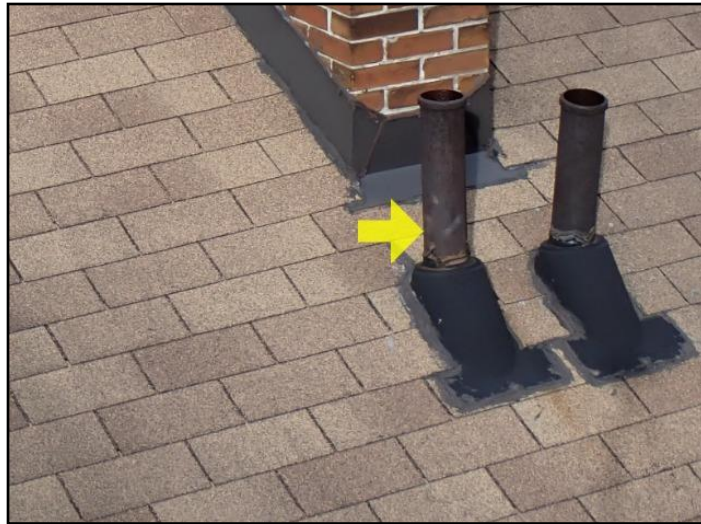
Cast iron waste stack

Condition: • The cast iron waste piping is near the end of its normal life expectancy and is prone to rusting through or splitting. Replacement may be required in the near future.
