Your Inspection Report

59 Parkway Ave
Toronto, ON M6R 1T6

INSPECTION DATE:
Tuesday, February 17, 2026

RE: Report No. 96090, v.2
59 Parkway Ave
Toronto, ON
M6R 1T6

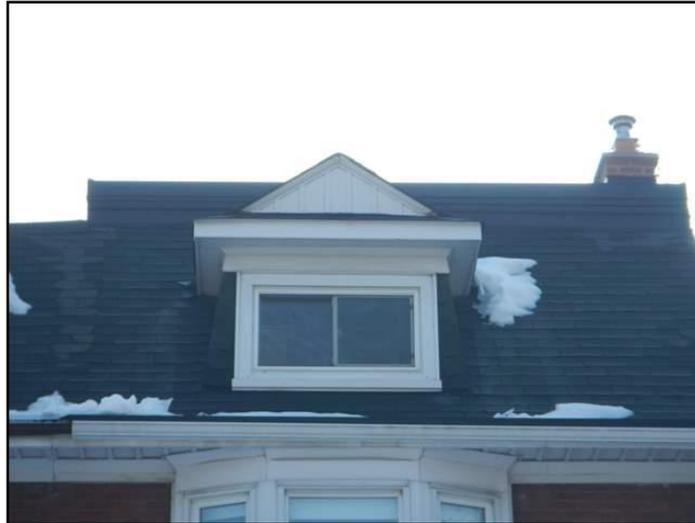
Asphalt shingles: front

StreetView shows old shingles in 2014, & new in 2015. Ask the seller for their documents.

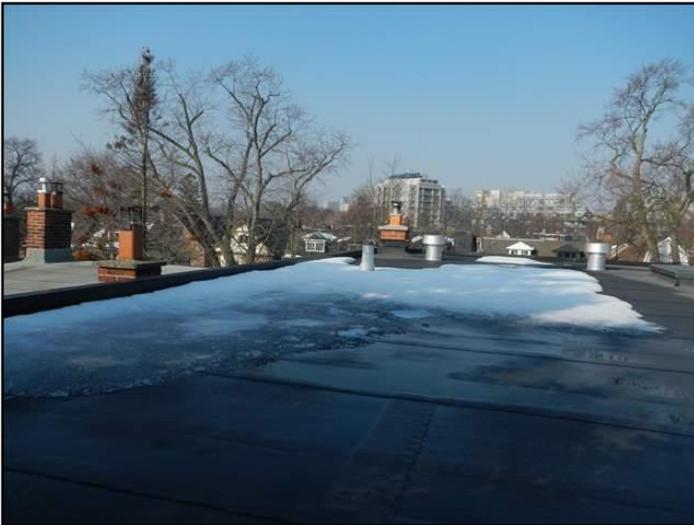
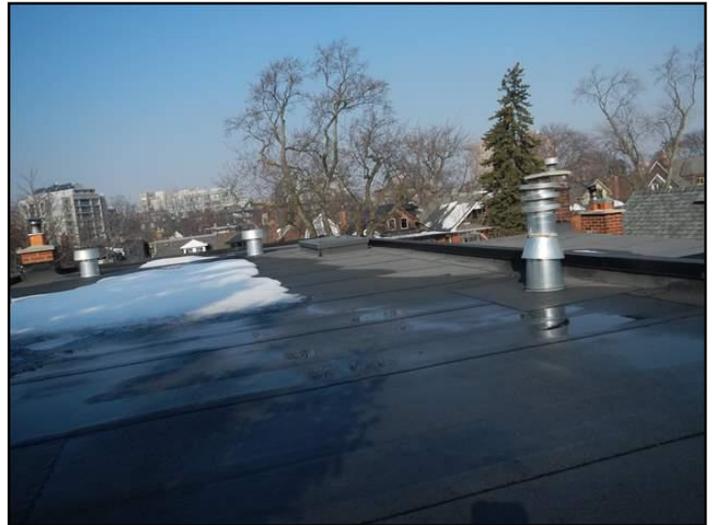
Modified bitumen membrane

The sellers stated that it was replaced in 2014: ask for the invoice & warranty.

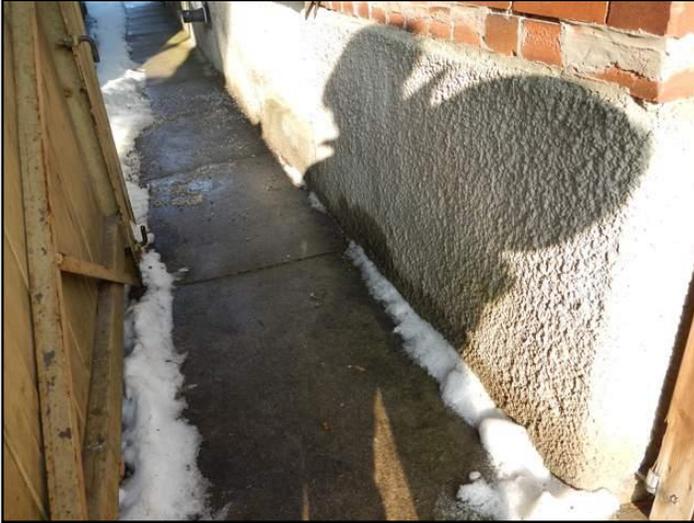
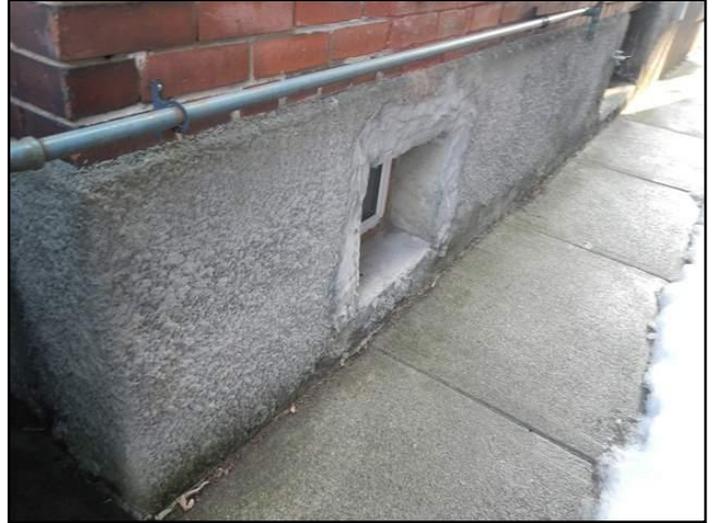
Condition: • The gap at the wall should be well sealed.

Task: Improve

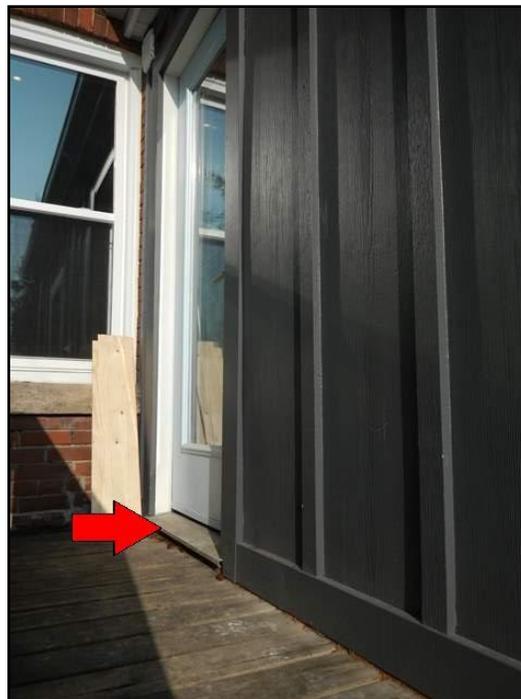
Condition: • Threshold - ineffective

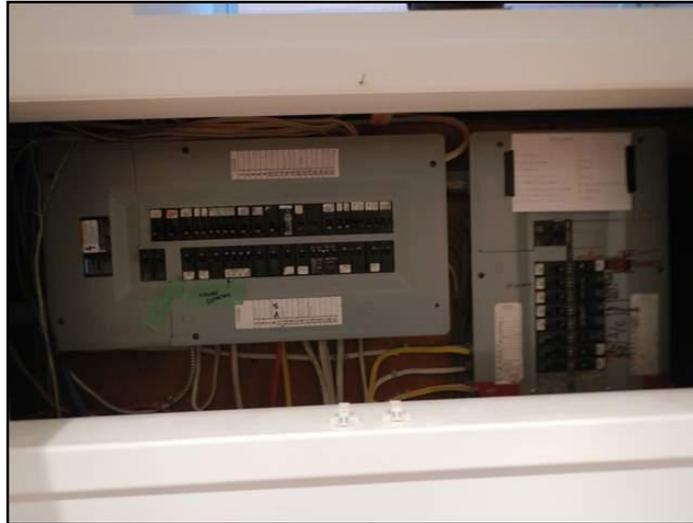
The electrical system has been s

- The electrical system has been substantially updated.

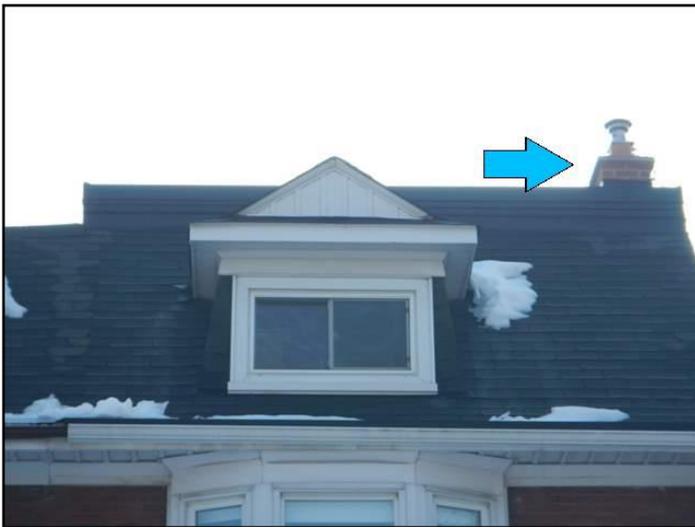
Masonry

Right side/front: it has been rebuilt from the roofline-up, and now has a proper cap.

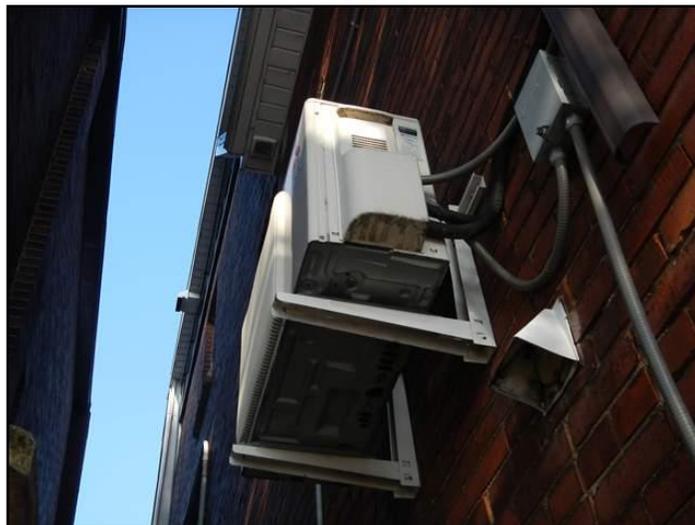
Air source

...for the 3rd floor bedroom: 12,000 BTU/hr, s/n may indicate made in 2012.

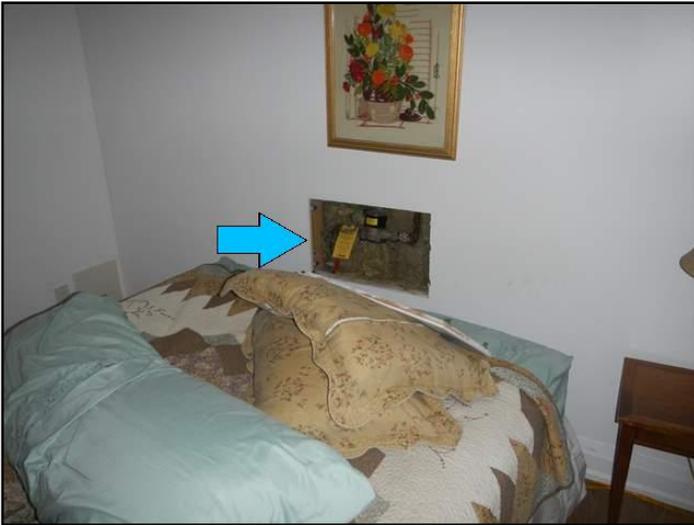
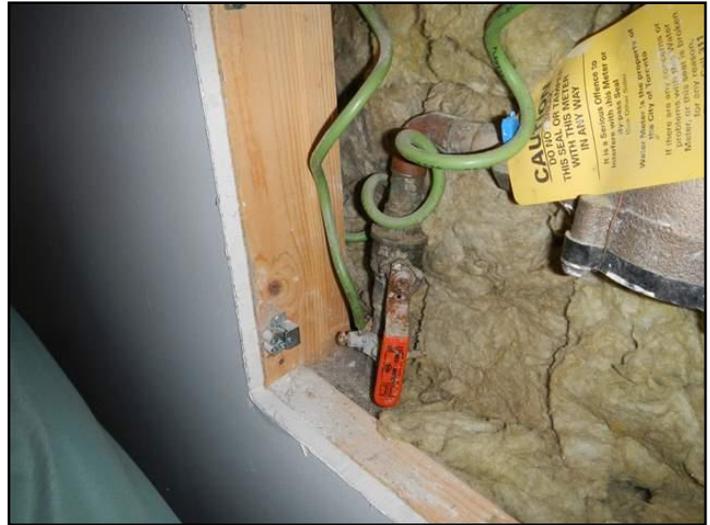
Not visible

The actual entry point is not visible: ask the seller and/or call 311.

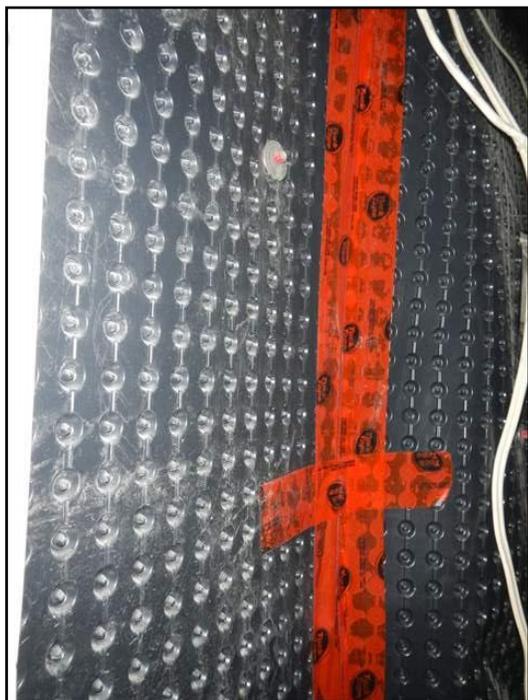
General: • A damp-proof membrane can be seen at the electrical panel: ask the seller for more information.
