Your Inspection Report

19 Halford Ave
Toronto, ON M6S 4G1

INSPECTION DATE:
Wednesday, February 4, 2026

RE: Report No. 96014
19 Halford Ave
Toronto, ON
M6S 4G1

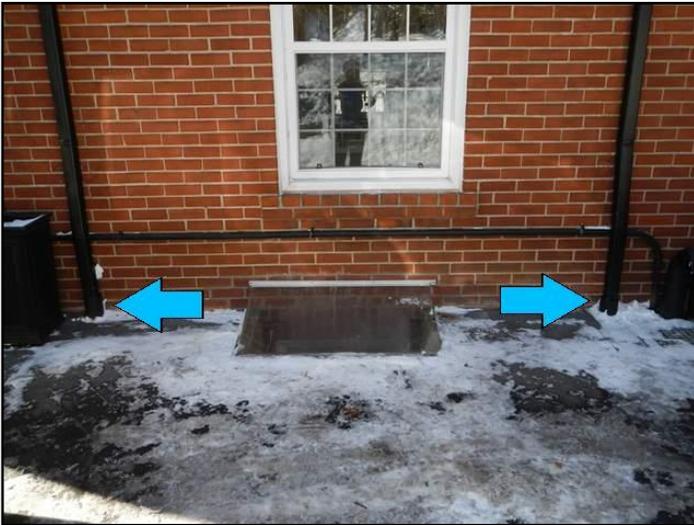
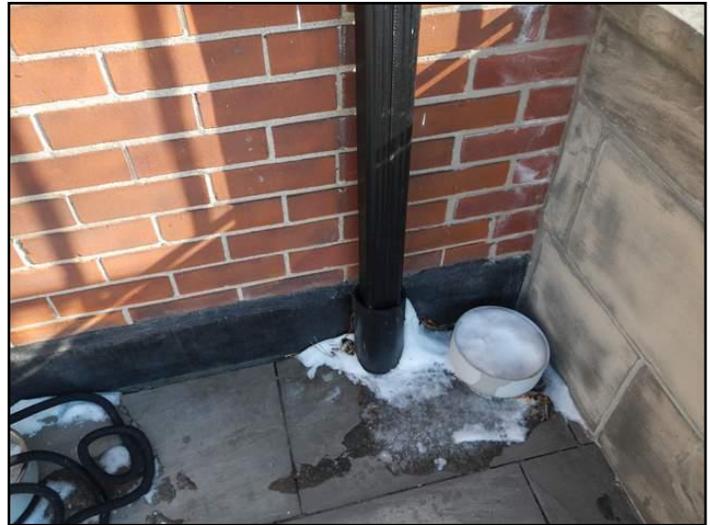
WALLS \ Masonry (brick, stone) and concrete

Condition: • [Spalling](#)

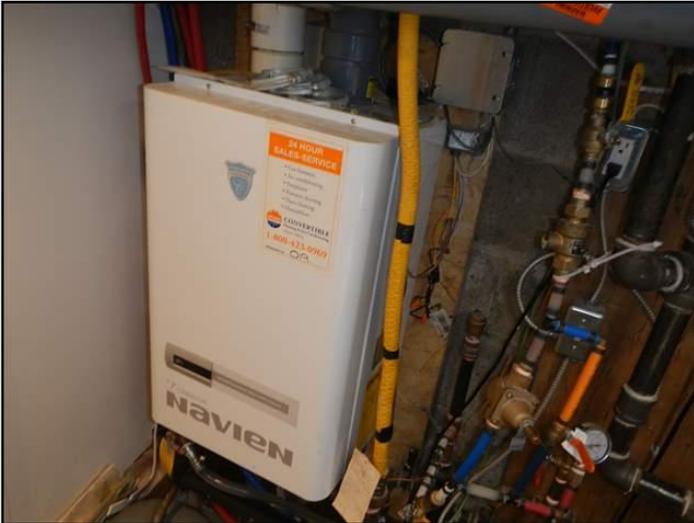
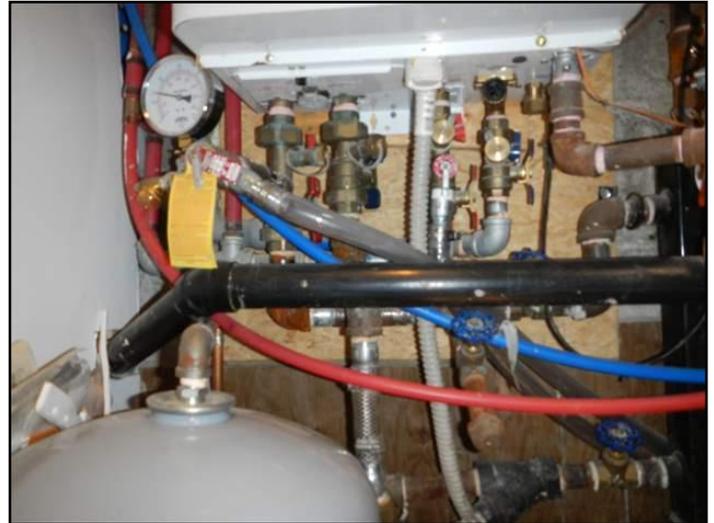
Boiler

Condition: • Near end of life expectancy.

Although the boiler is close to the end of its life, continue to use and maintain the unit until it fails. Be prepared to replace the boiler at any time.

Task: Replace

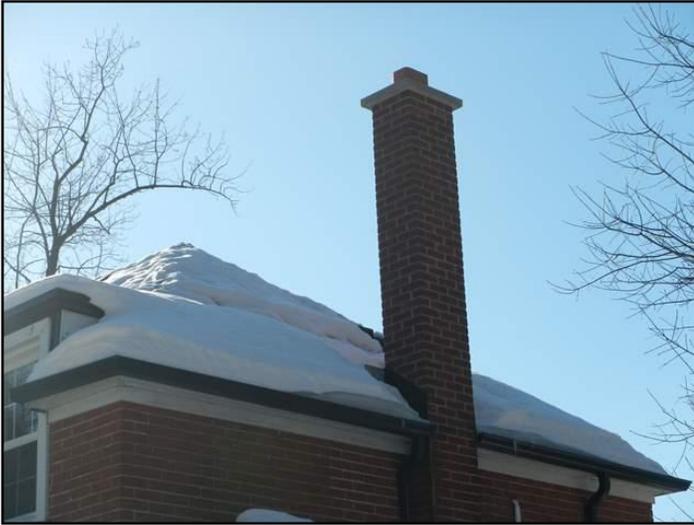
Left side

Left side: it has been repaired and now has a proper cap.

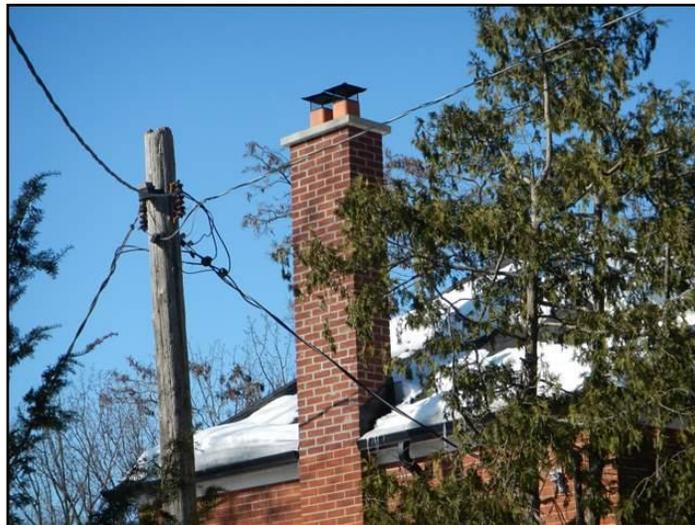
Right side: it has been rebuilt from the roofline-up, and now has a proper cap.

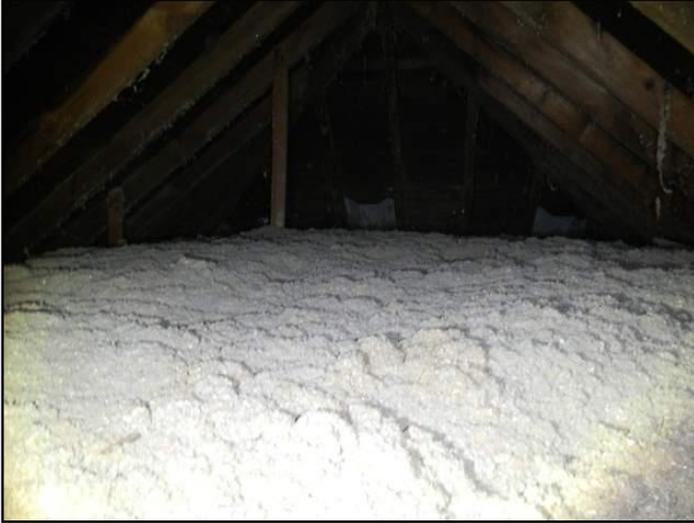
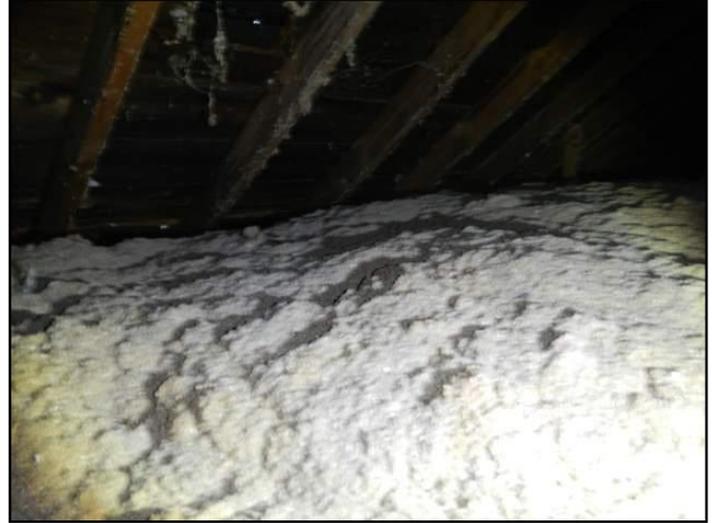
Cellulose

Condition: • [Amount less than current standards](#)

Insulation levels are below modern standards (R50-R60) and, in many cases, it is not practical (or cost effective) to improve it unless the opportunity presents itself (e.g. during renovations). Improvements may lead to lower heating/air conditioning costs and improved comfort.

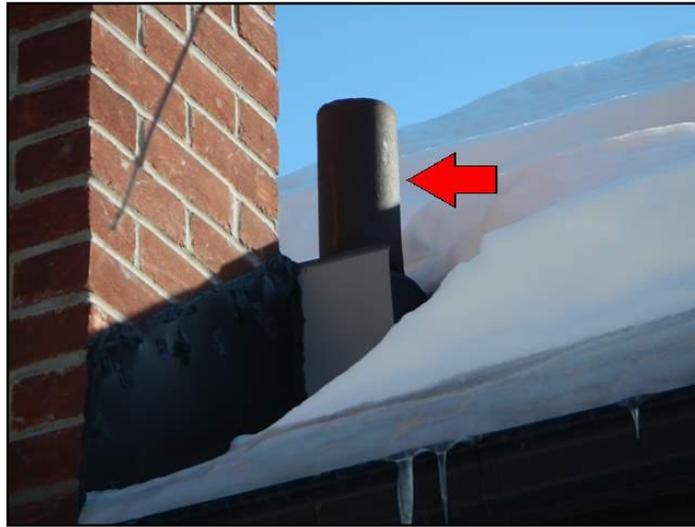
Cast iron

Condition: • The cast iron waste piping is near the end of its normal life expectancy and is prone to rusting through or splitting. Replacement may be required in the near future.

Task: Further evaluation Replace

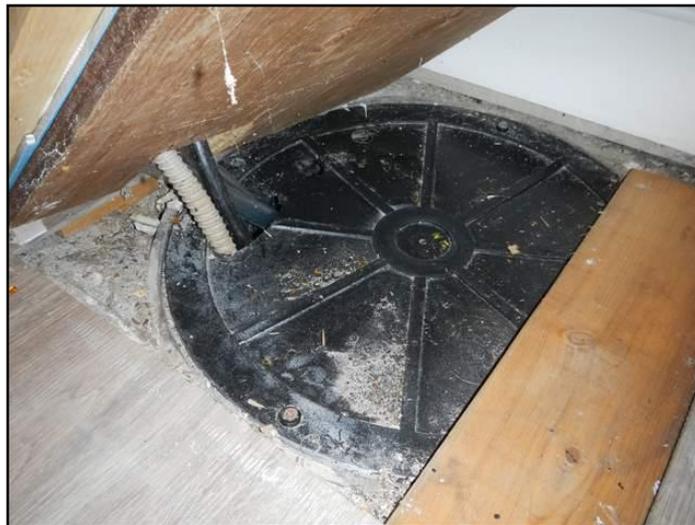
Sump pump
