Your Inspection Report

31 Runnymede Rd
Toronto, ON M6S 2Y1

INSPECTION DATE:
Monday, March 23, 2026

RE: Report No. 96580, v.2
31 Runnymede Rd
Toronto, ON
M6S 2Y1

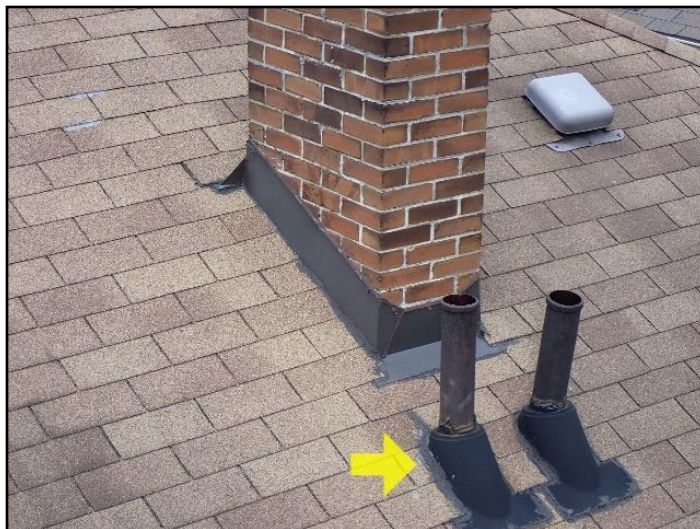
SLOPED ROOF FLASHINGS \ Roof vent

Condition: • Caulked

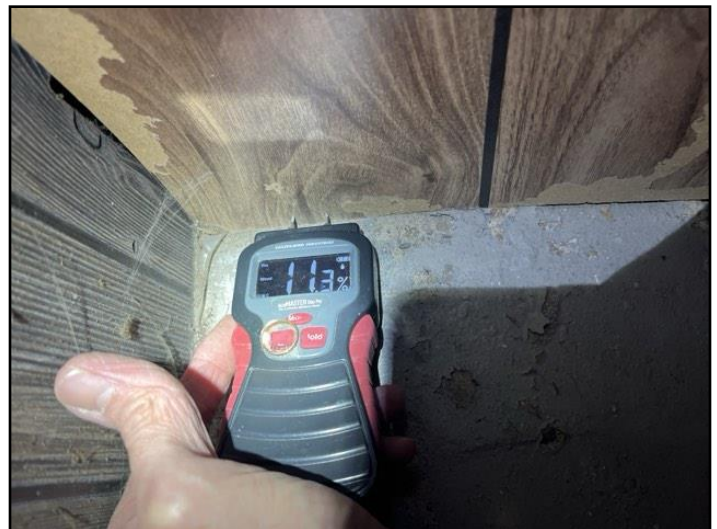
Right (looking from street) [Closet]: Low

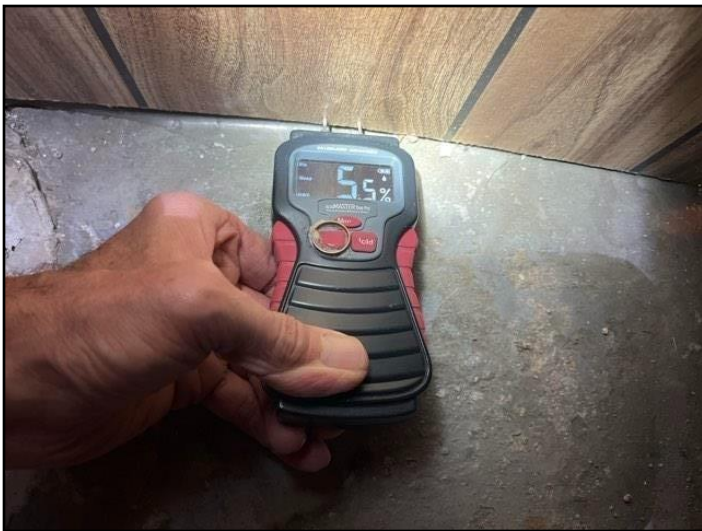
Front Left: Low moisture

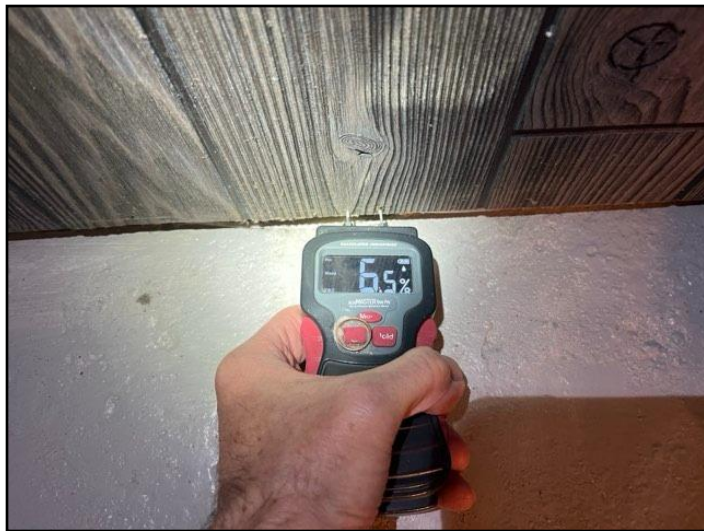
Right Side: Low moisture

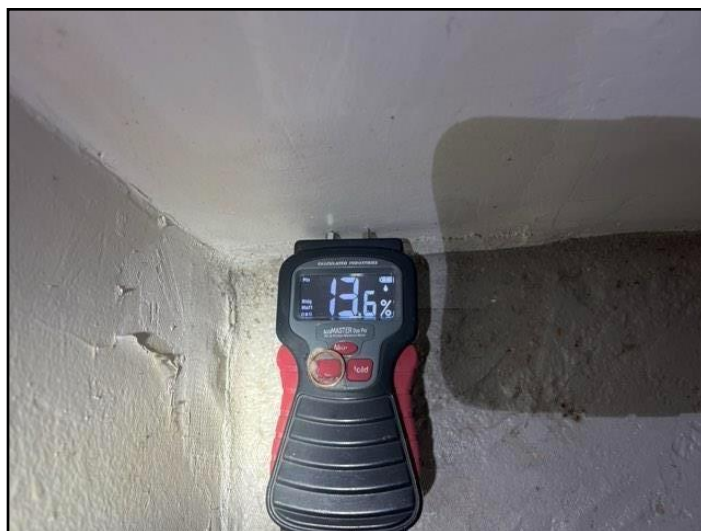
Rear Right: Low moisture

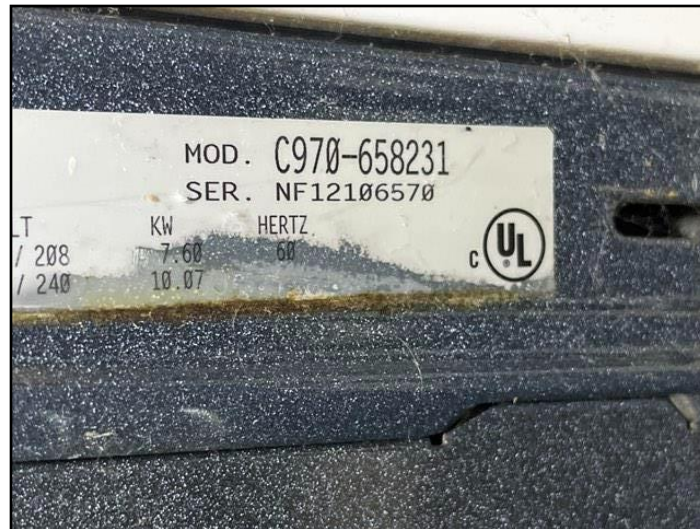
Kenmore

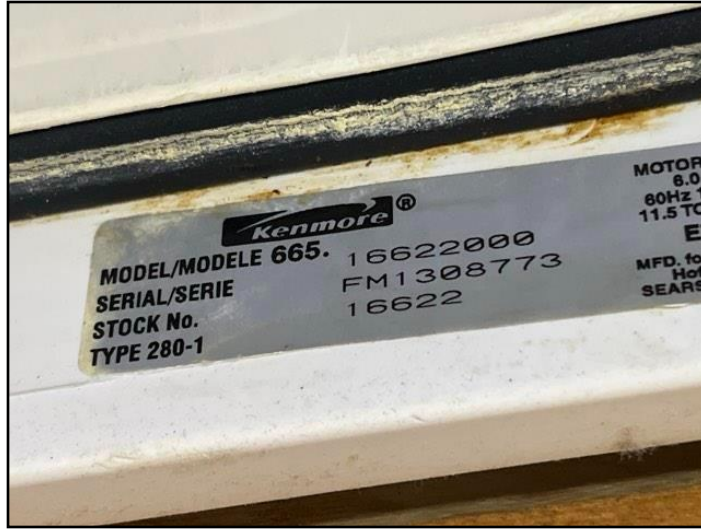
Kenmore
